3D Virtual Design Technology, Inc.

# Nondestructive Testing and Evaluation (NDT)

Combining Terrestrial Laser Scanning  
&  
Infrared Thermography

Case Studies

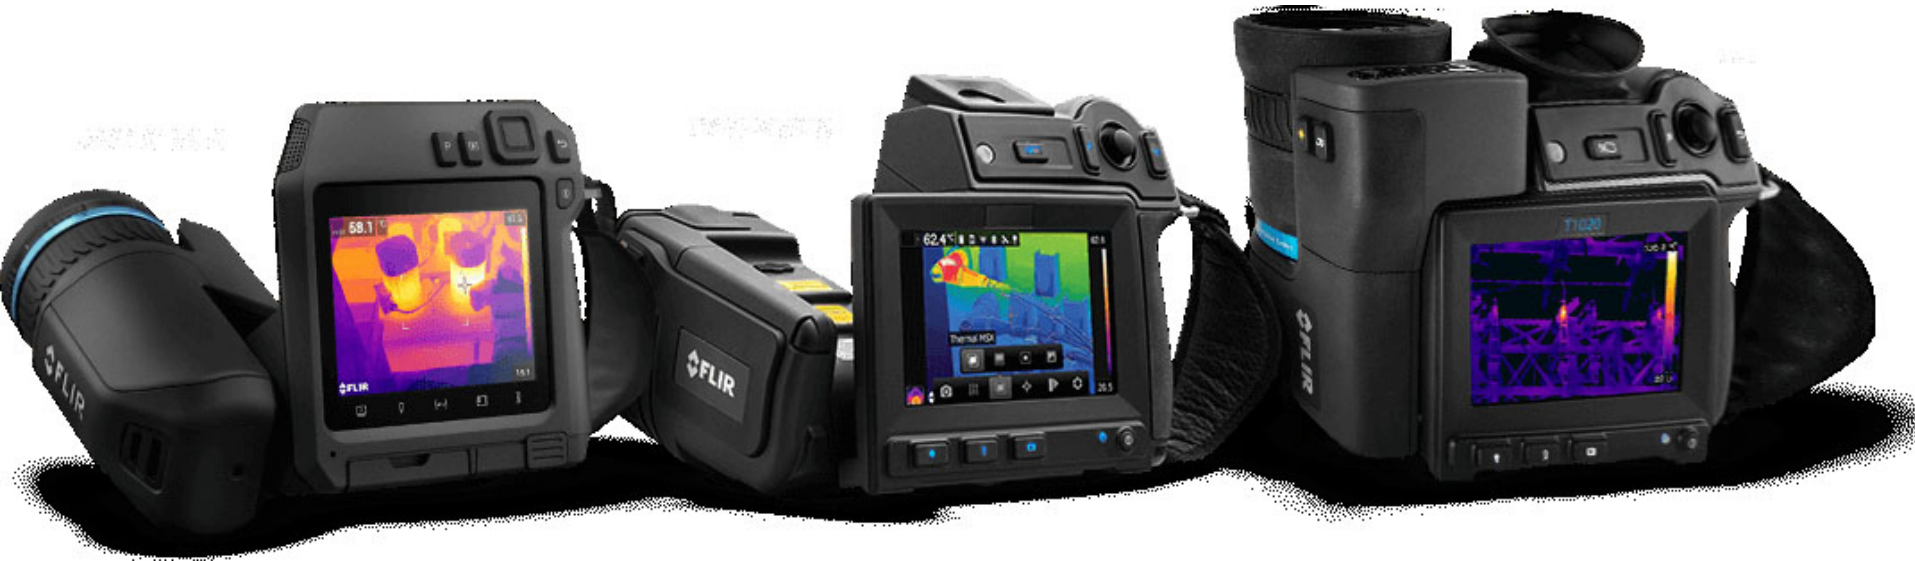
## Infrared Camera:

A non-contact device that detects infrared energy (heat) and converts it into an electronic signal, which is then processed to produce a thermal image on a video monitor and perform temperature calculations.

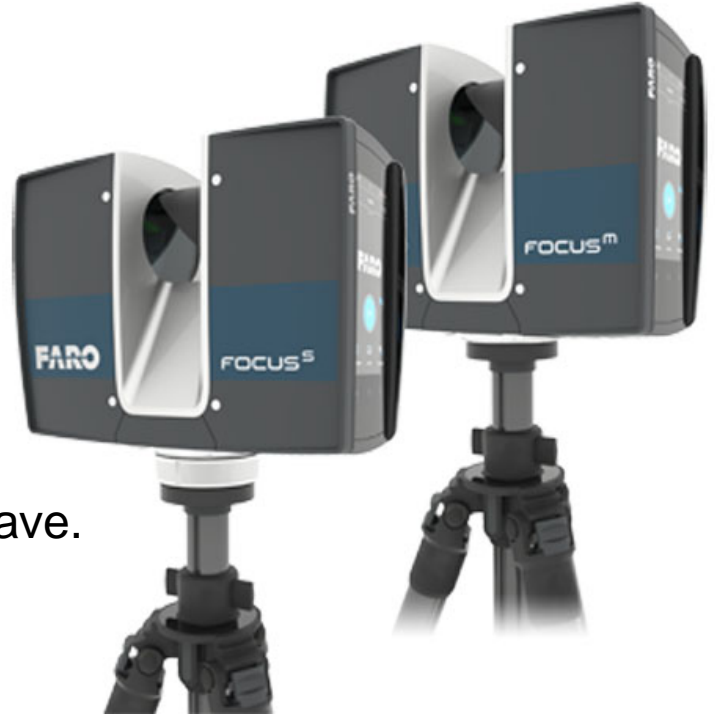
## Point Cloud:

A collection of data points defined by a given coordinate system (3D data set).

Information from each recorded point:

- Position, as a set of coordinates
- Reflectance, as a ratio between the emitted and reflected phases of the laser wave.

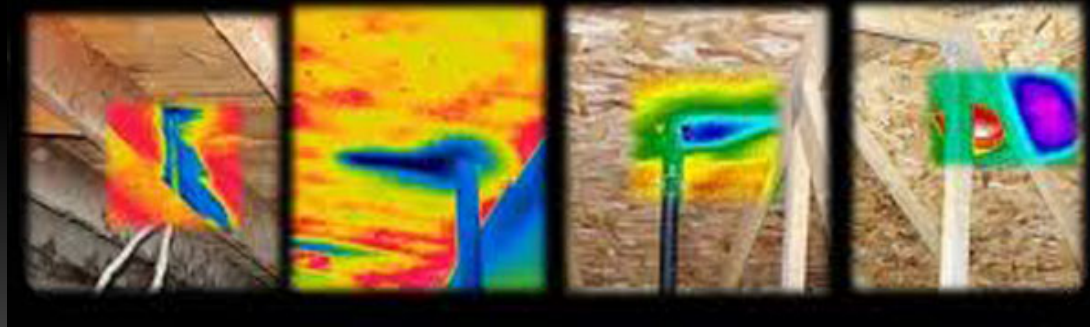
Roof Leaks Detected

The ability to visualize heat makes thermography a powerful tool for studying energy efficiency. Excessive levels of heat loss through a structure and/or damage are easily located with further investigation required to determine the cause (e.g. poor insulation, air leakage, moisture damage)

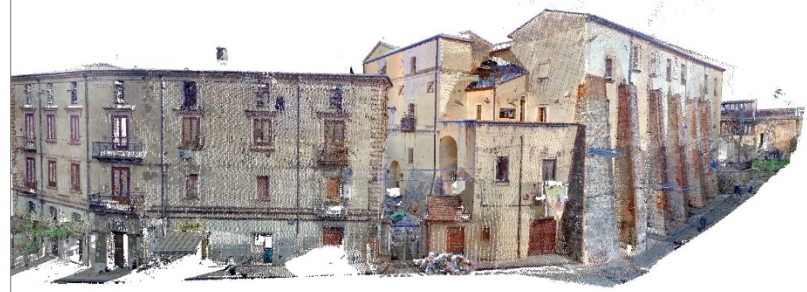
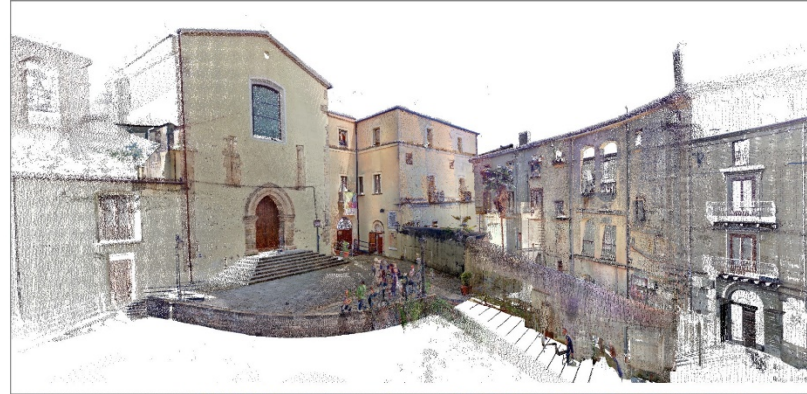
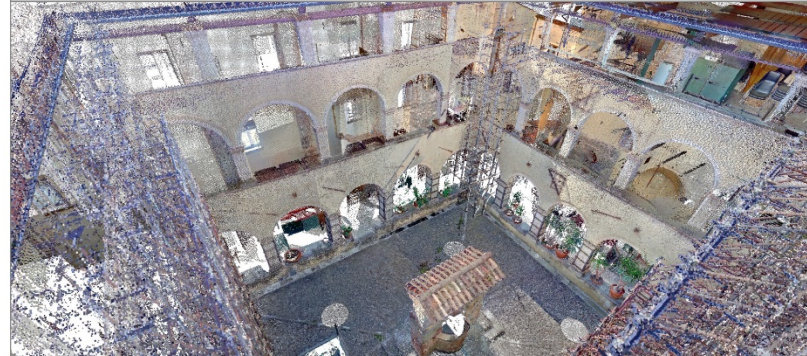
Overlaying and comparing the collected data using a combination of 3D laser scanning (TLS) for 3D reconstruction and Infrared Thermography (IRT) to detect the thermal anomalies aimed to realize a monitoring system of monumental buildings in seismic areas and to analyze the vulnerability of the structural elements.

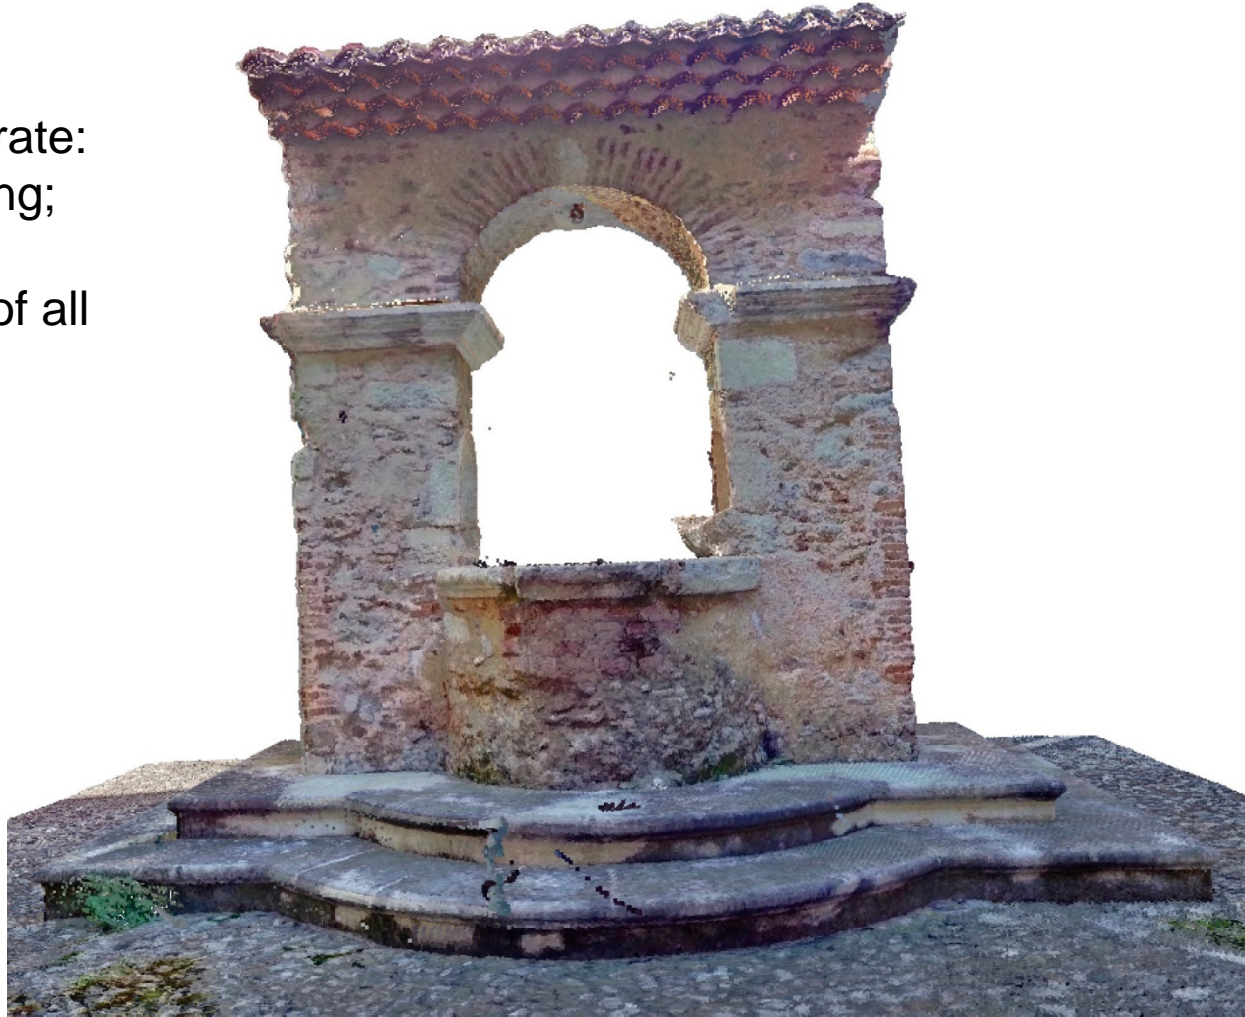
TLS was used to define accurate:

- geometry of the building;
- spatial position;
- geometric dimension of all structural elements.

Some architectural elements were scanned at a higher resolution and some were meshed for a more realistic representation.

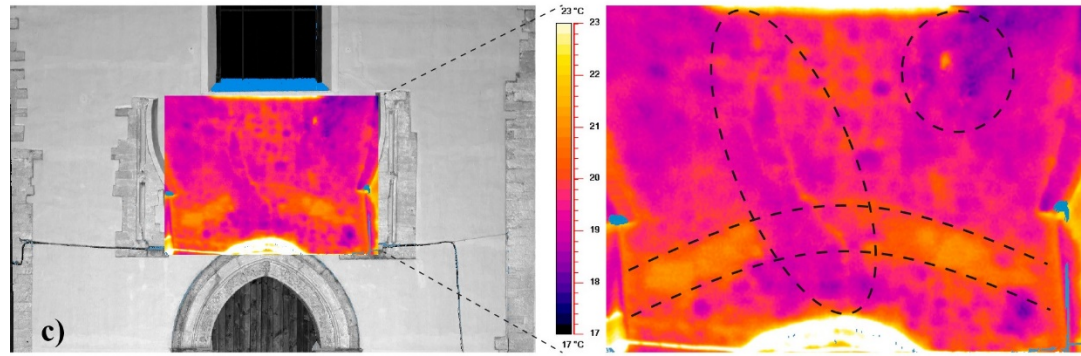
- a) The map of residuals assumes the shape of a segmental arc linking the two columns.
- b) Thermal image obtained in the evening.
- c) Thermal image obtained in the morning.

Different lighting conditions can influence the detection of anomalies.

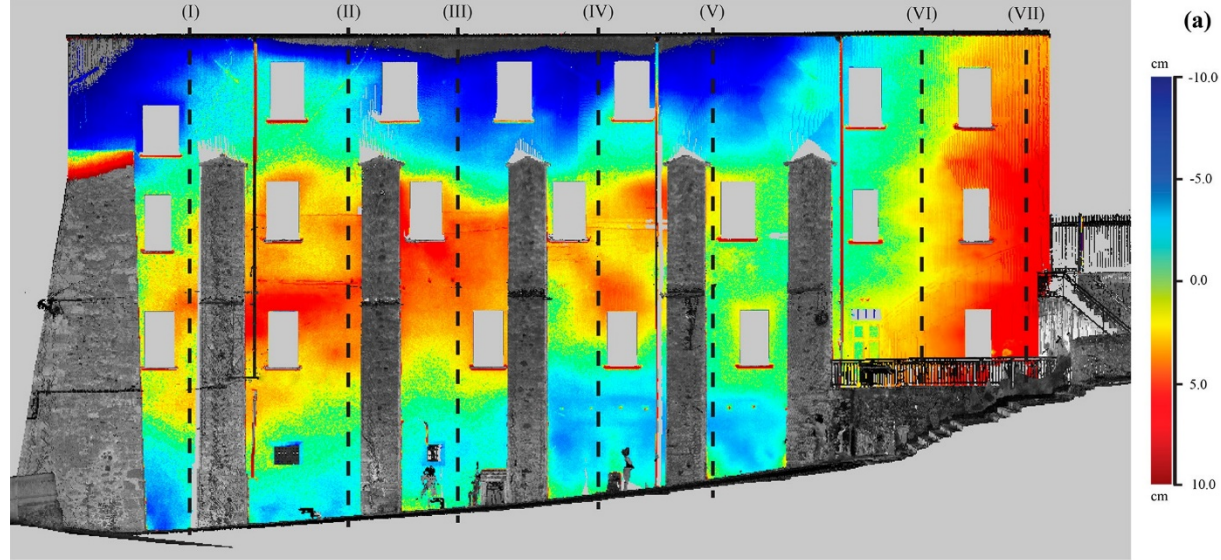
- a) Point cloud and map of residuals of the exterior wall.
- b) Vertical profiles of the distance out of plane.

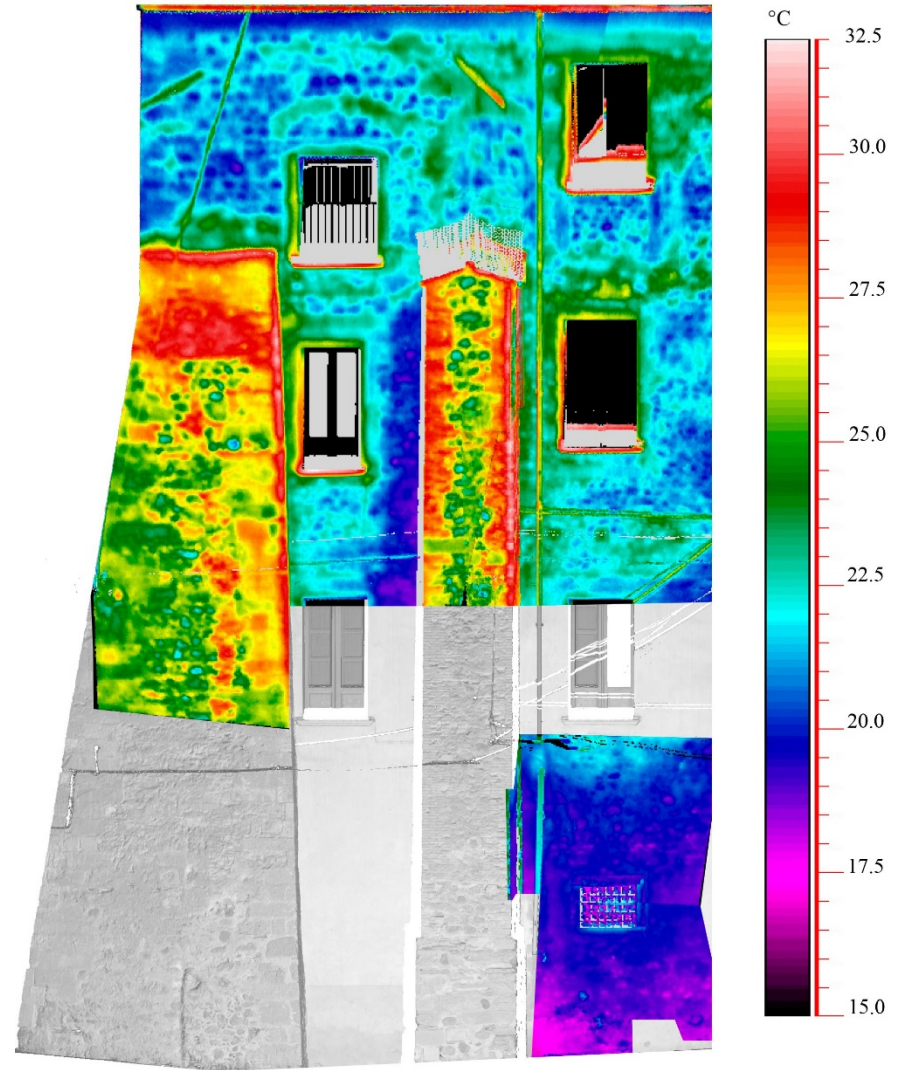
Thermograms projected onto the point cloud of the wall, constructed with stones covered by plaster.

The buttresses are made up of composite material containing both stones and brick.

The lower right of the wall shows the presence of moisture due to the capillary rise of water from the subsoil.

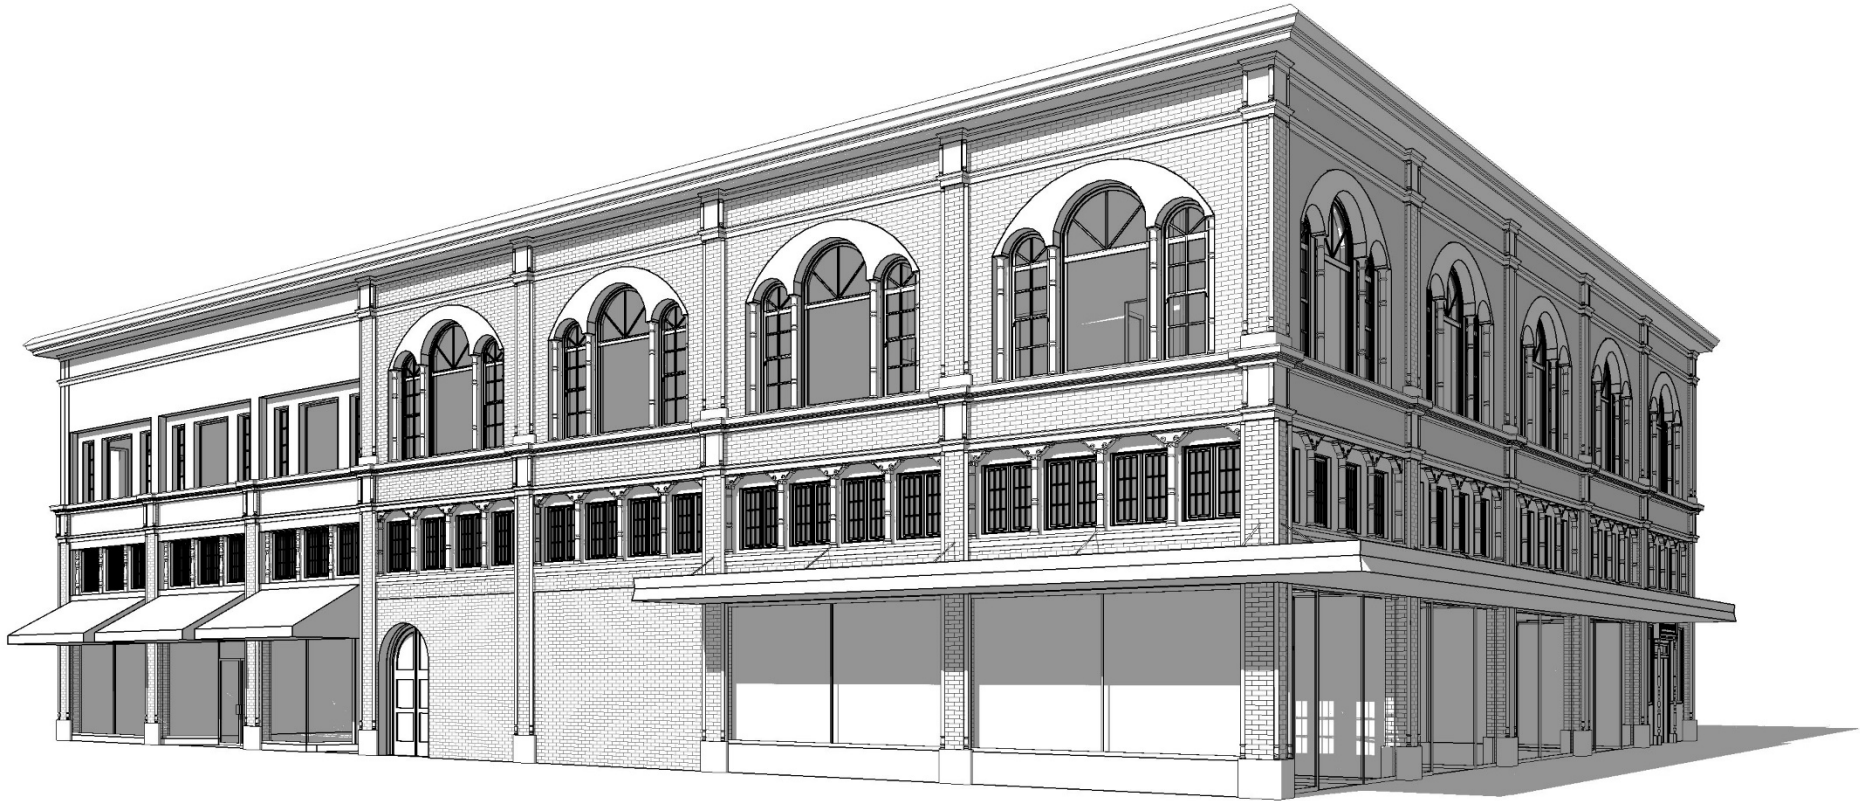
Axonometric &  
Plan View

Pre-Earthquake

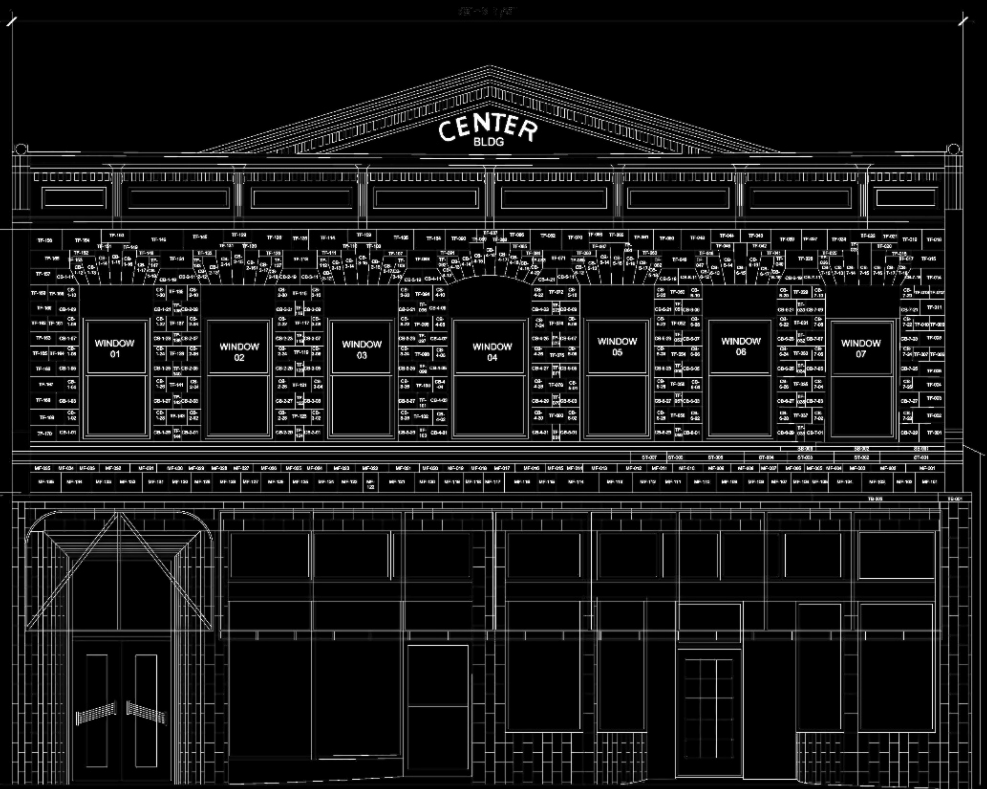
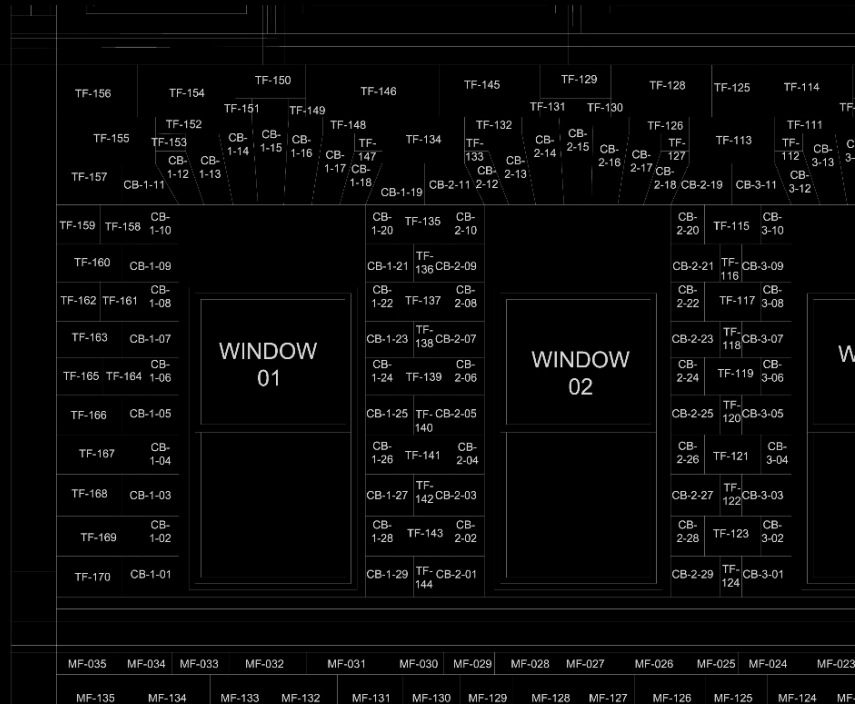
# 2D CAD masonry layout & stone mapping

LEGEND:  
 TF-XXX = TOP FIELD BLOCK  
 MF-XXX = MIDDLE FIELD BLOCK  
 SB-XXX = SILL BLOCK  
 ST-XXX = SILL TRIM BLOCK  
 TB-XXX = TRIM BLOCK  
 CB-XXX & CB-XXX-BLOCK - WINDOW # - XXX

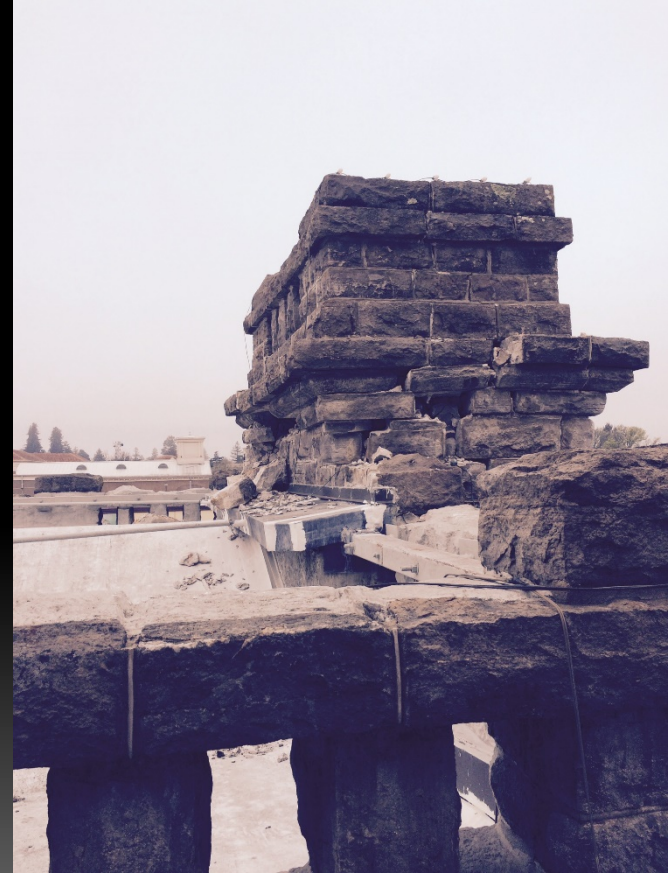
# National Landmark - Goodman Library, Napa, CA

Laser scanning is an effective, non-invasive method to capture a building too fragile or structurally unsound for direct contact.

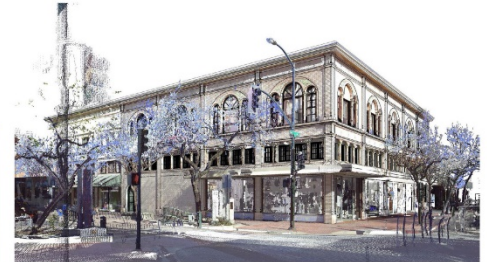
Figure 1: 3D point cloud overlaying the 3D BIM model.
