Dunbar Hotel

4255 S. Central Avenue, Los Angeles, CA 90011
(Constructed 1928)

Rehabilitation: Project Scope

Rehabilitation: Philosophy

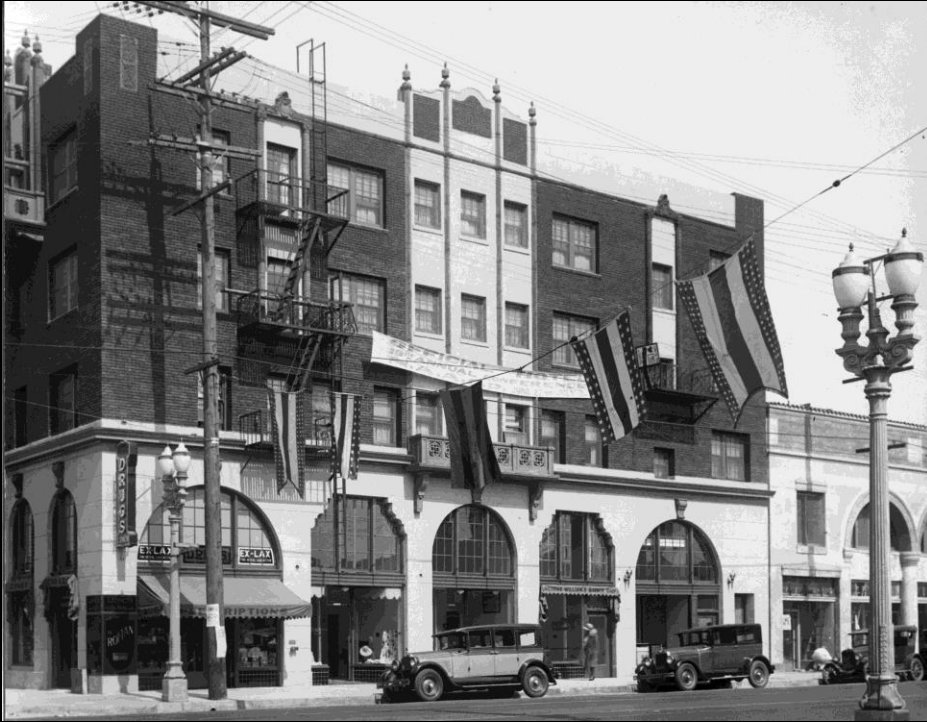
Primary (East) Central Avenue Elevation, Circa 1928

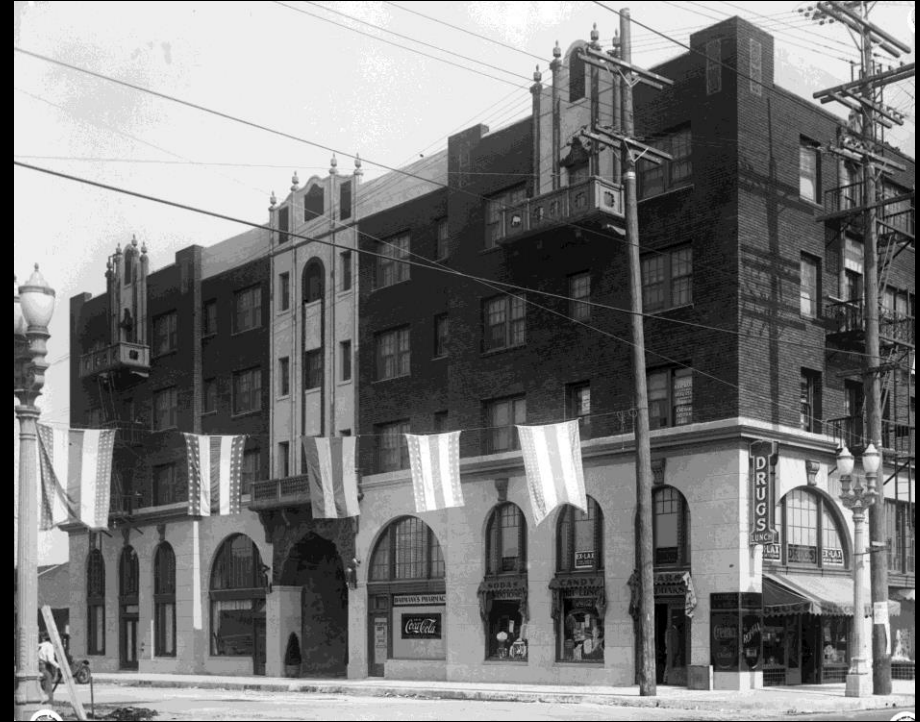
Secondary (South) 42nd Place Elevation, Circa 1928

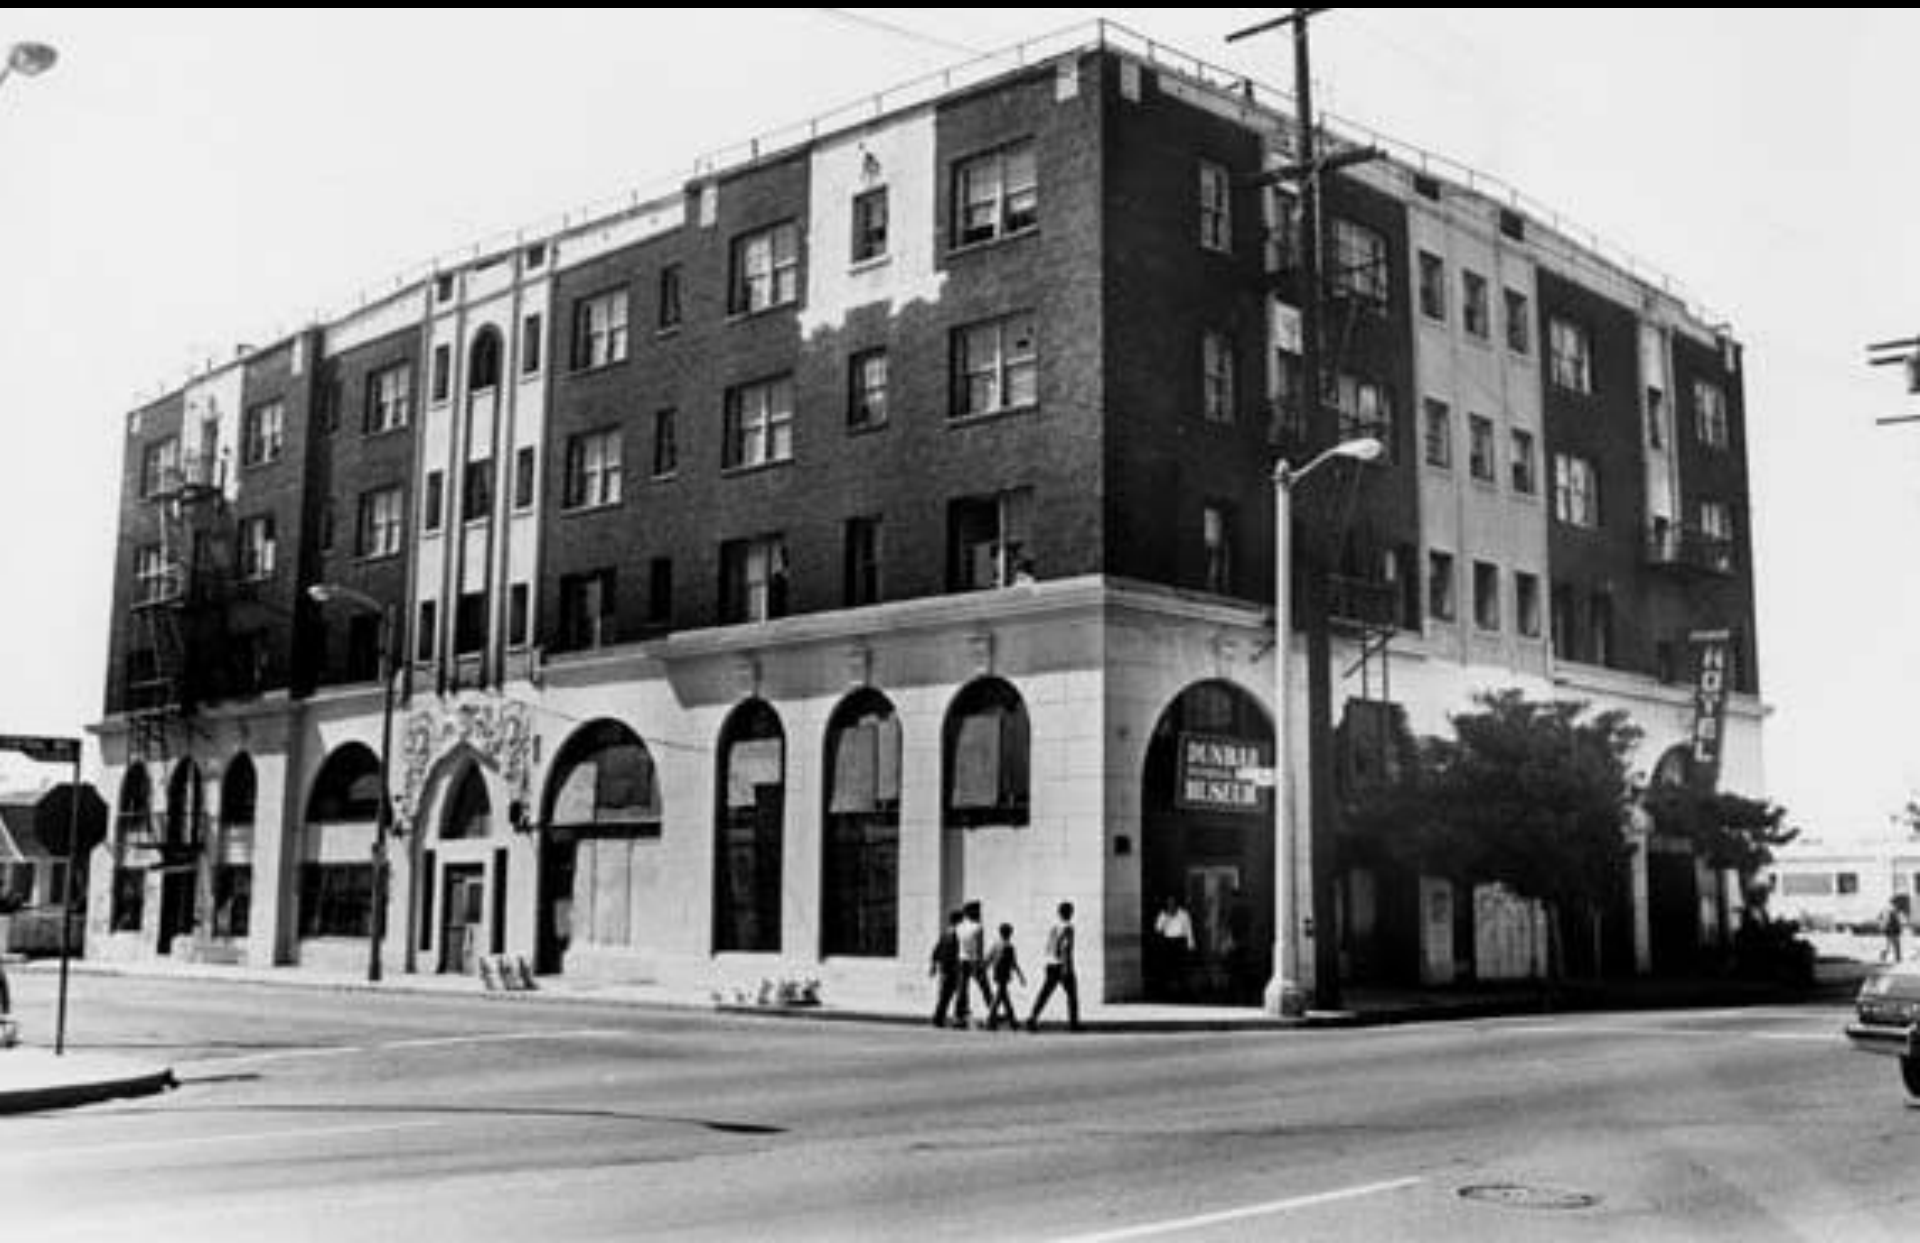
Circa 1987

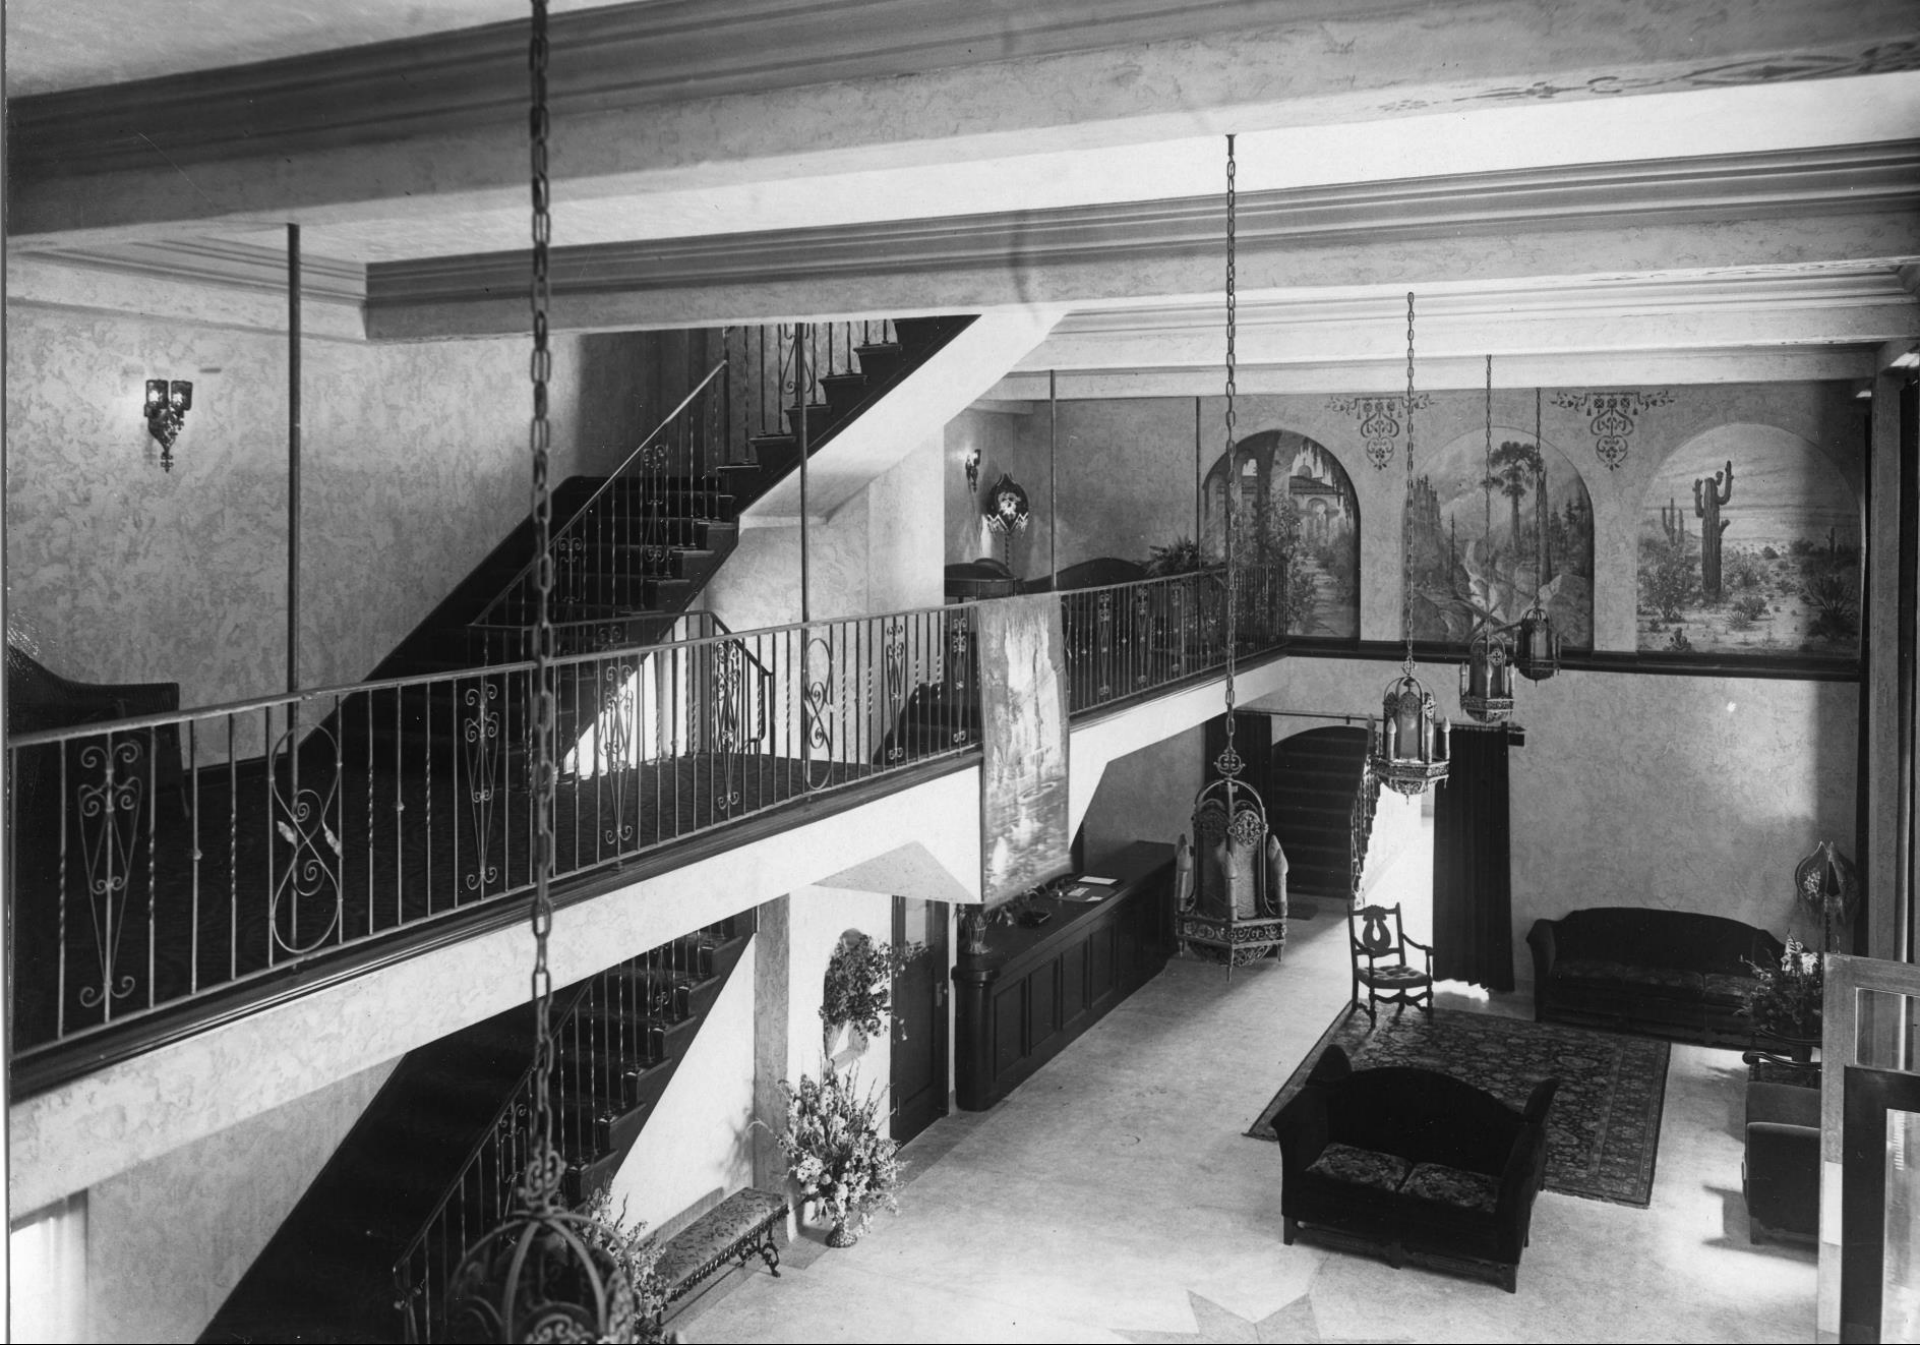
Historic Appearance of Lobby, Circa 1928

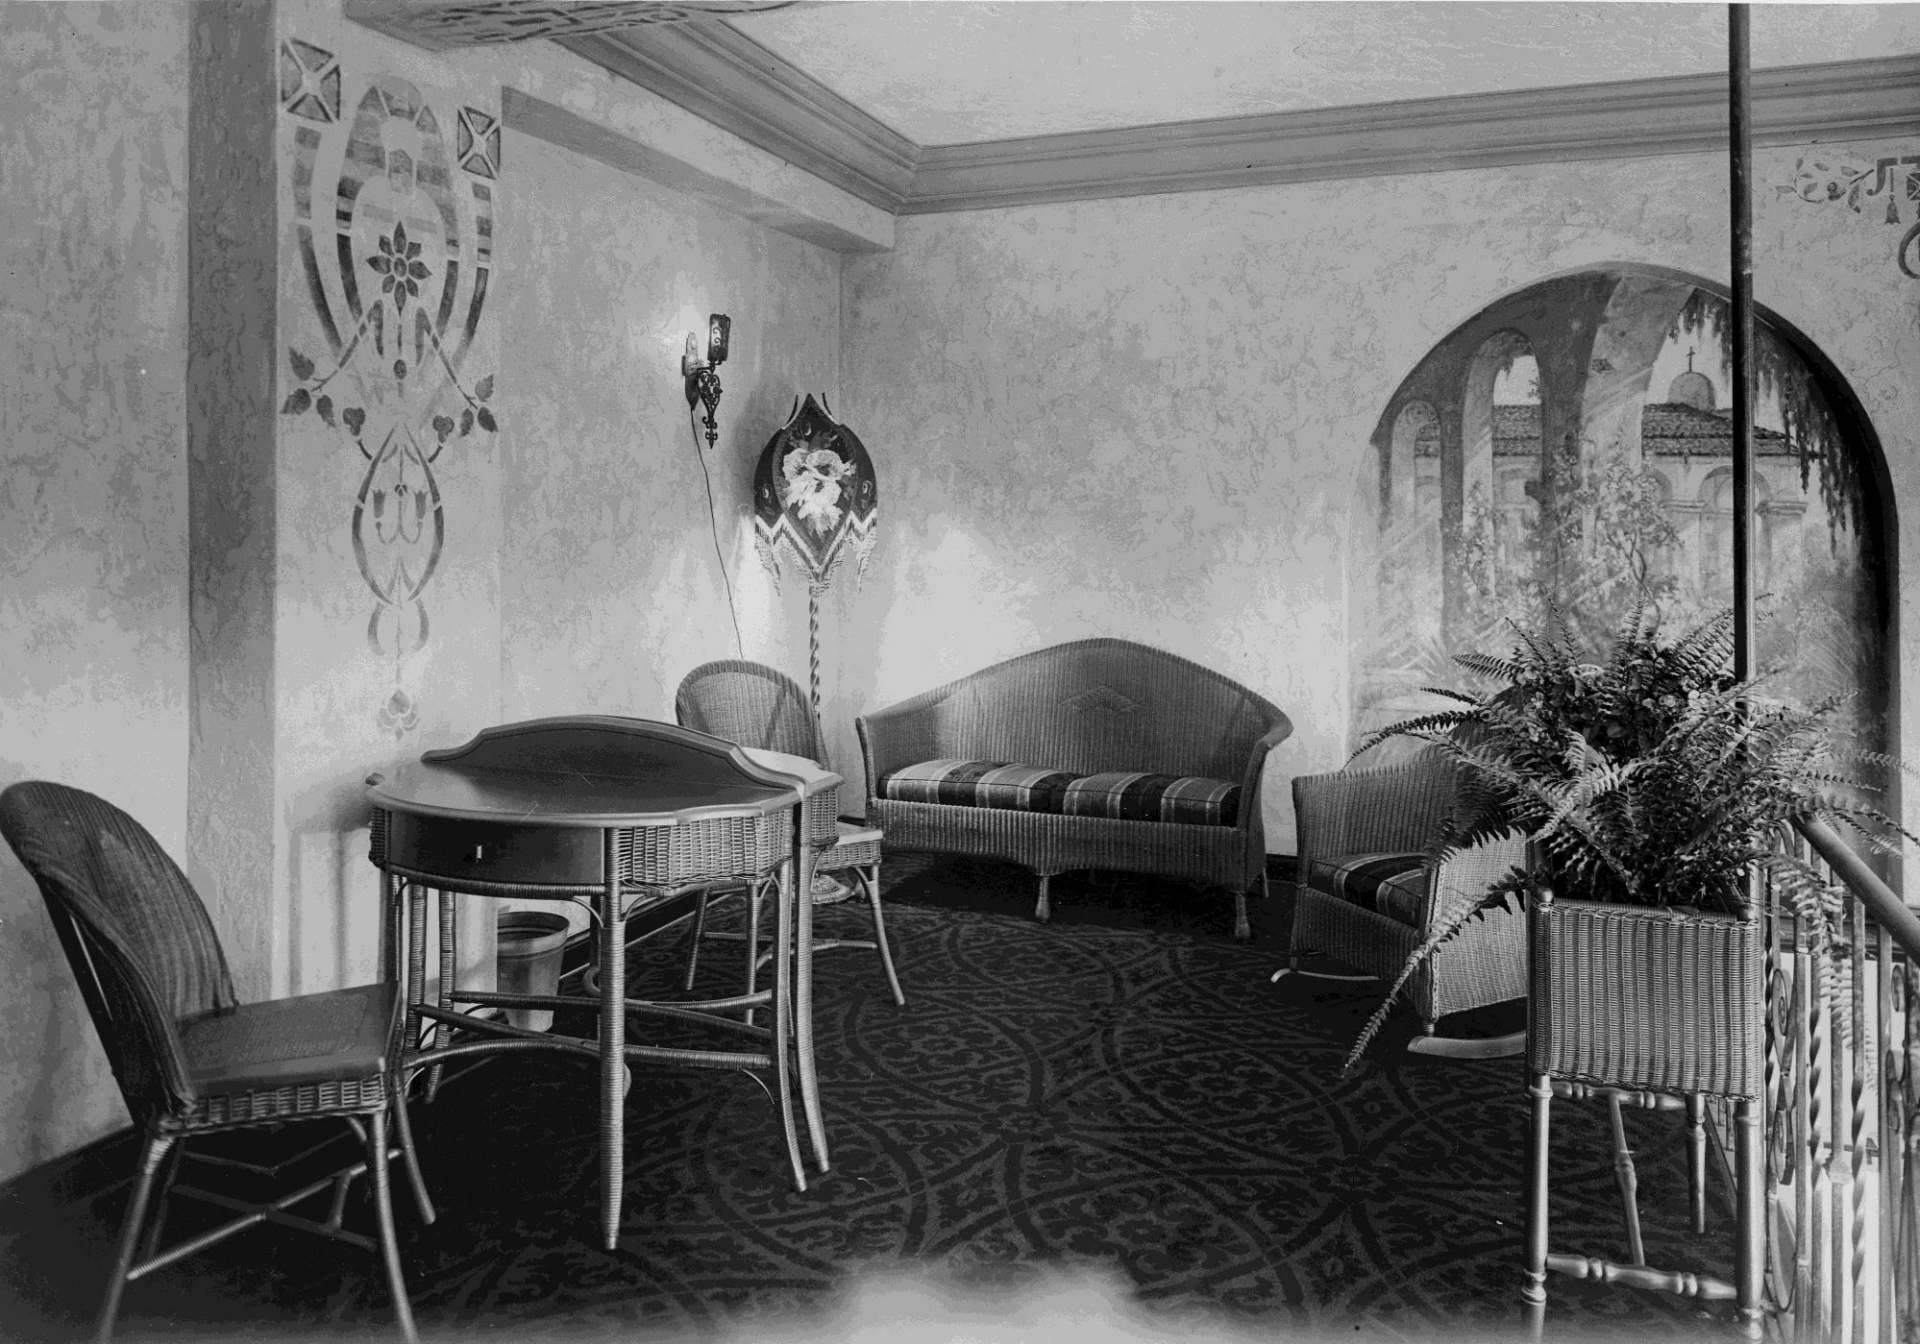
Historic Appearance of Mezzanine, Circa 1928

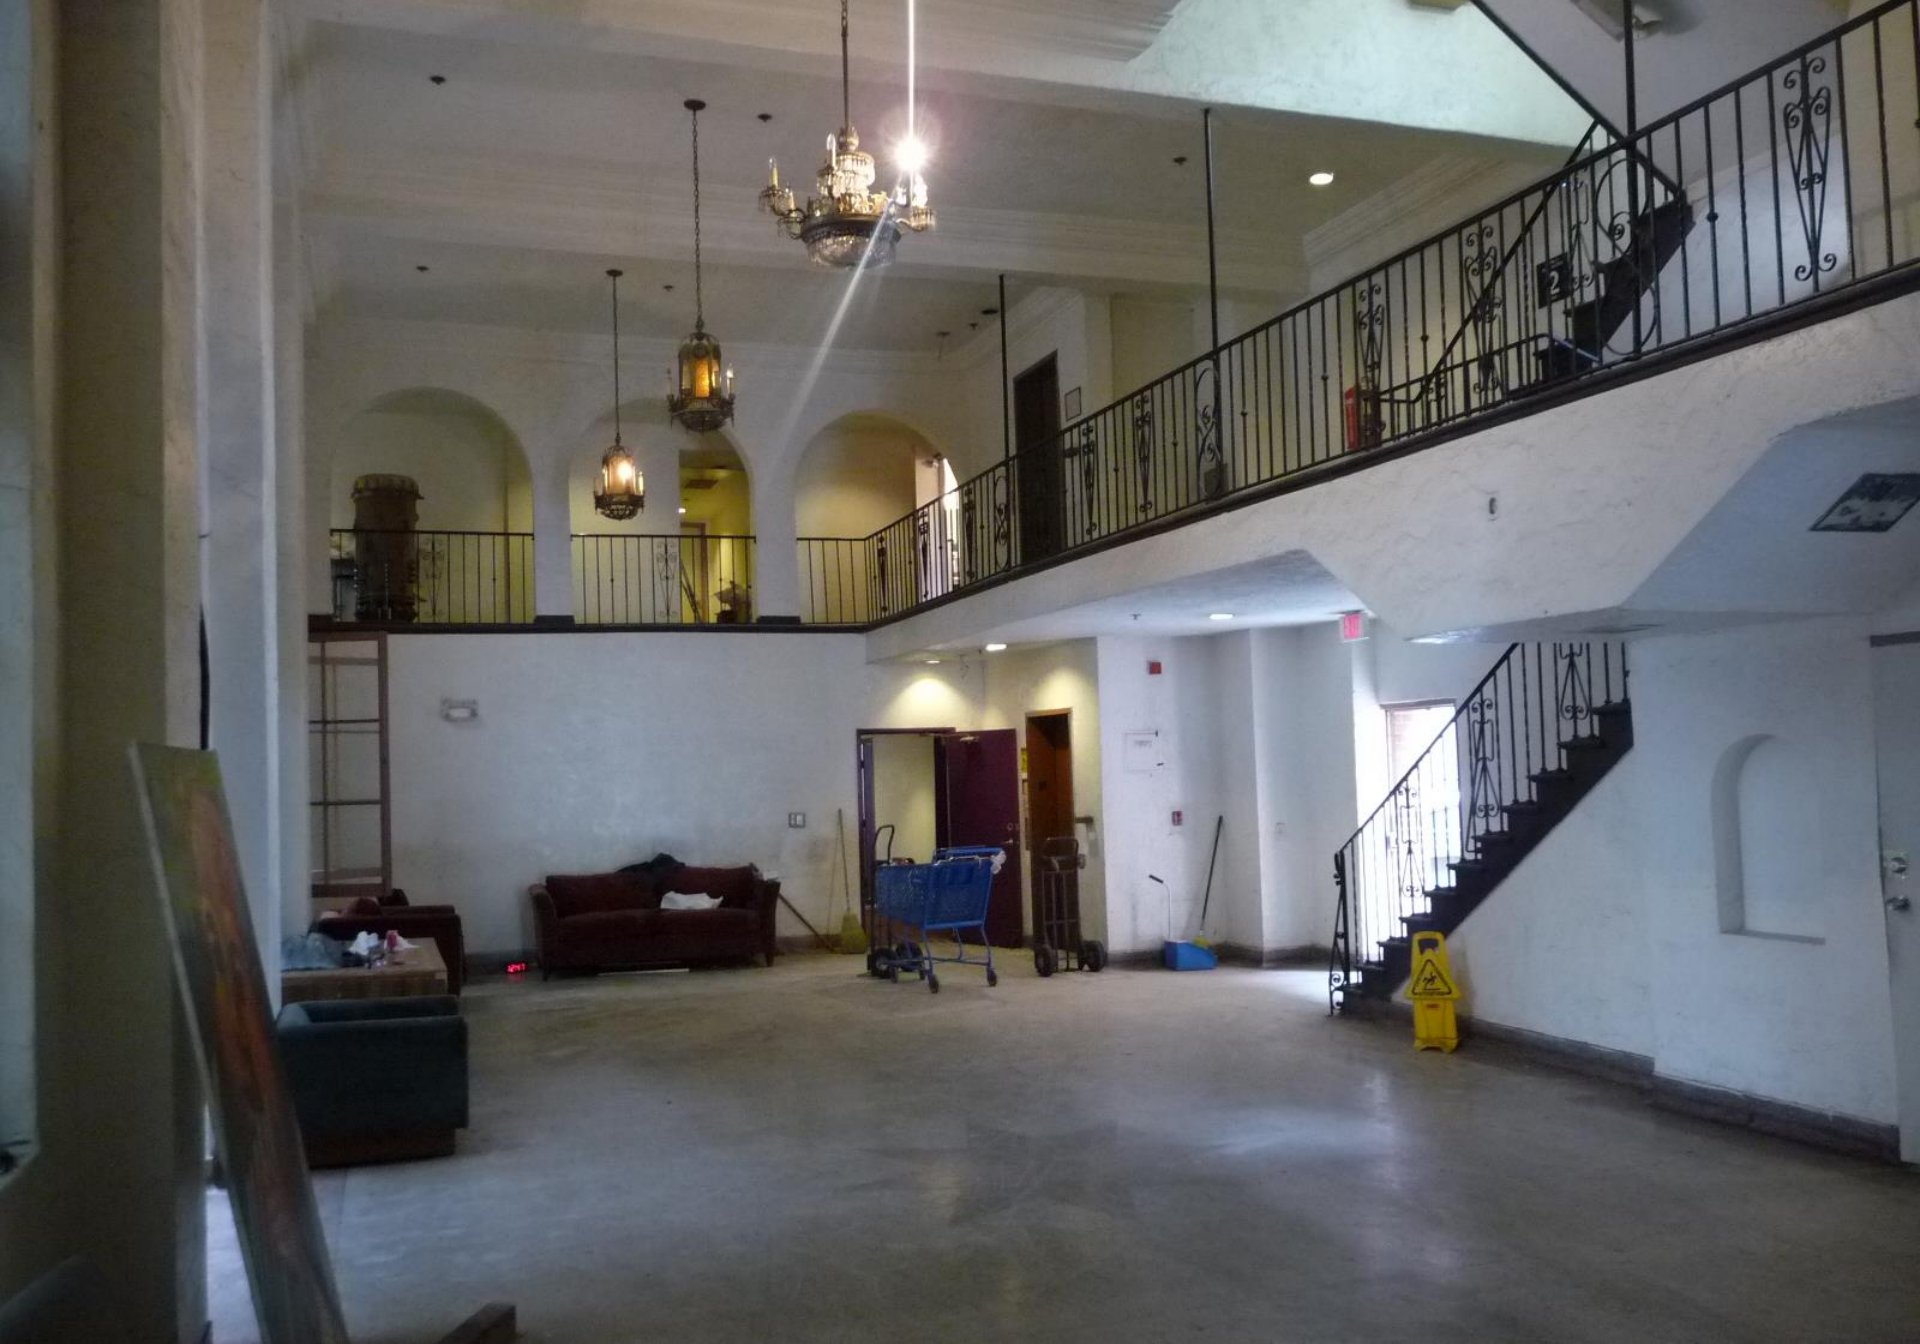
Lobby Before Rehabilitation, 2011

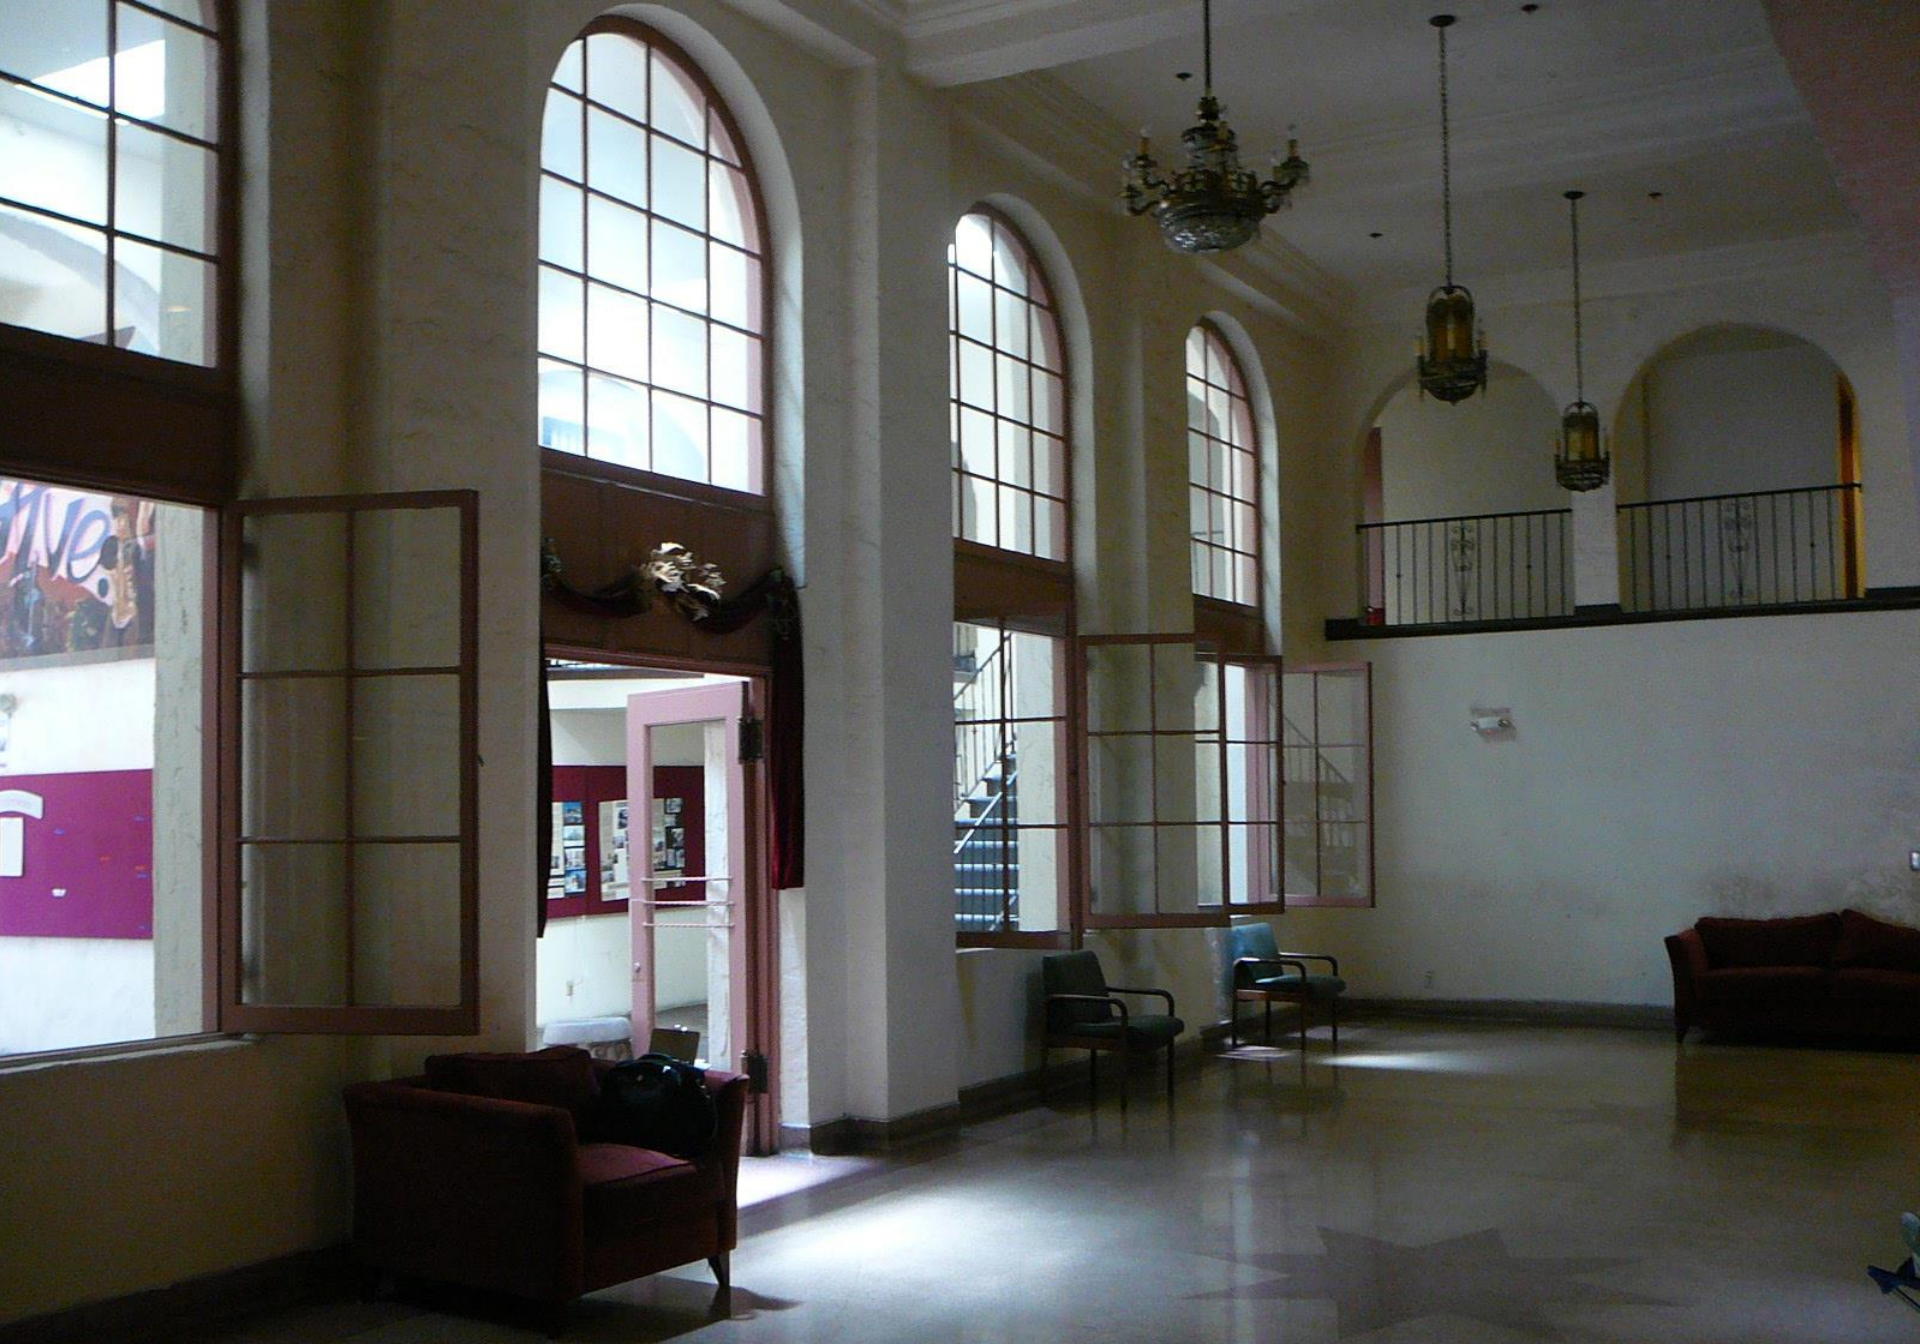
Lobby Before Rehabilitation, 2009

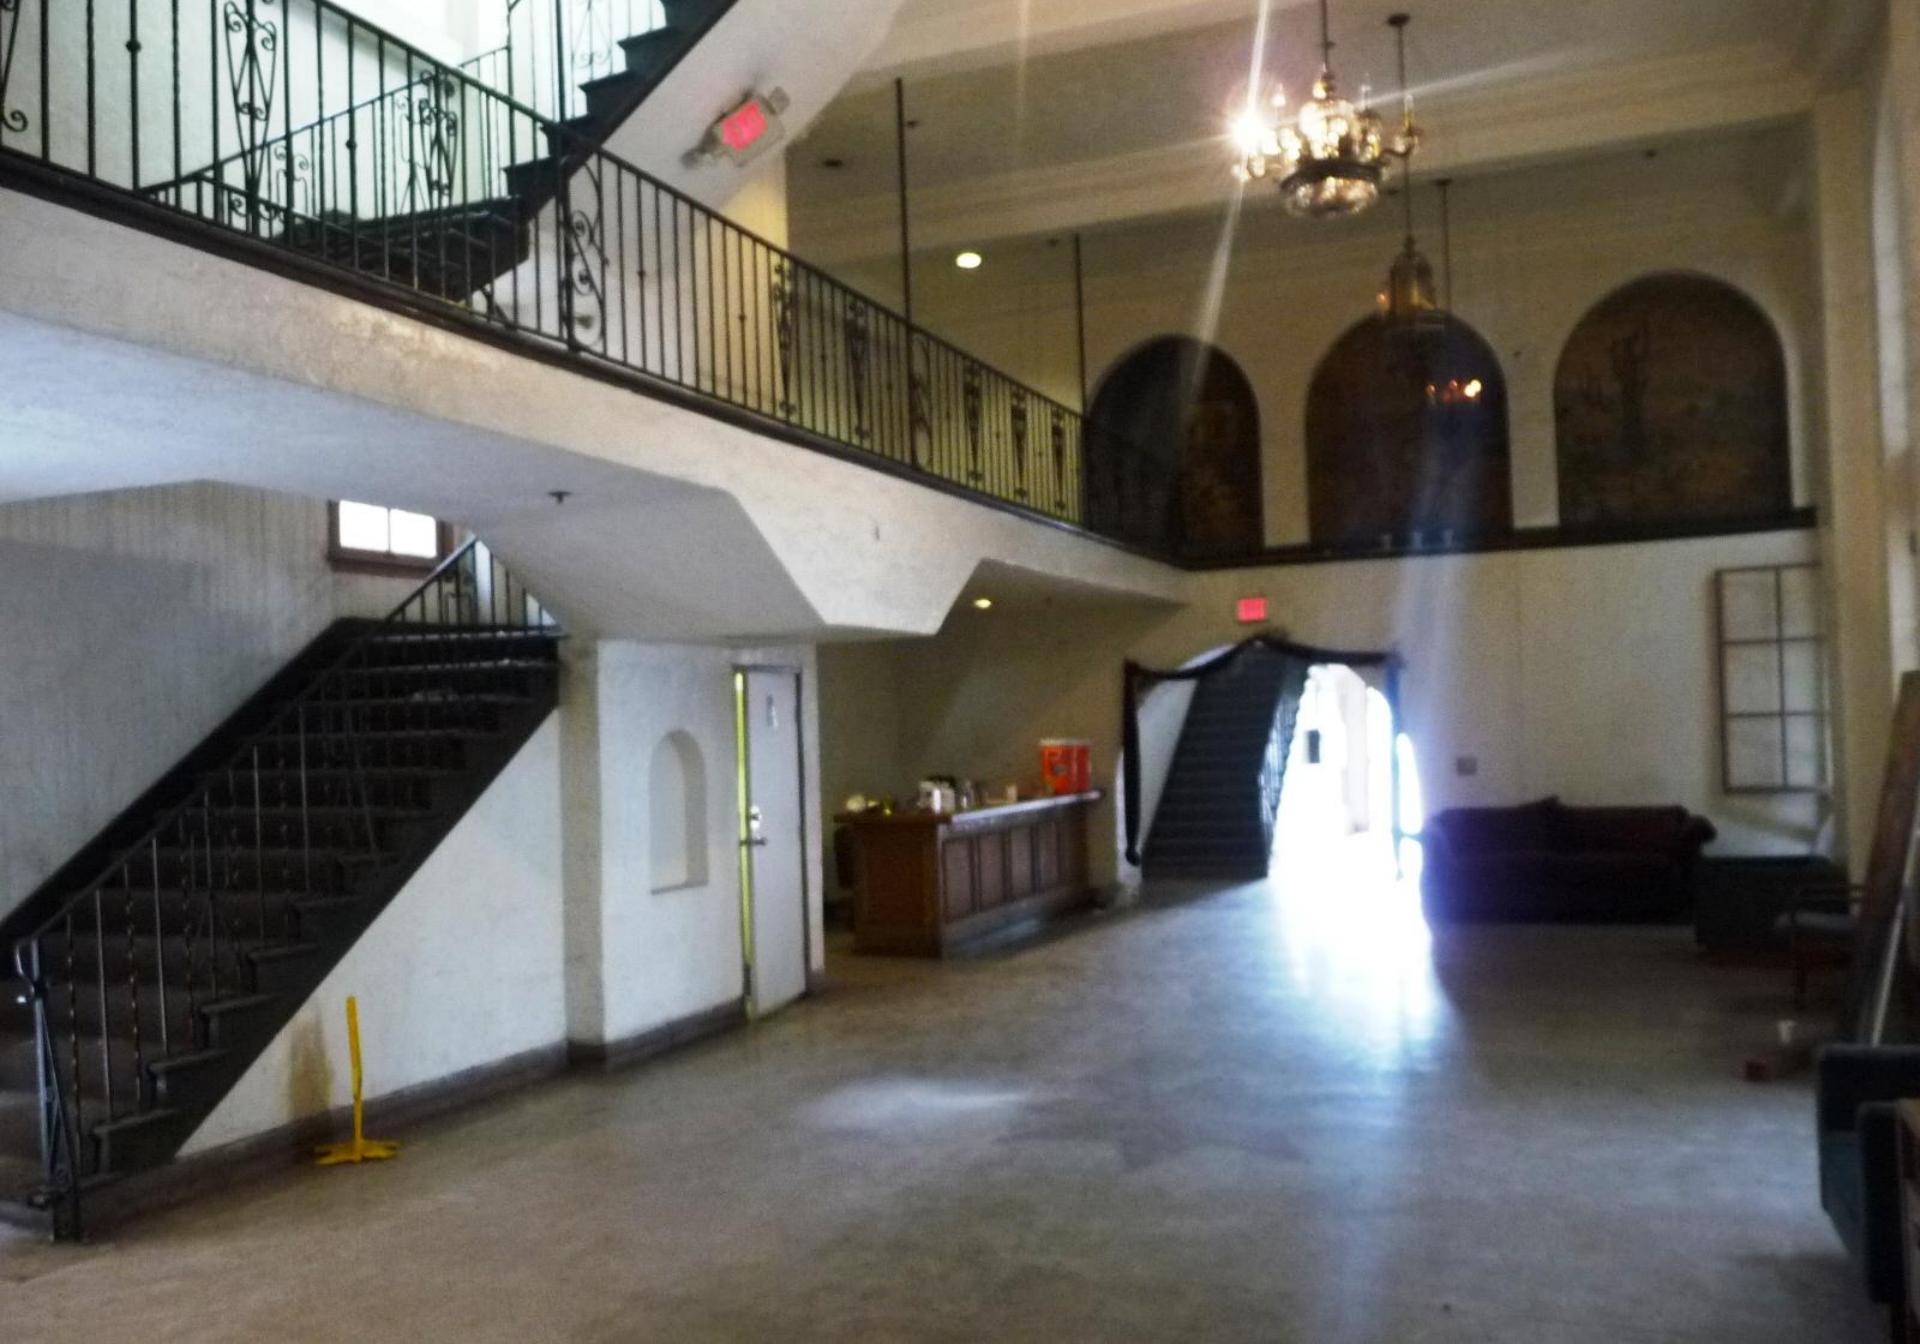
Lobby **Before** Rehabilitation, 2009

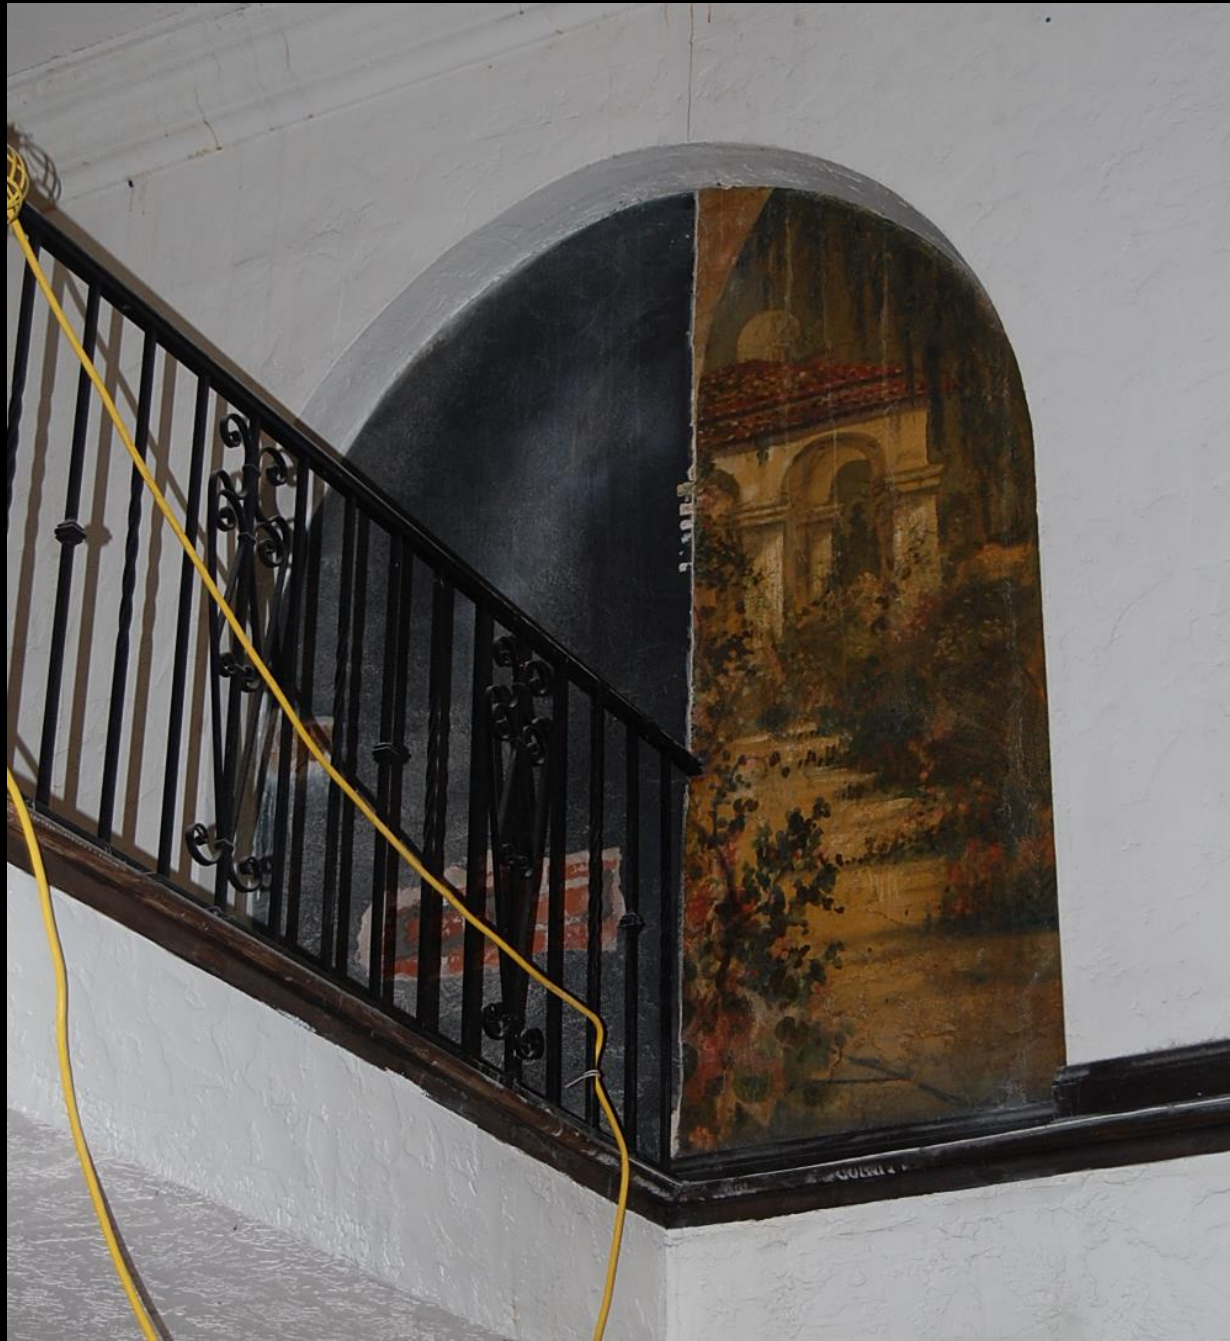
Lobby Mural **Before** Restoration

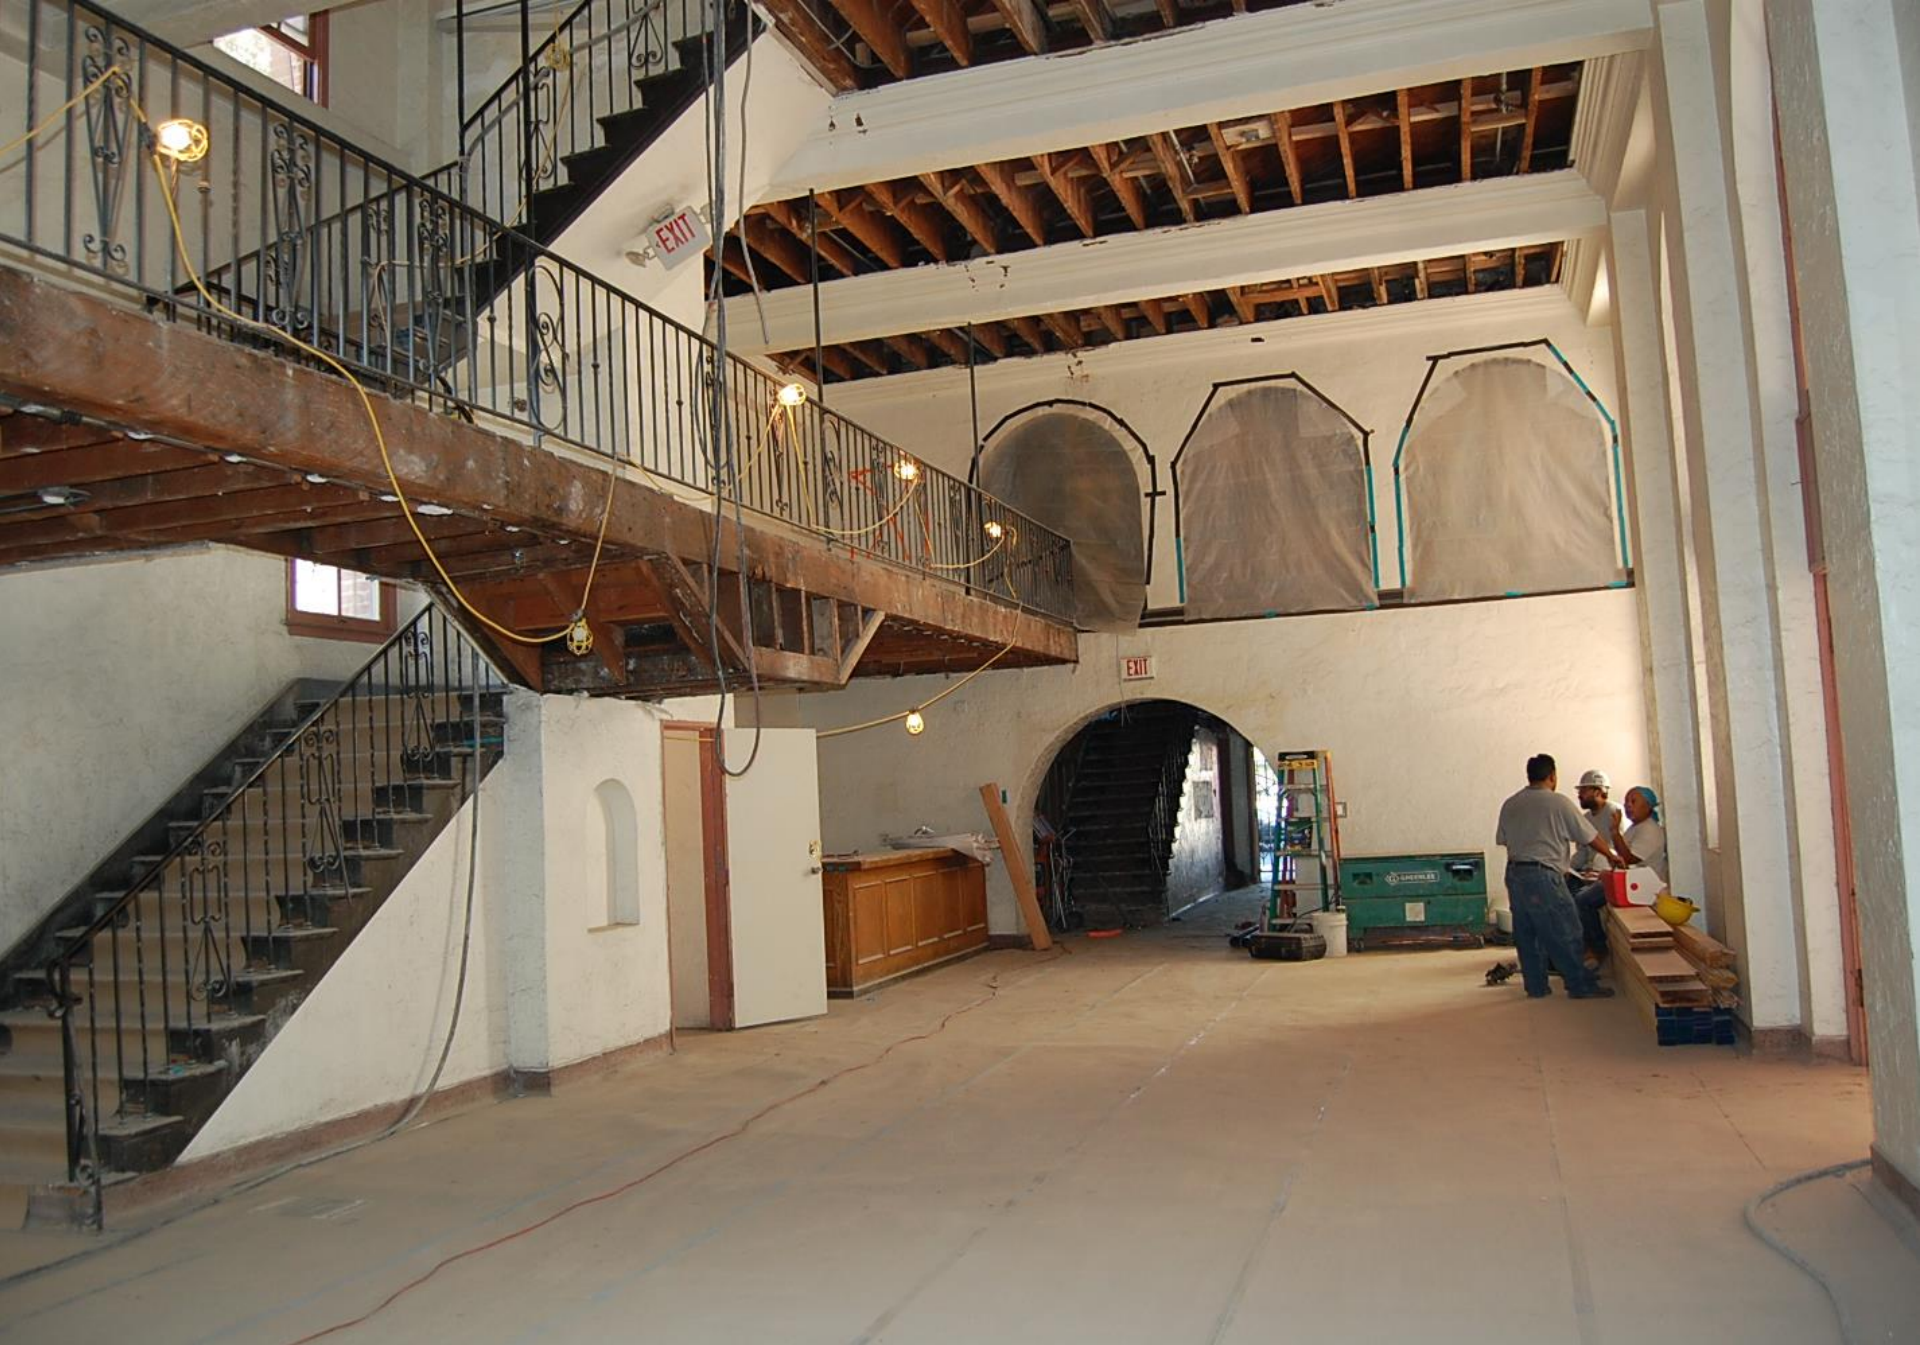
Lobby During Rehabilitation
