Dunbar Hotel

4255 S. Central Avenue, Los Angeles, CA 90011
(Constructed 1928)

Rehabilitation: Project Scope

Rehabilitation: Philosophy

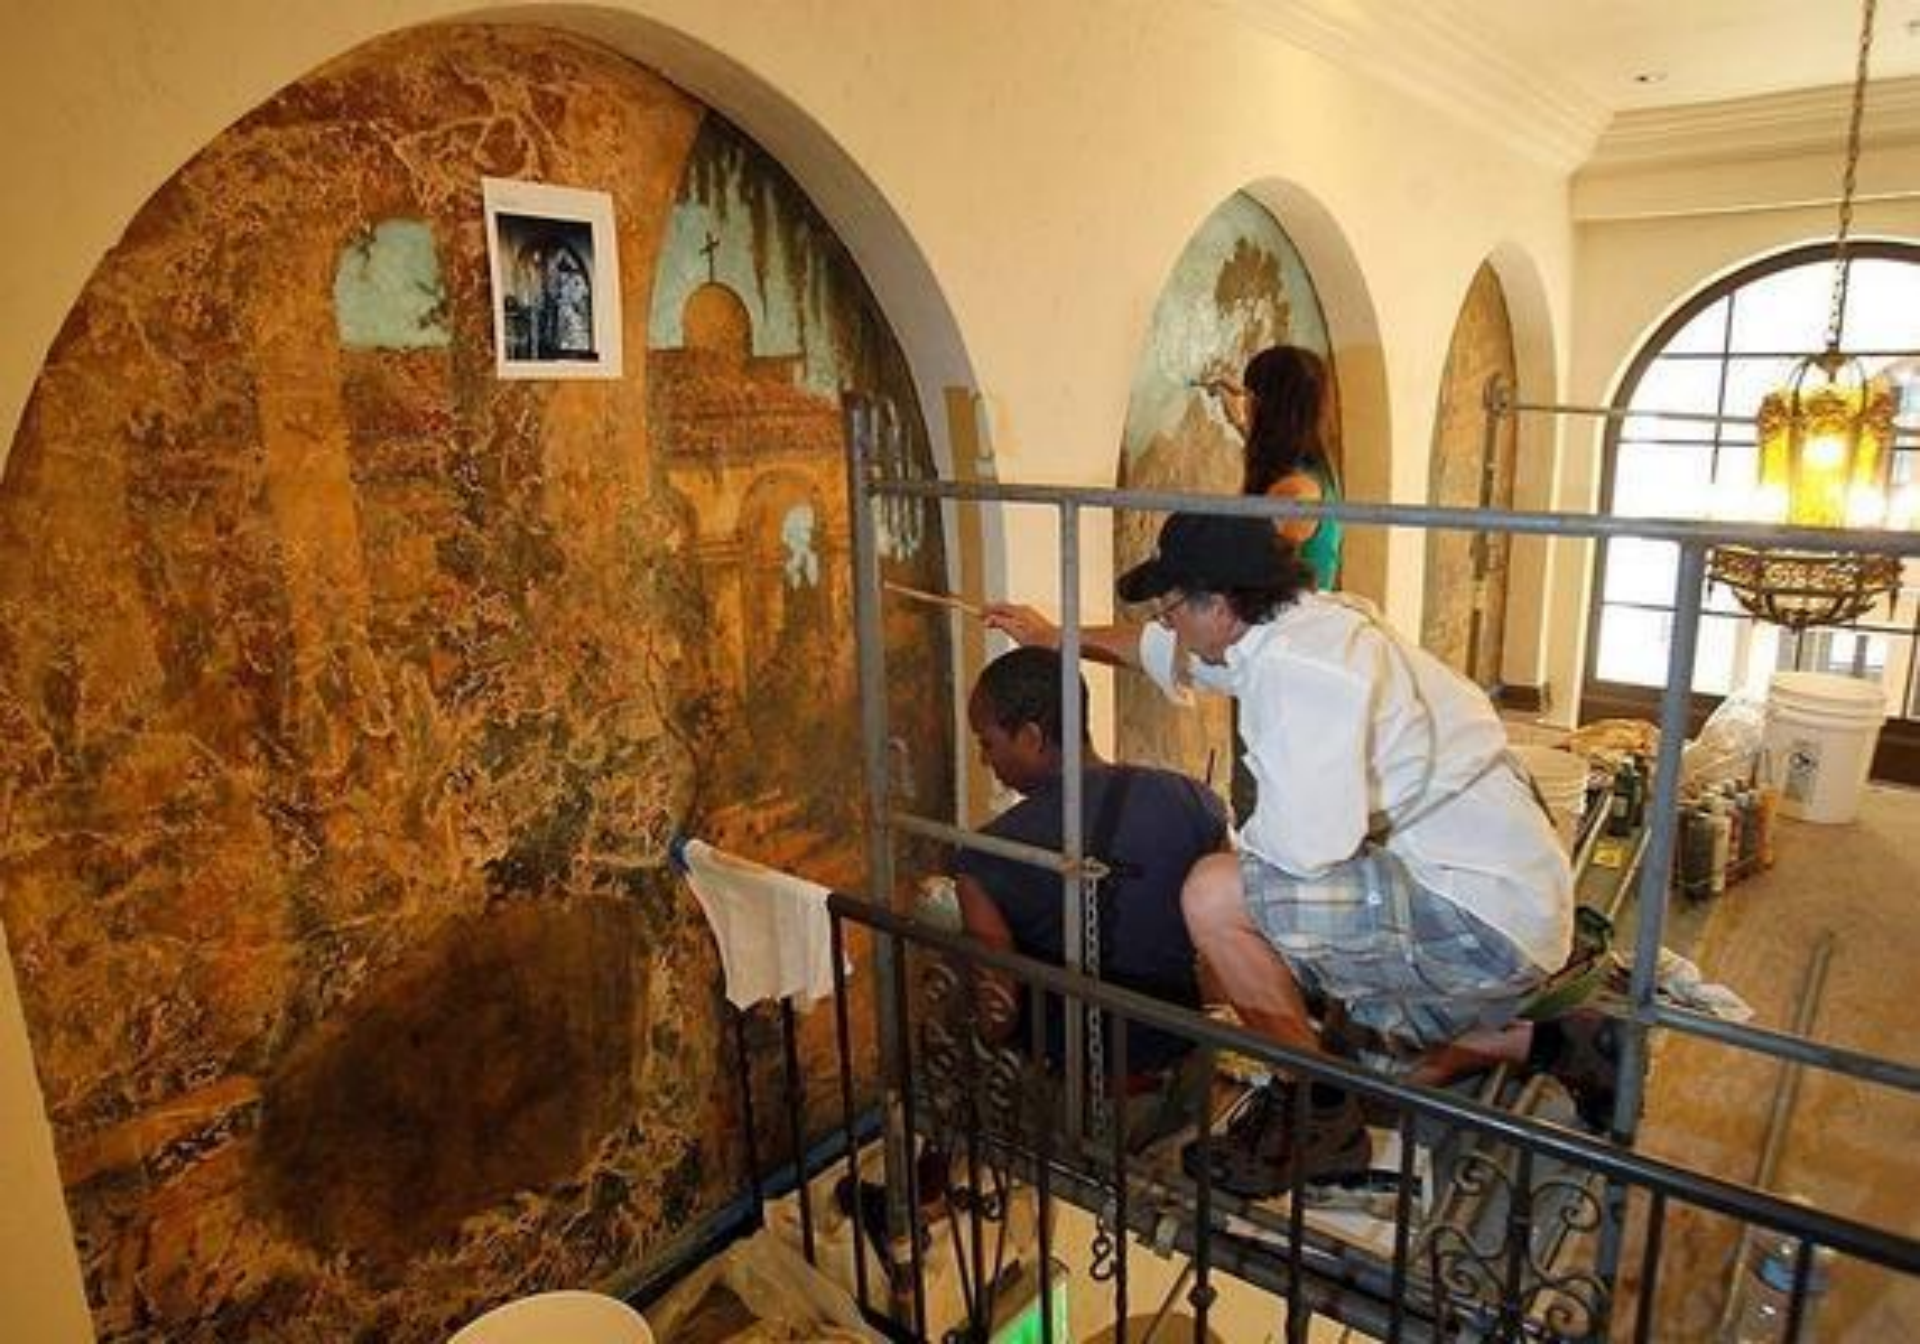
Mural Restoration by Chameleon Paintworks, Inc.

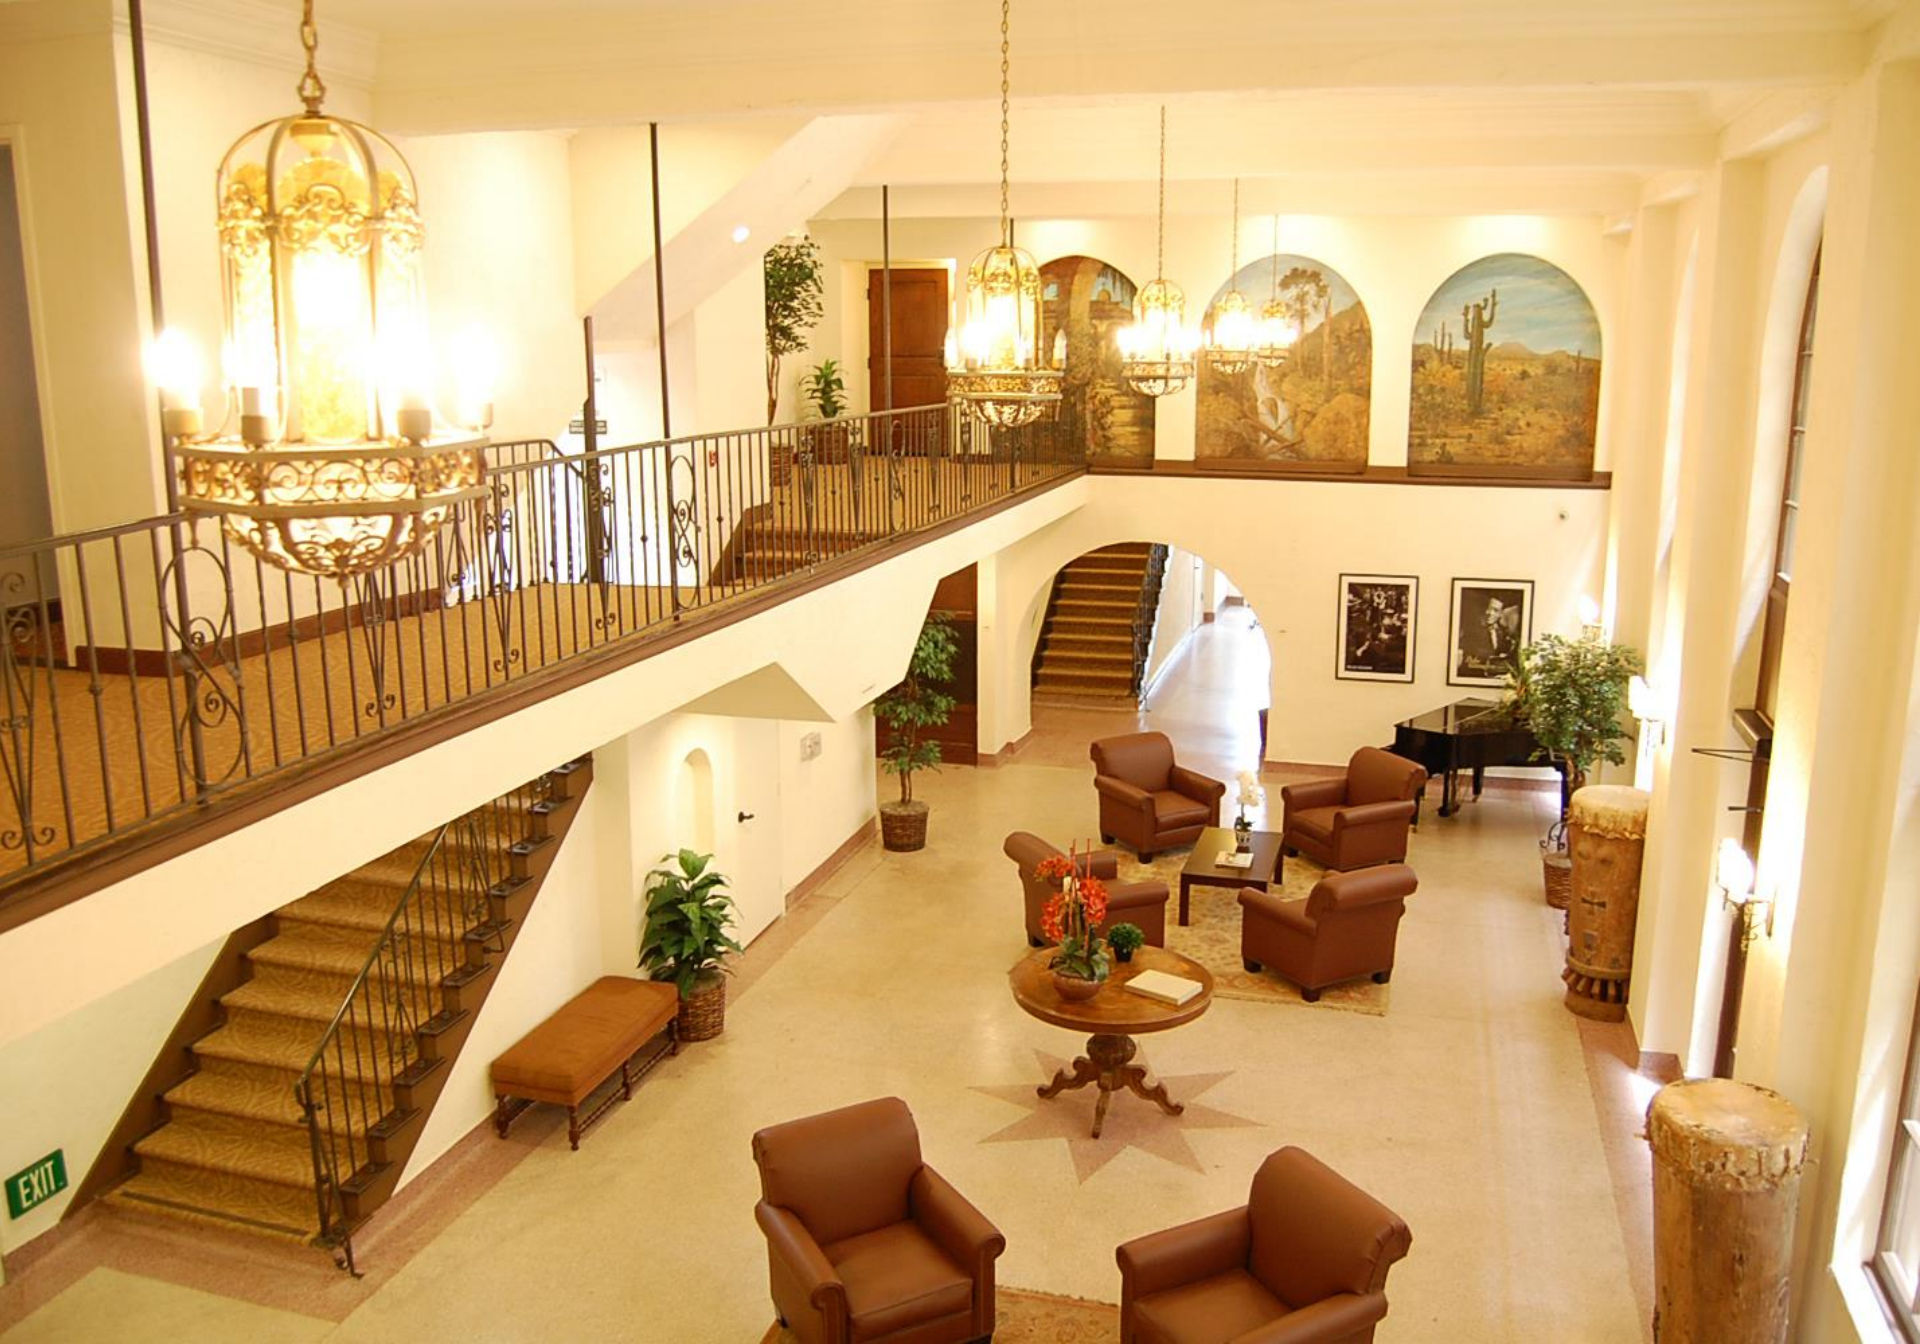
Lobby After Rehabilitation, 2013

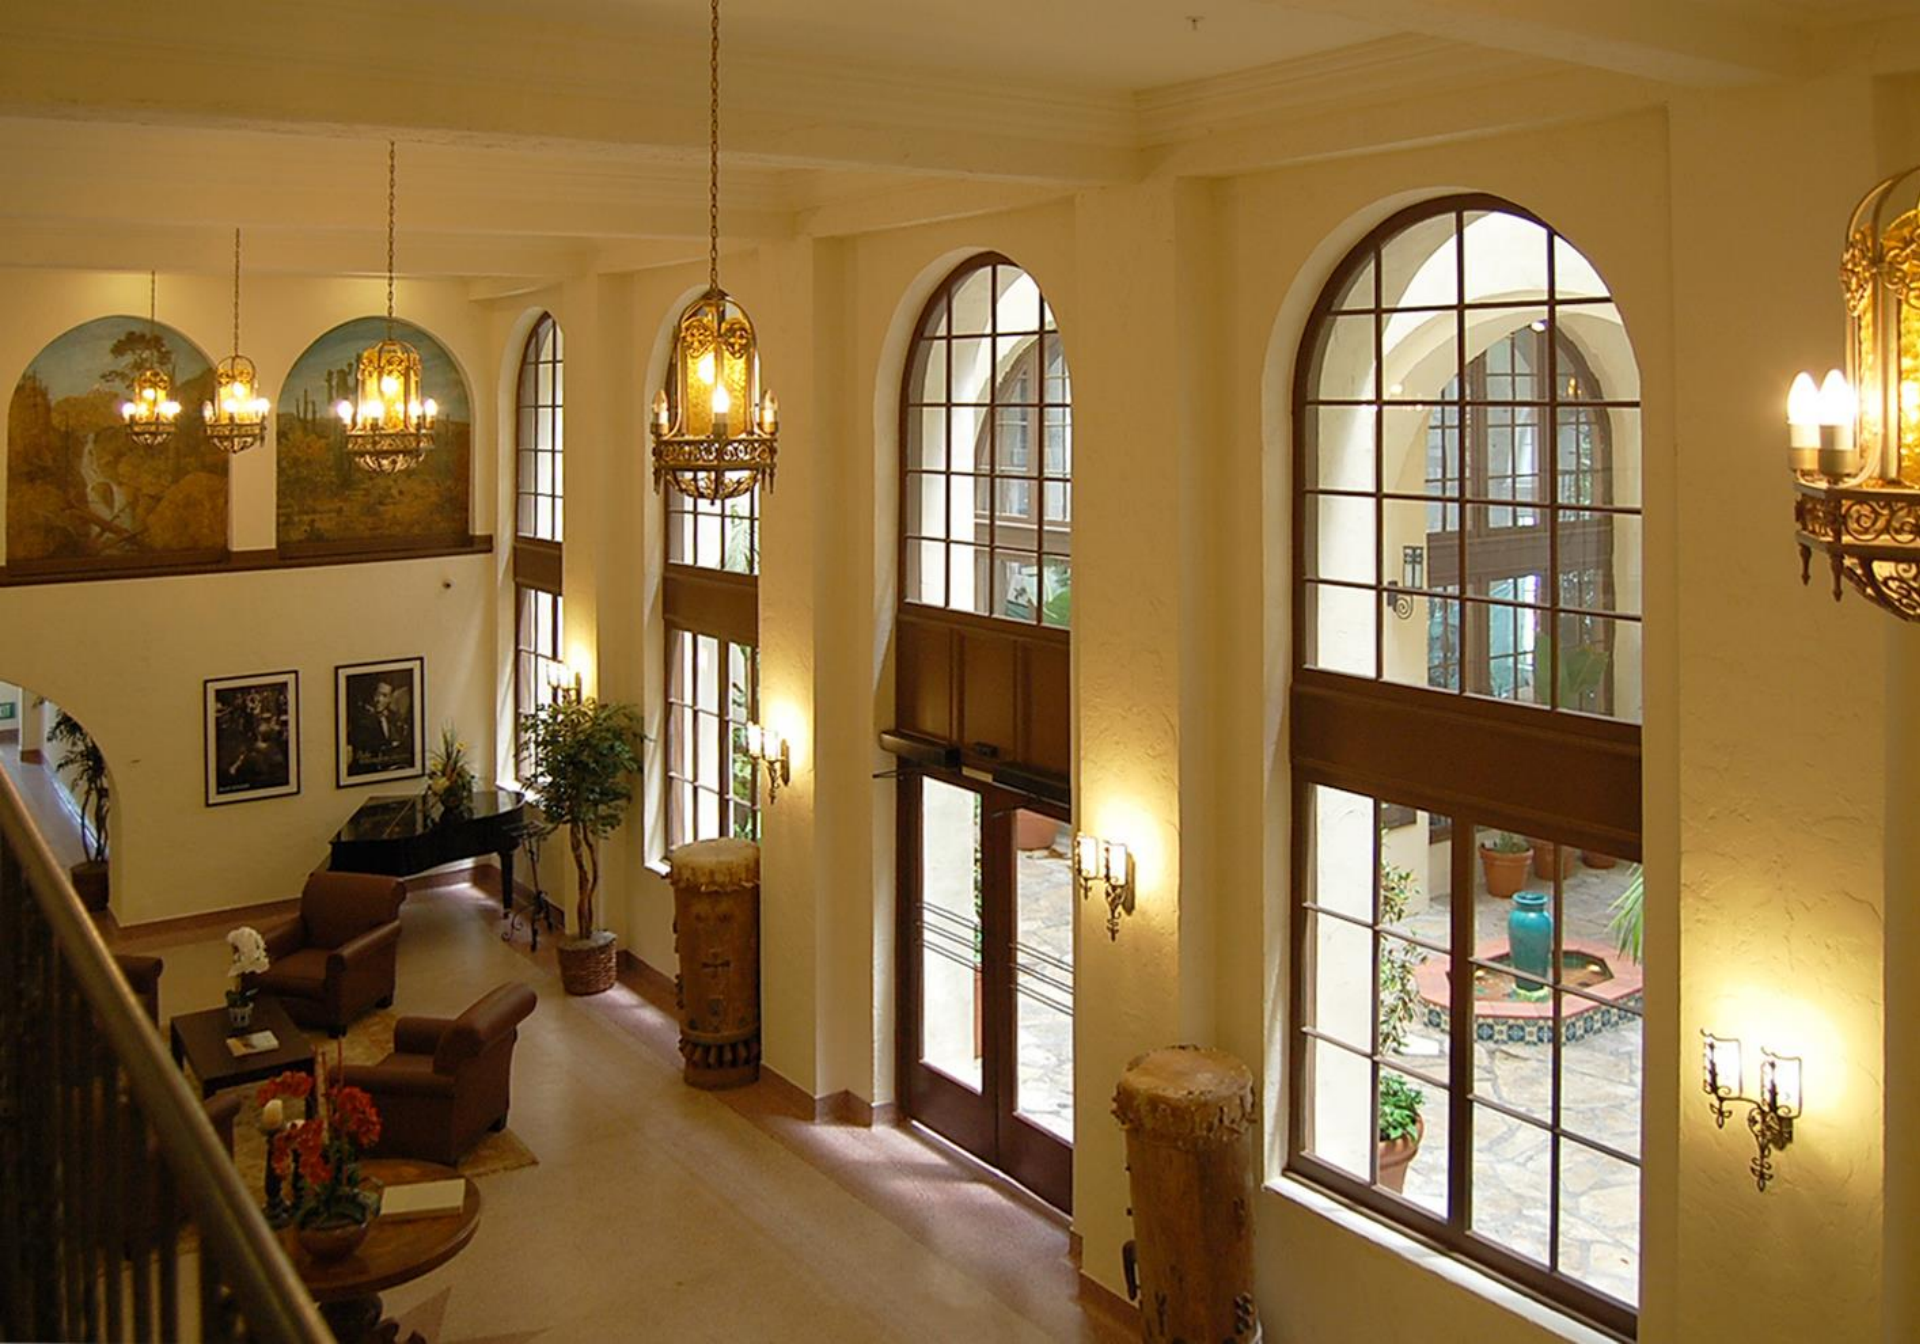
Lobby After Rehabilitation, 2013

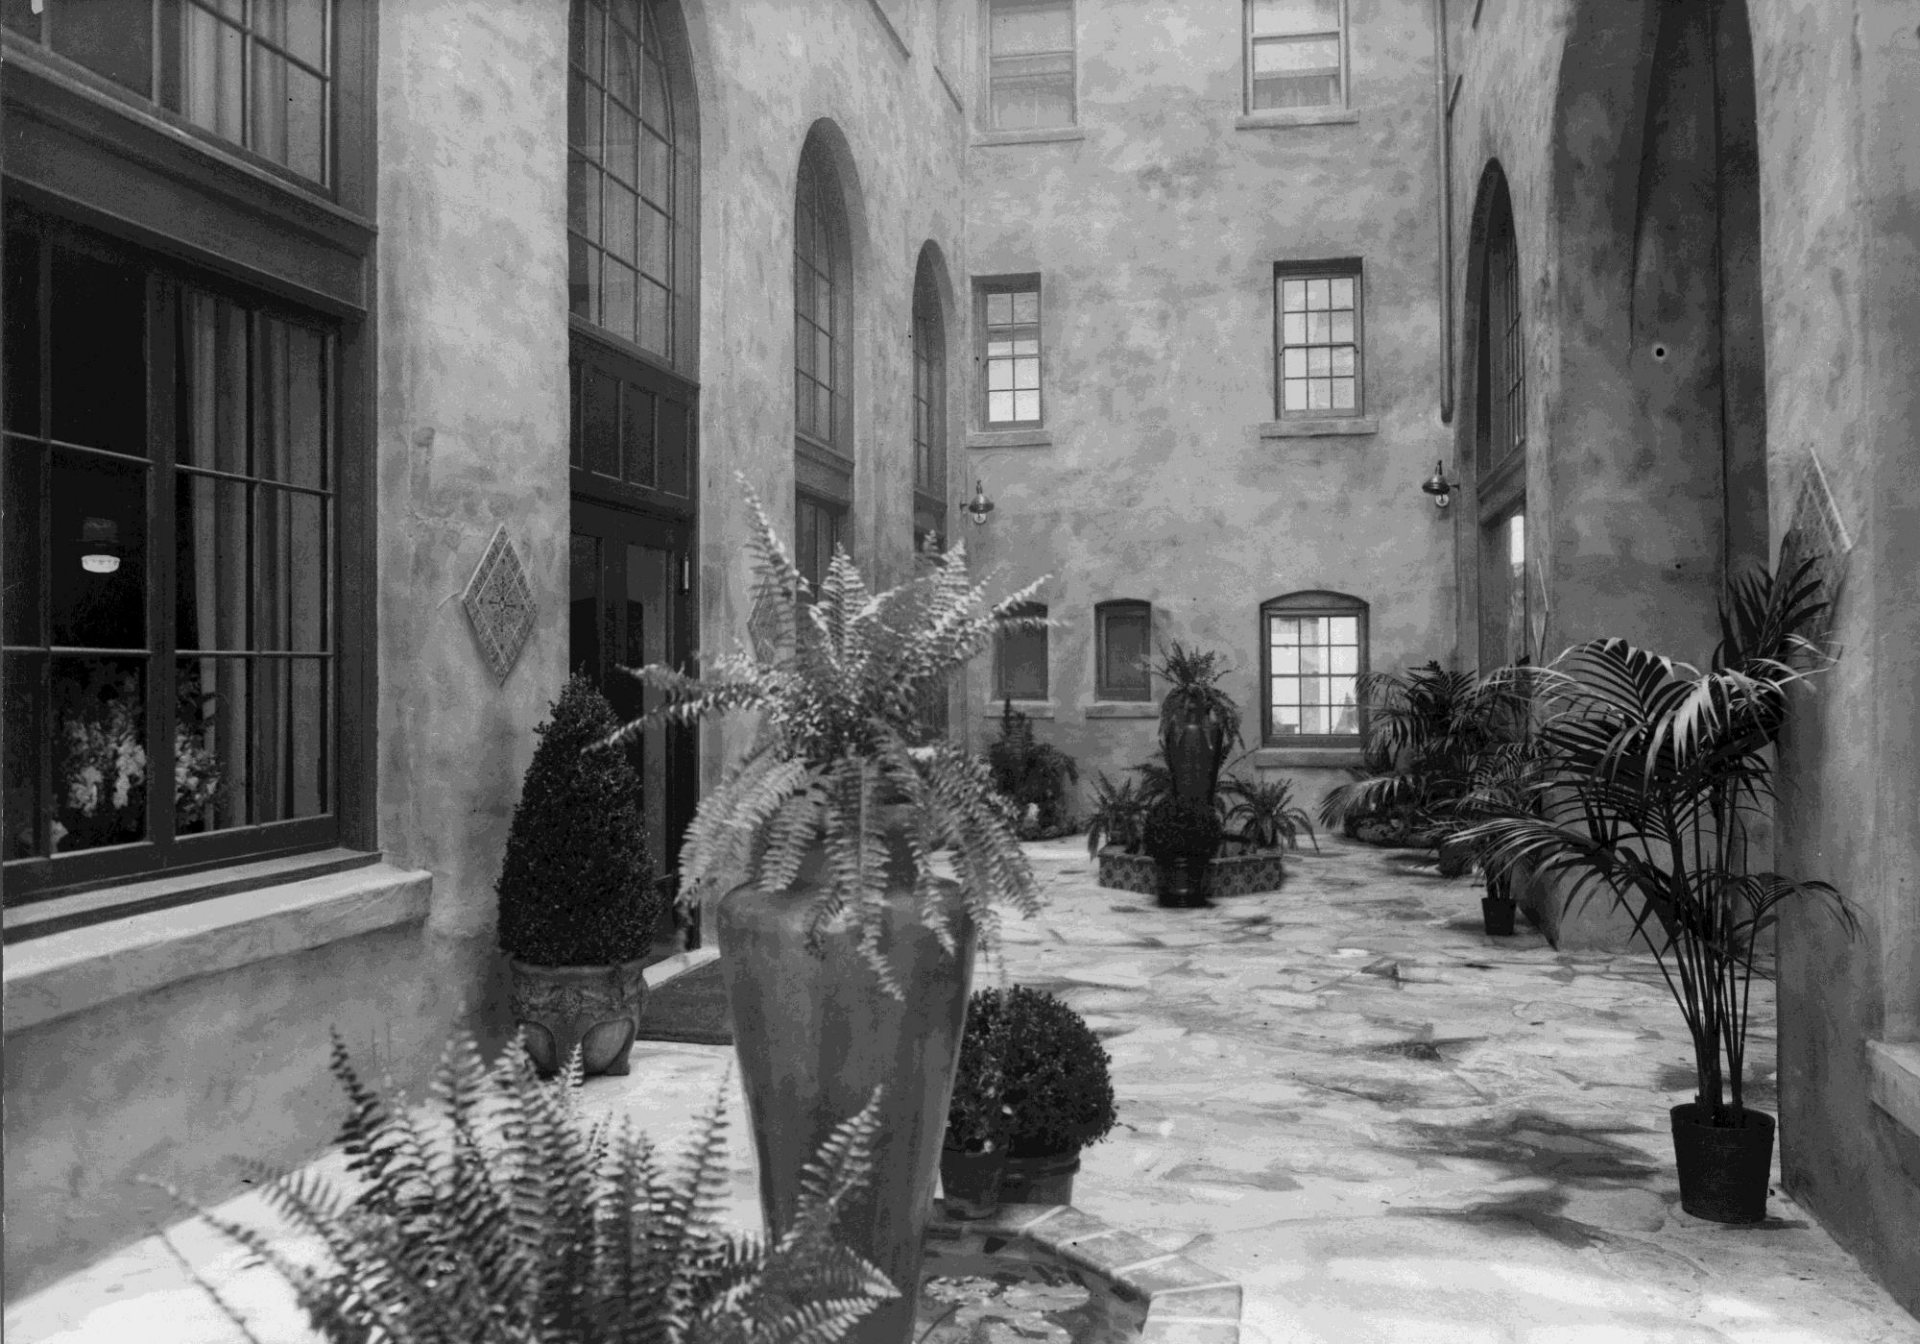
Historic Appearance of Atrium, Circa 1928

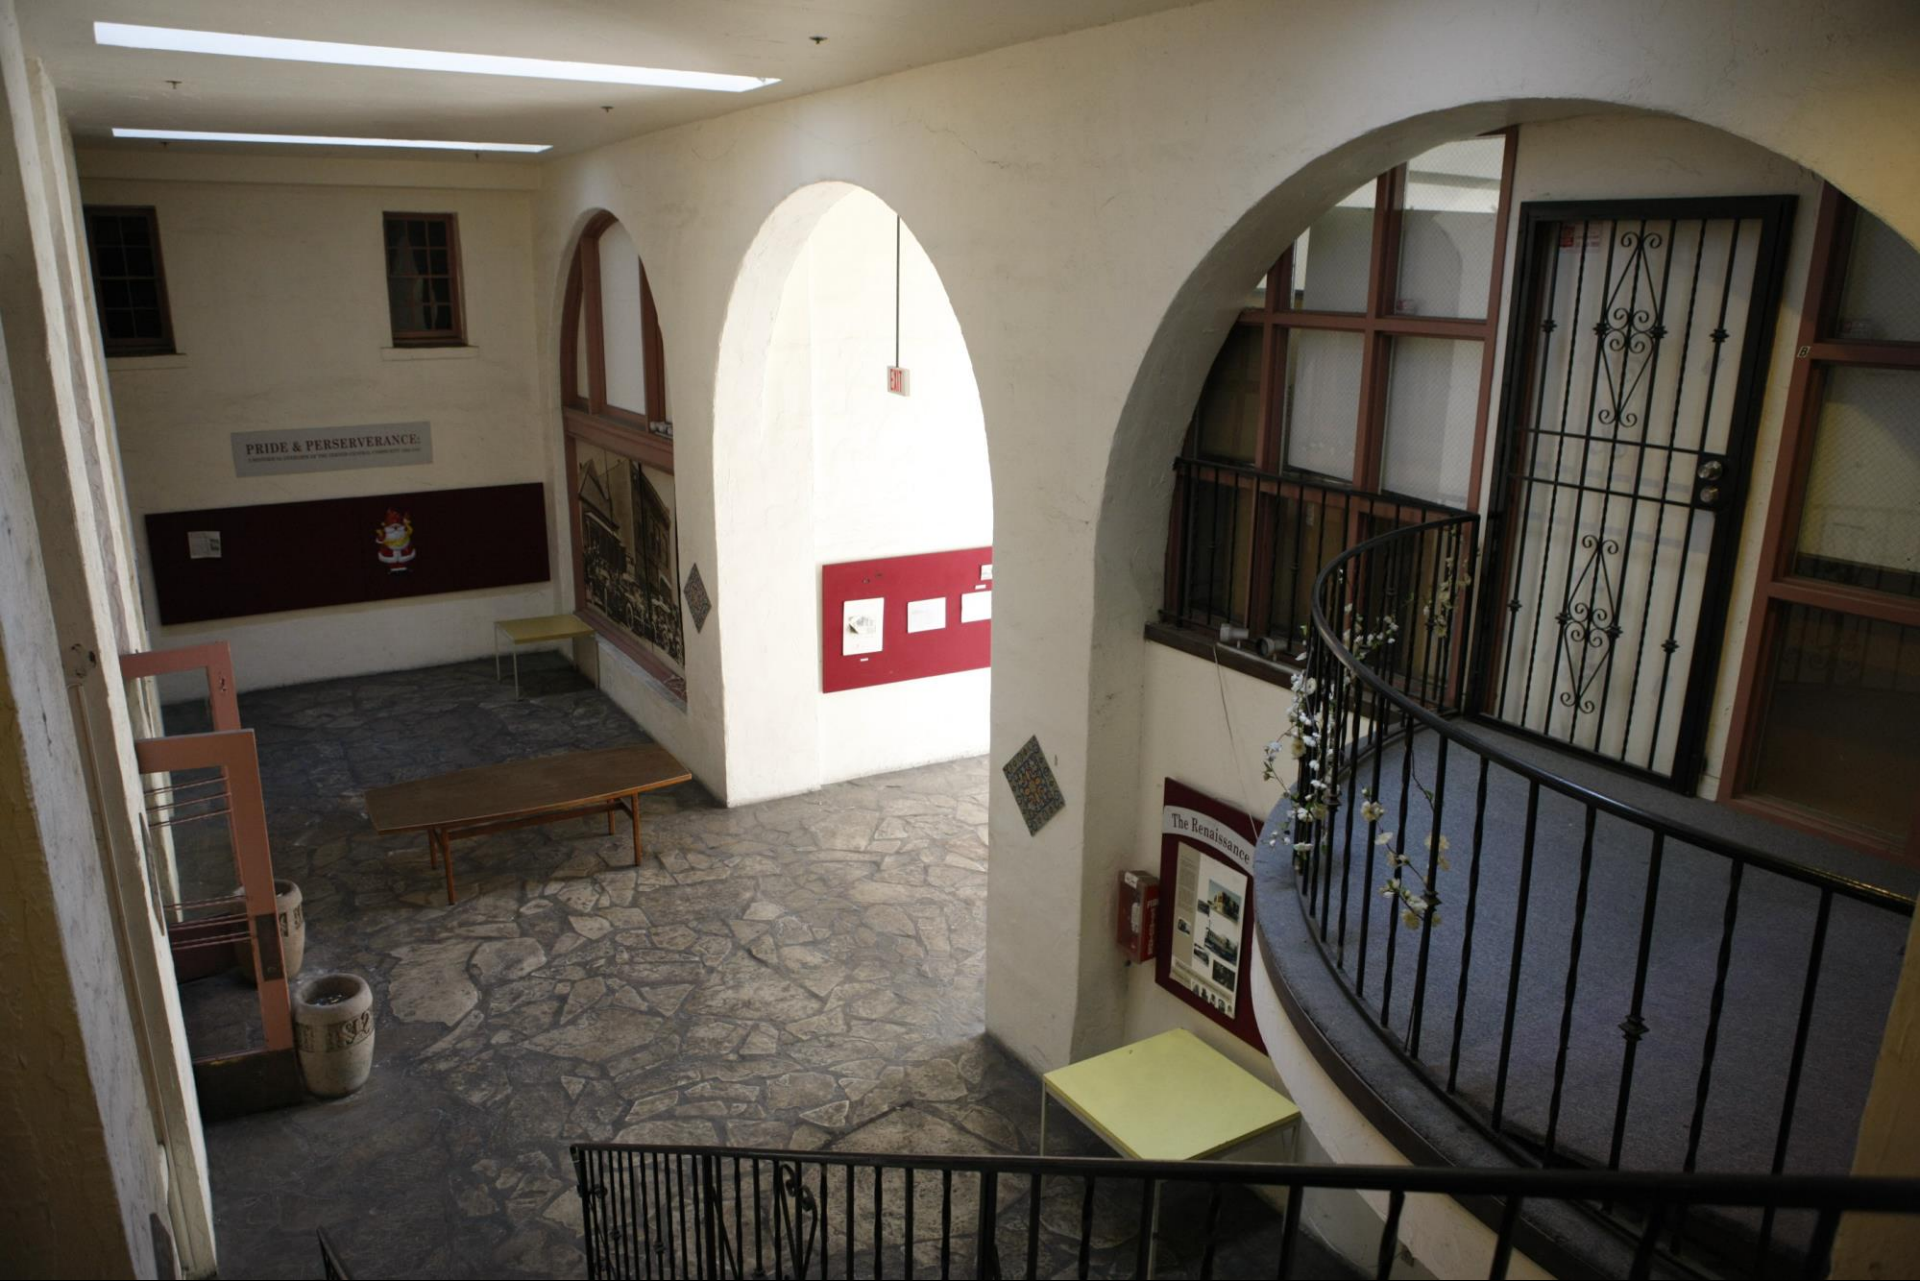
Atrium **Before** Rehabilitation, 2009

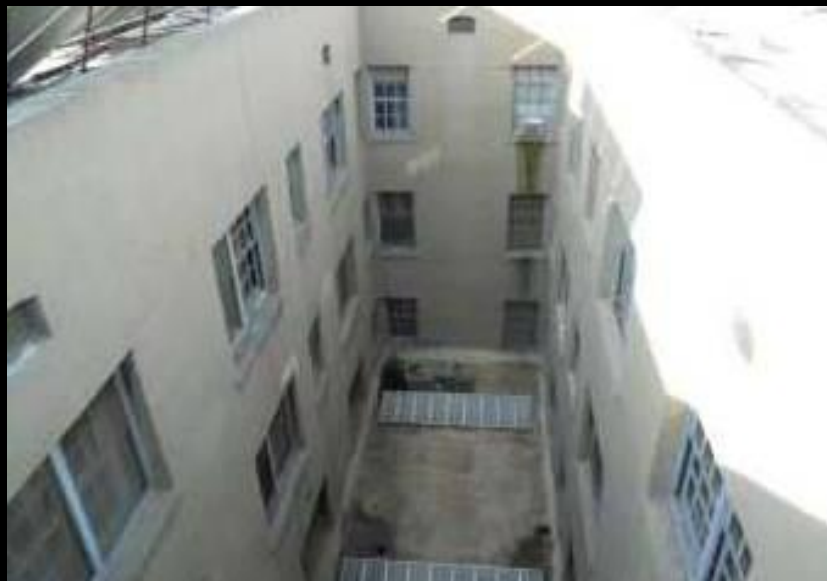
Atrium Enclosed Circa 1989 Rehab

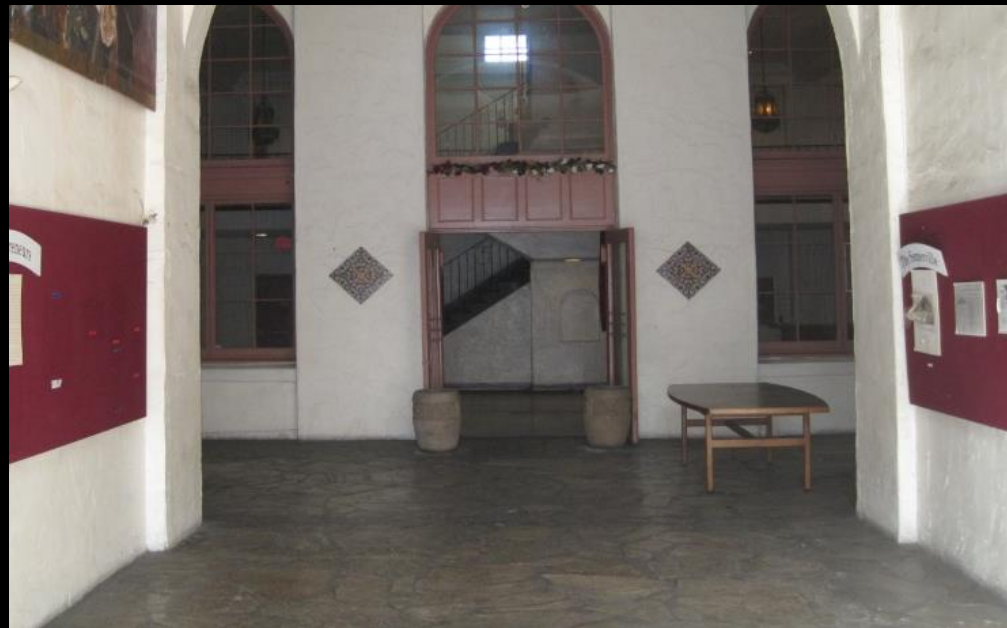
Atrium **Before** Rehabilitation, 2009

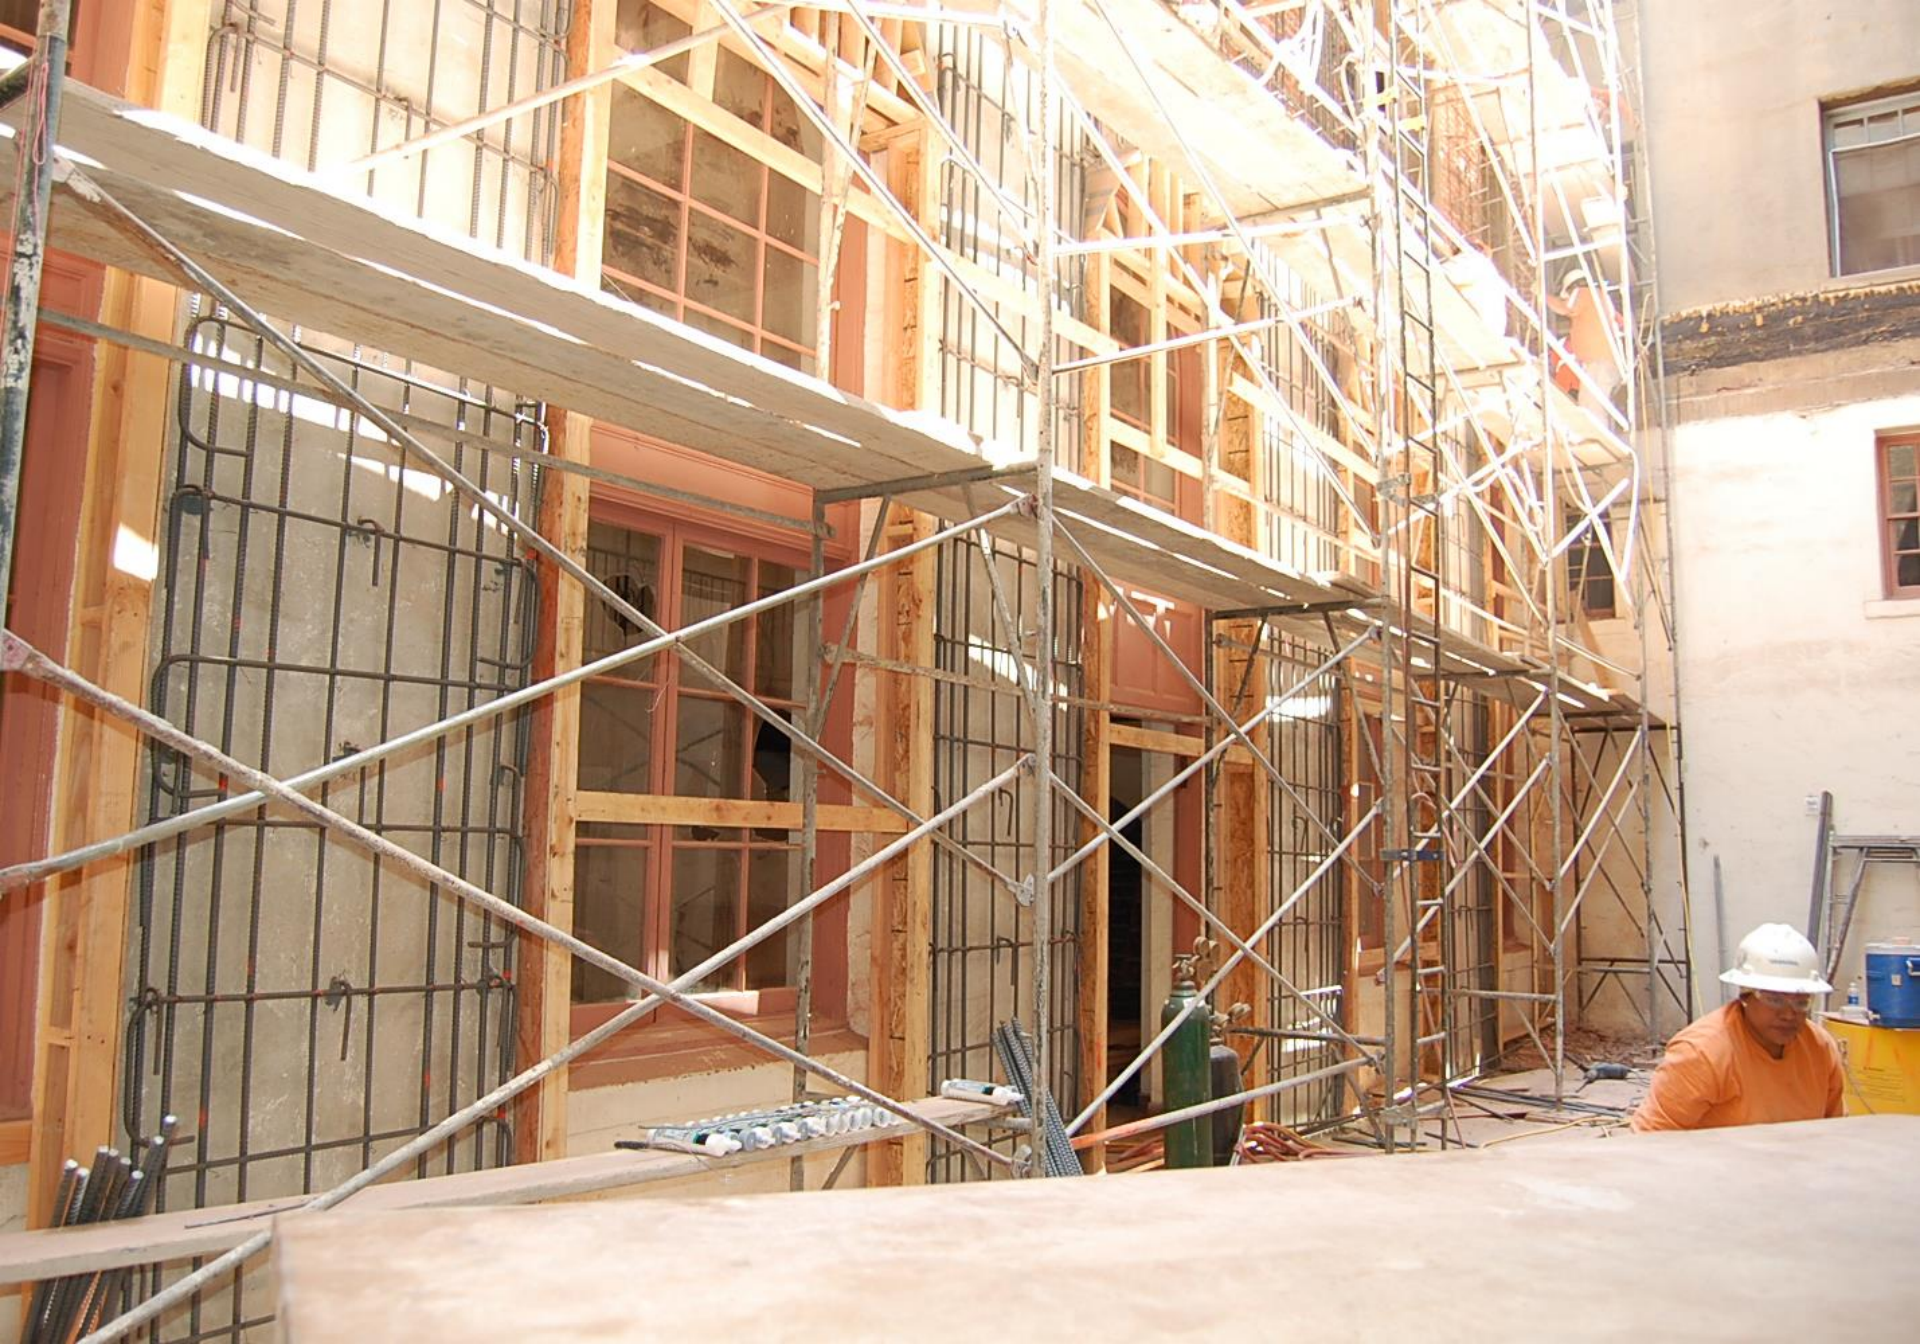
Atrium During Rehabilitation

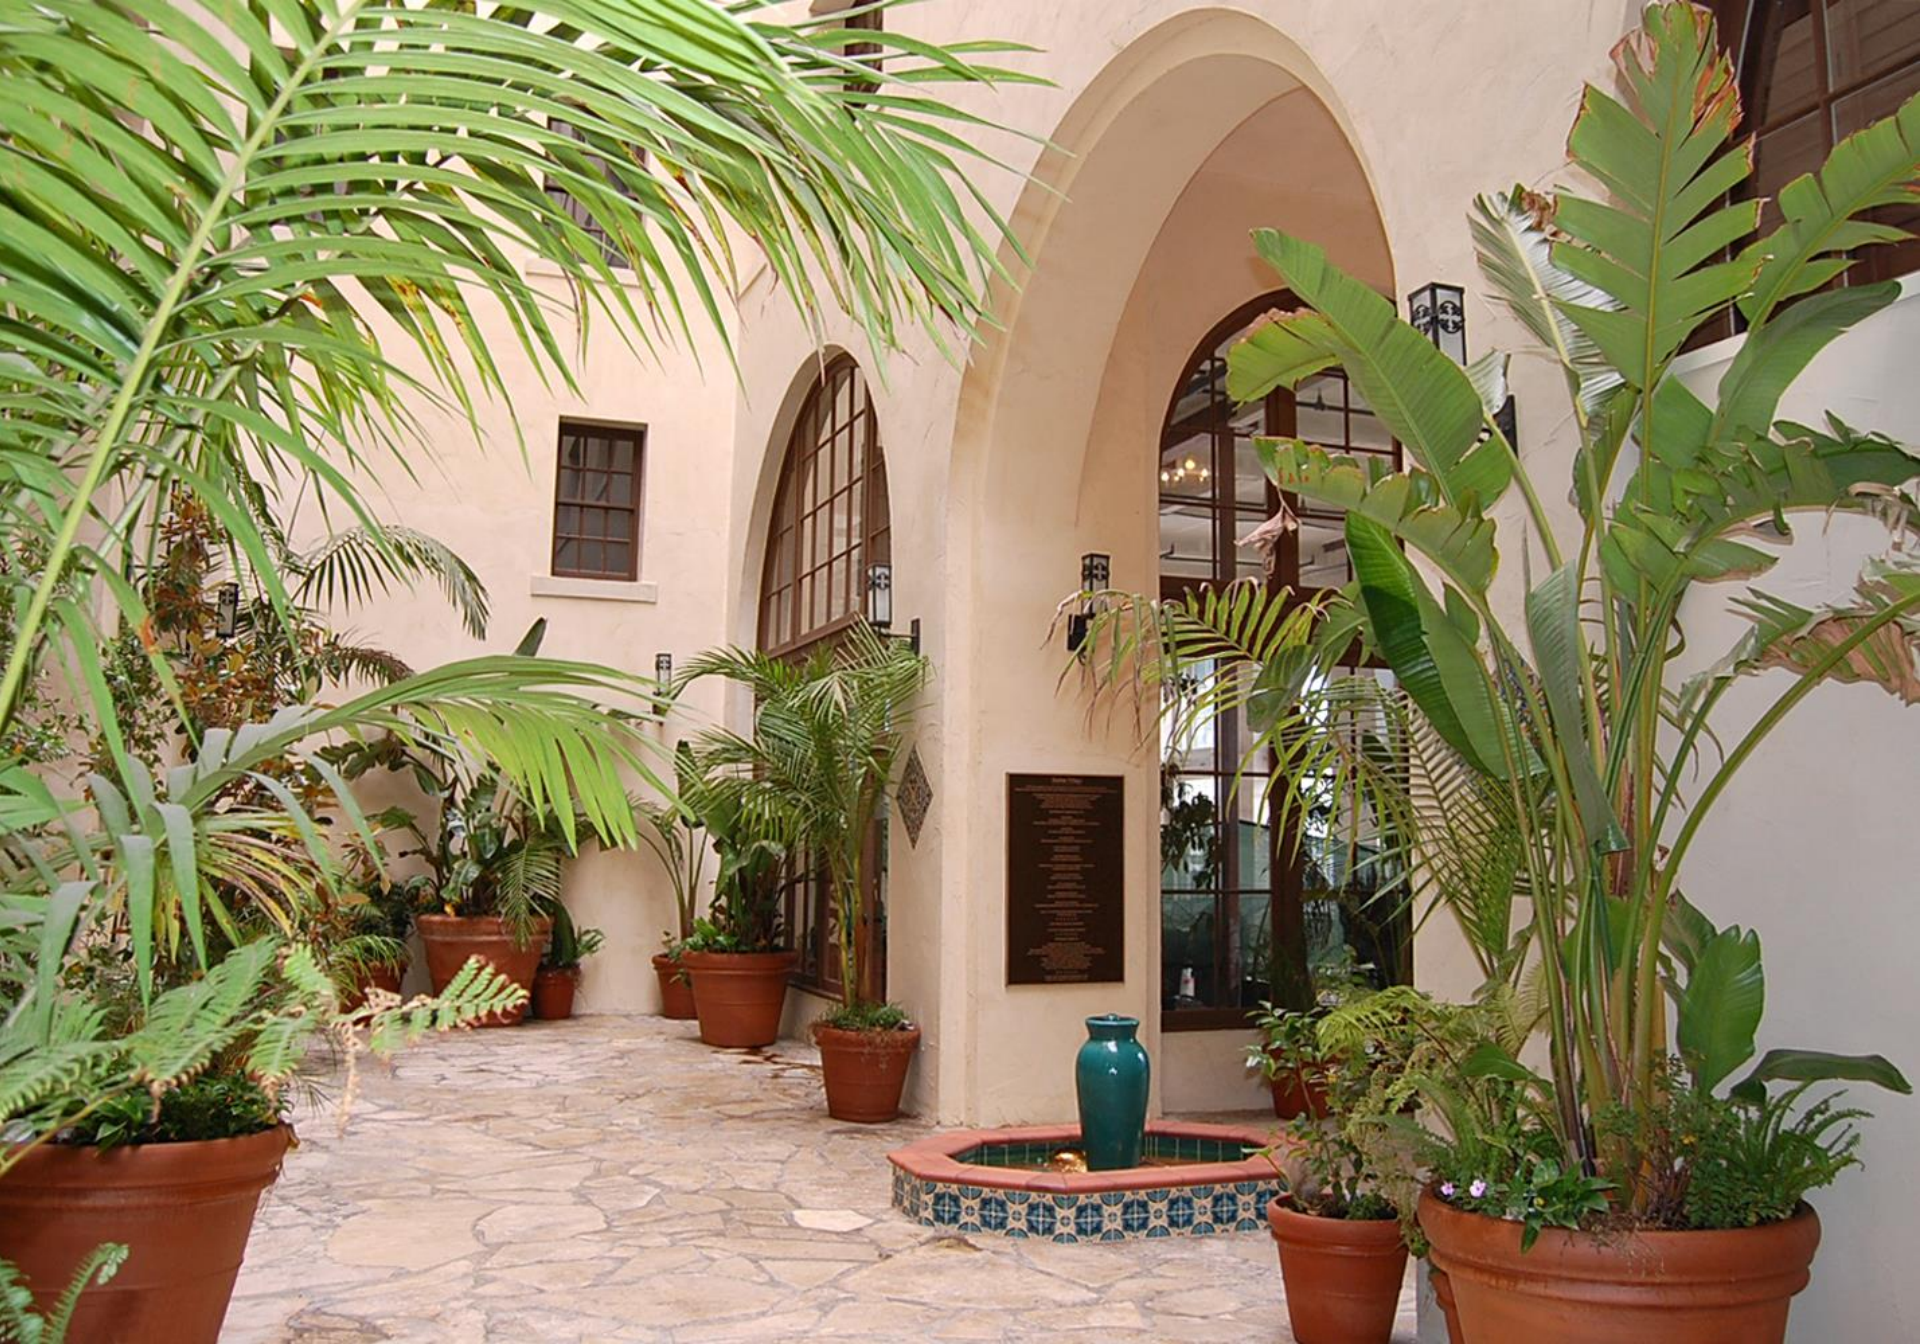
Atrium After Rehabilitation, 2013

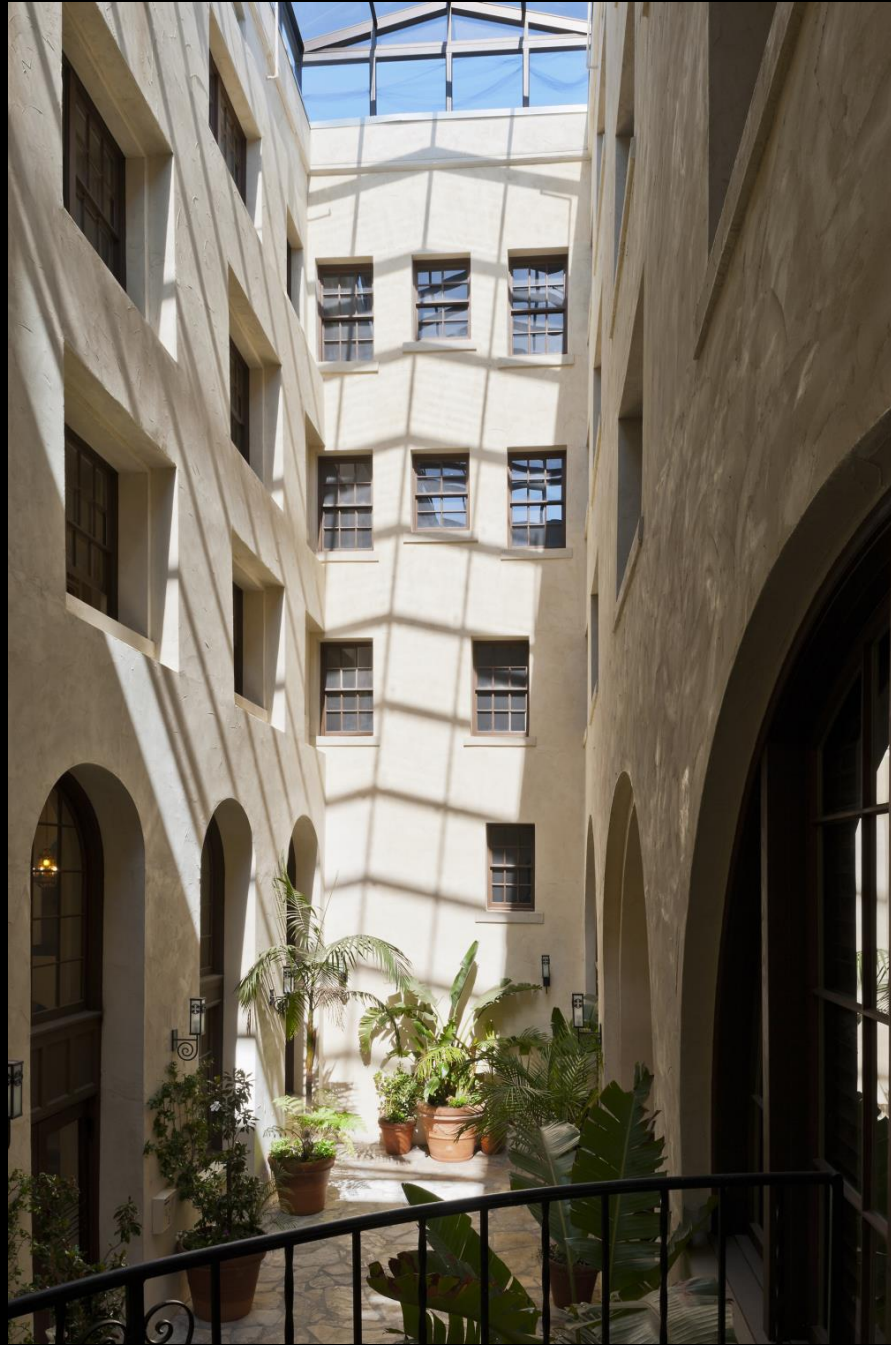
Atrium After Rehabilitation, 2013

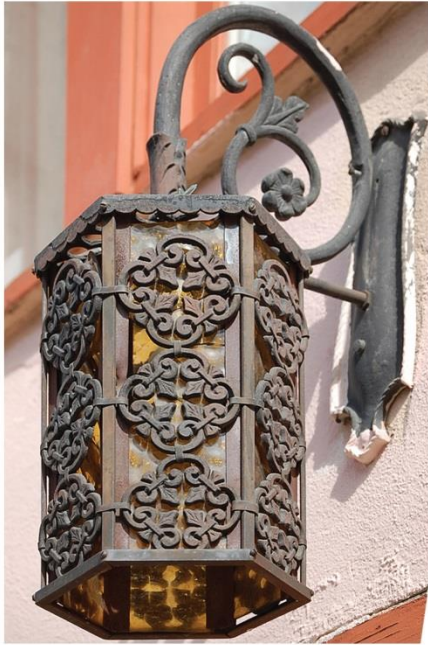
Exterior - Historic

Exterior - New

Atrium - New

Replication of Exterior and Interior Wall Sconces

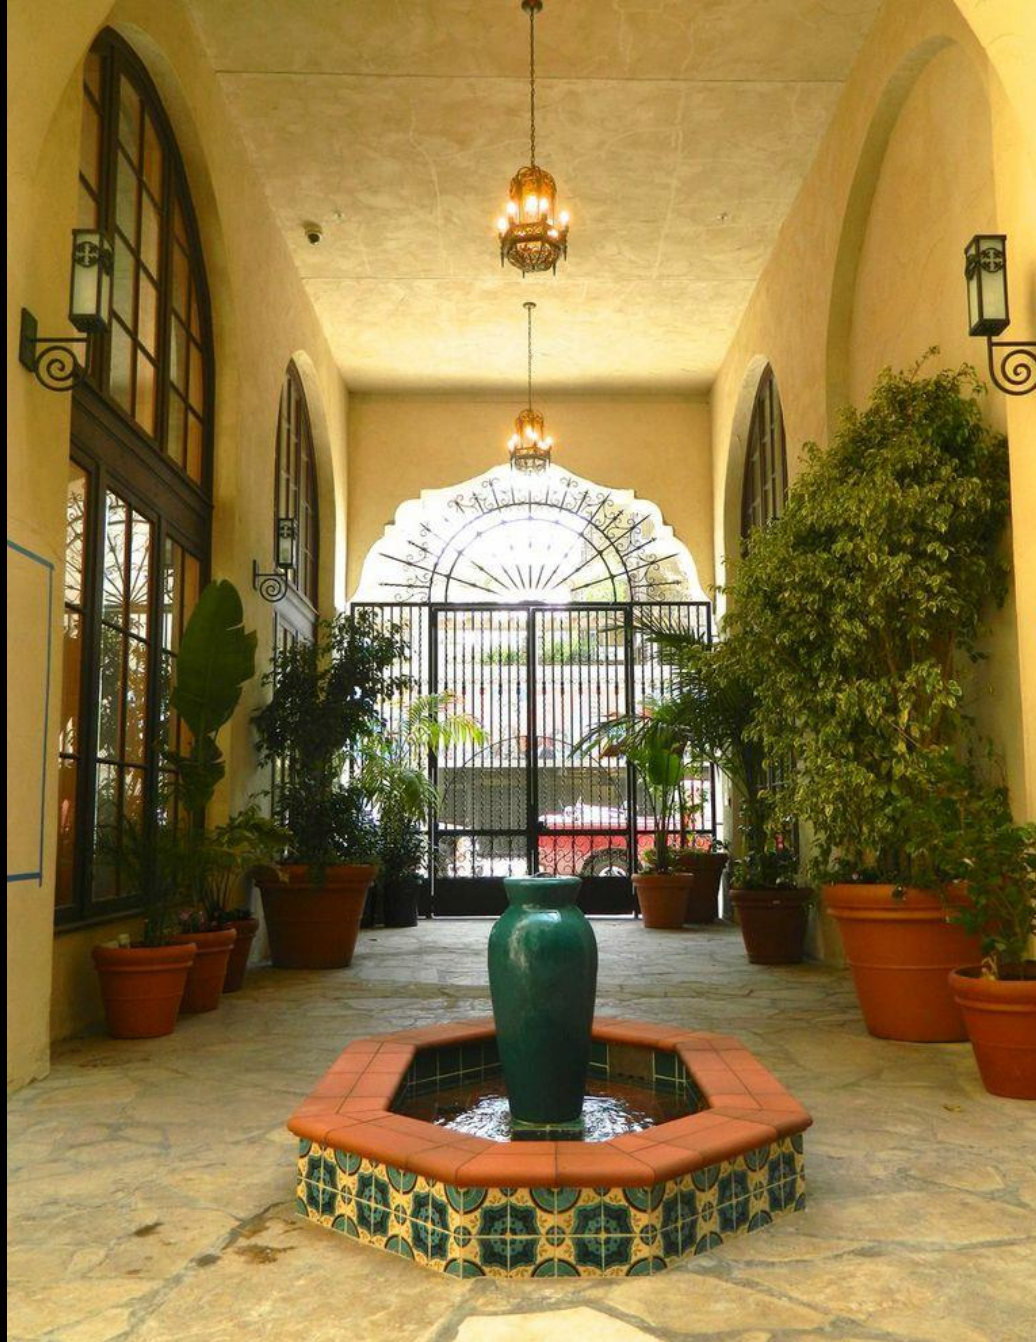
Atrium After Rehabilitation, 2013
