Dunbar Hotel

4255 S. Central Avenue, Los Angeles, CA 90011
(Constructed 1928)

Rehabilitation: Project Scope

Rehabilitation: Philosophy

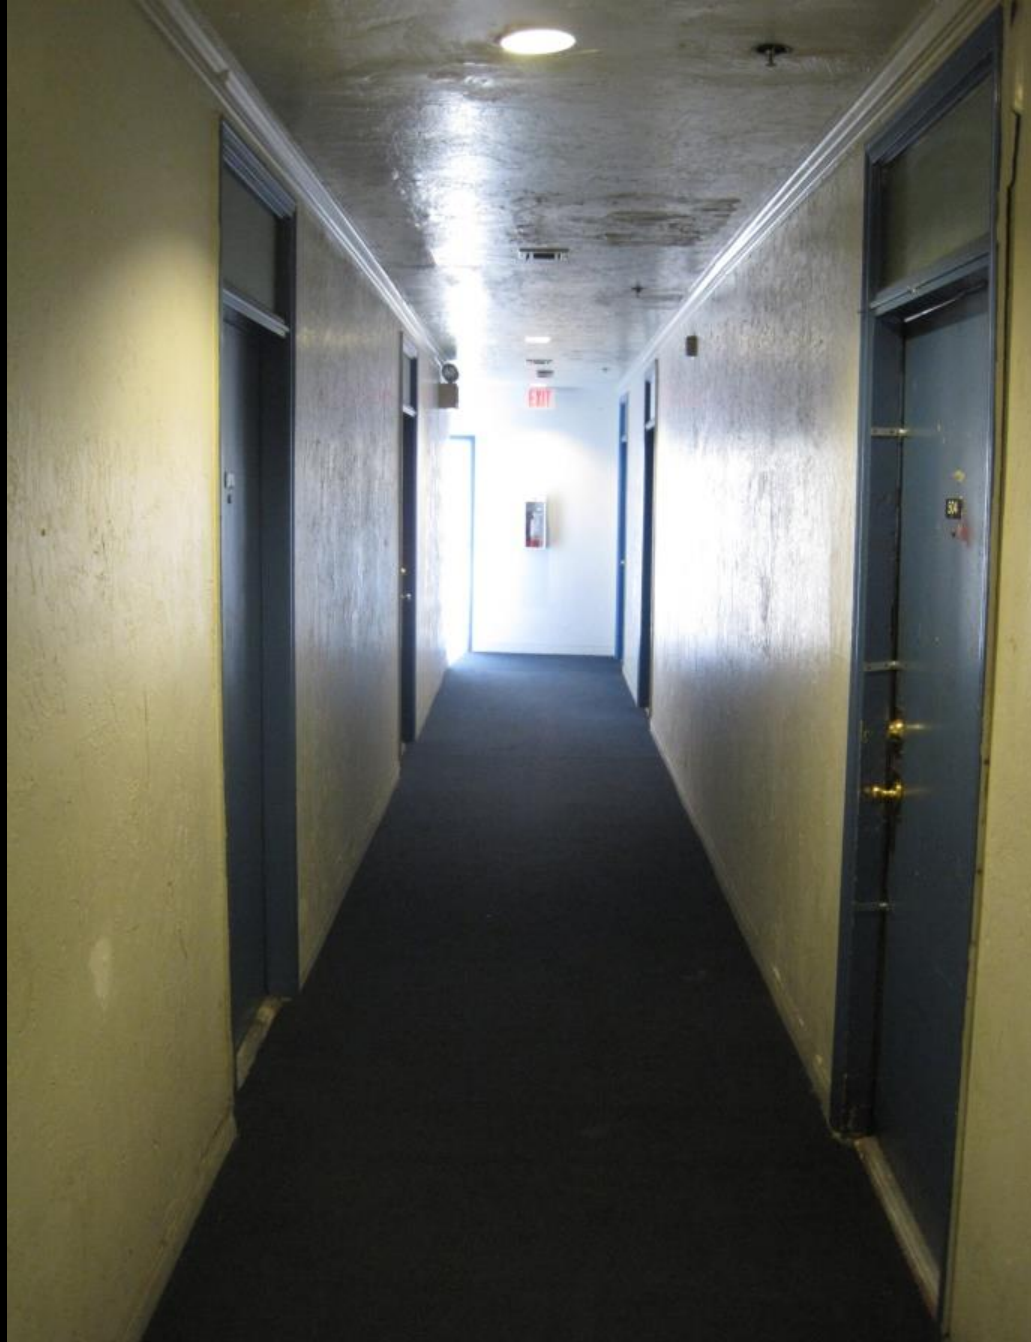
Corridor Floors 3 to 5 **Before** Rehabilitation, 2009

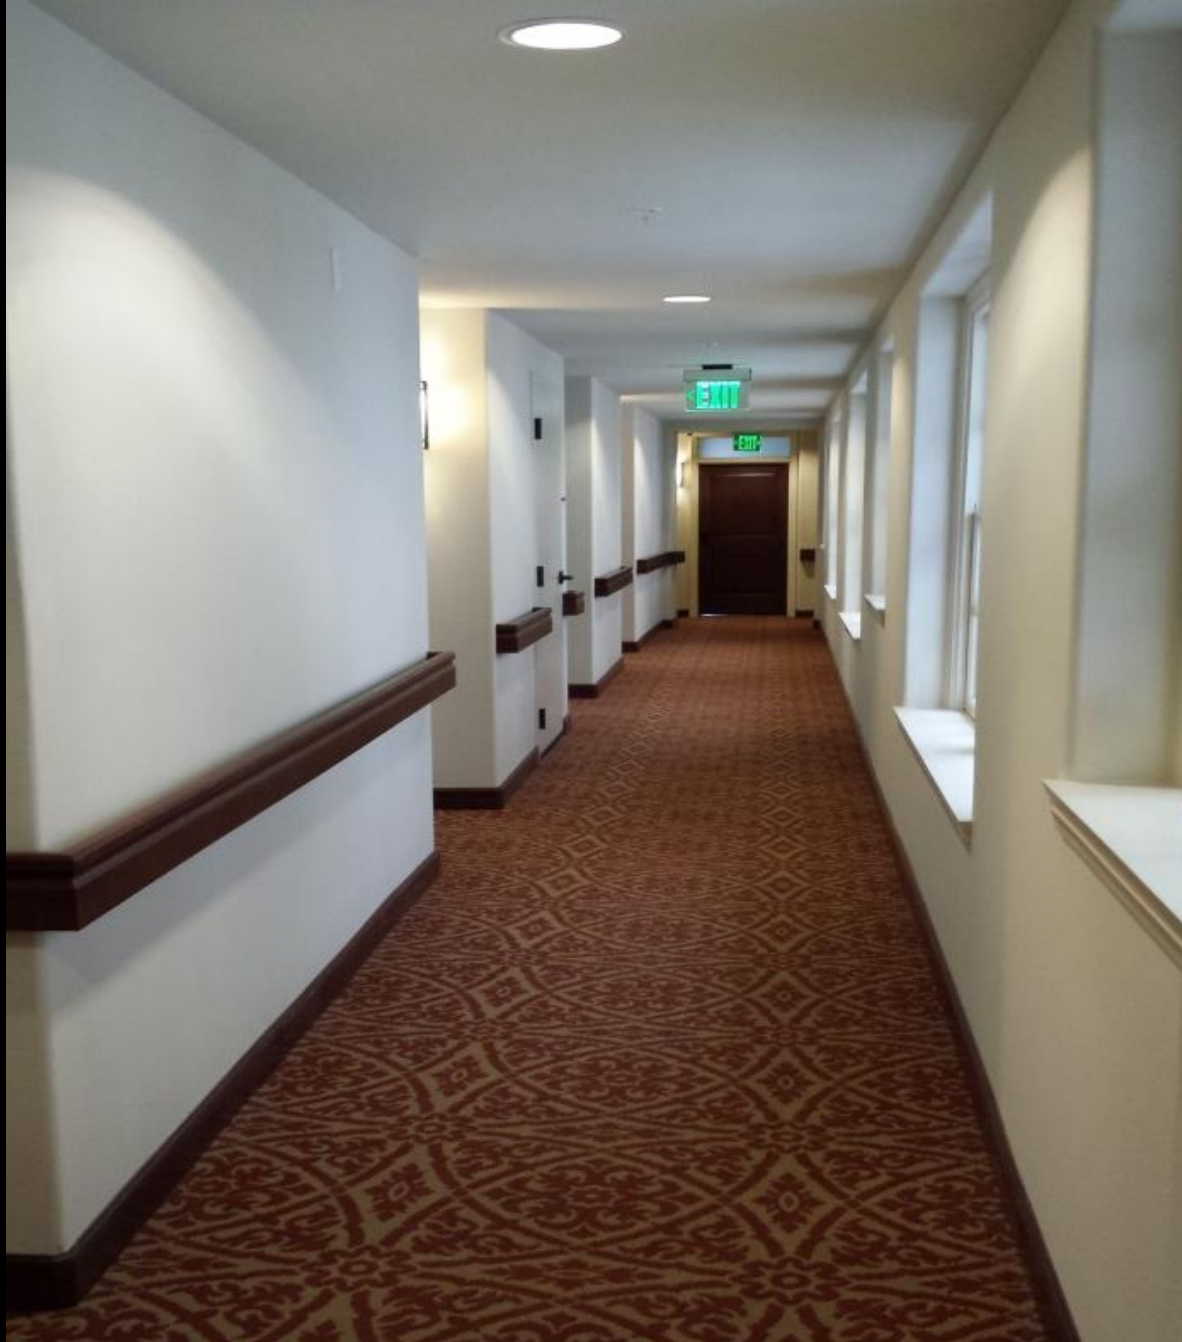
Corridor Floors **After** Rehabilitation, 2013

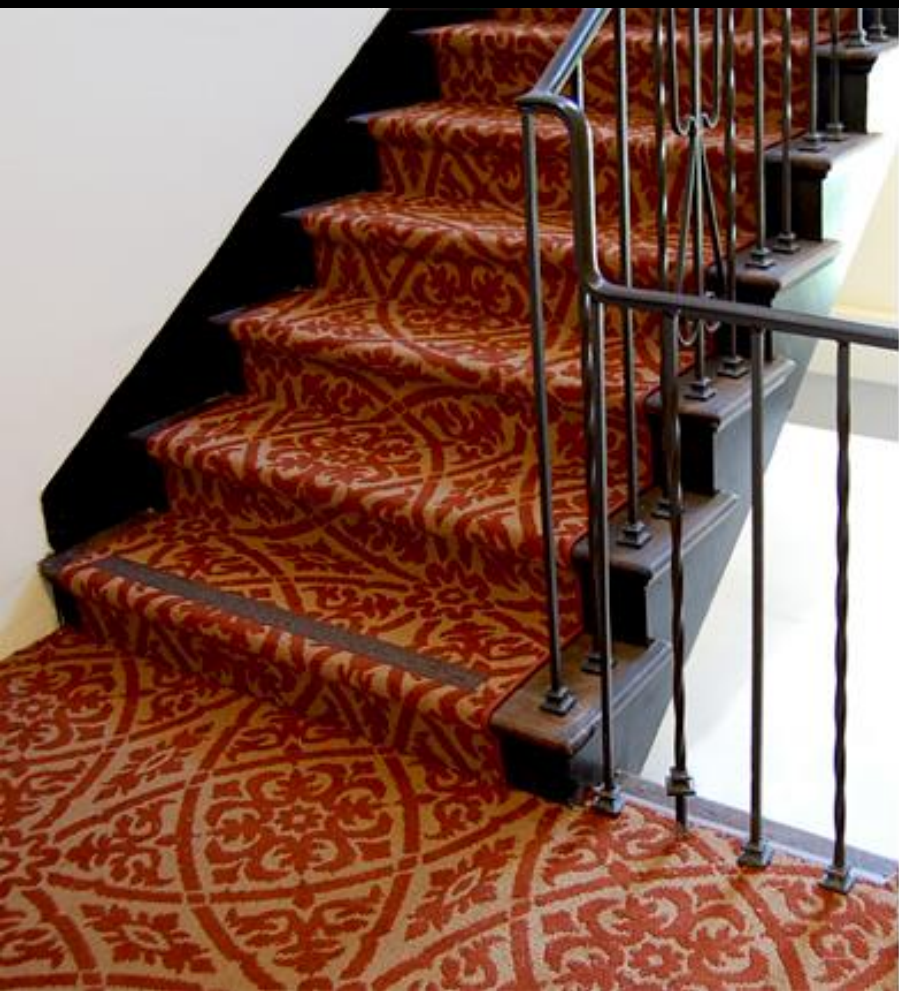
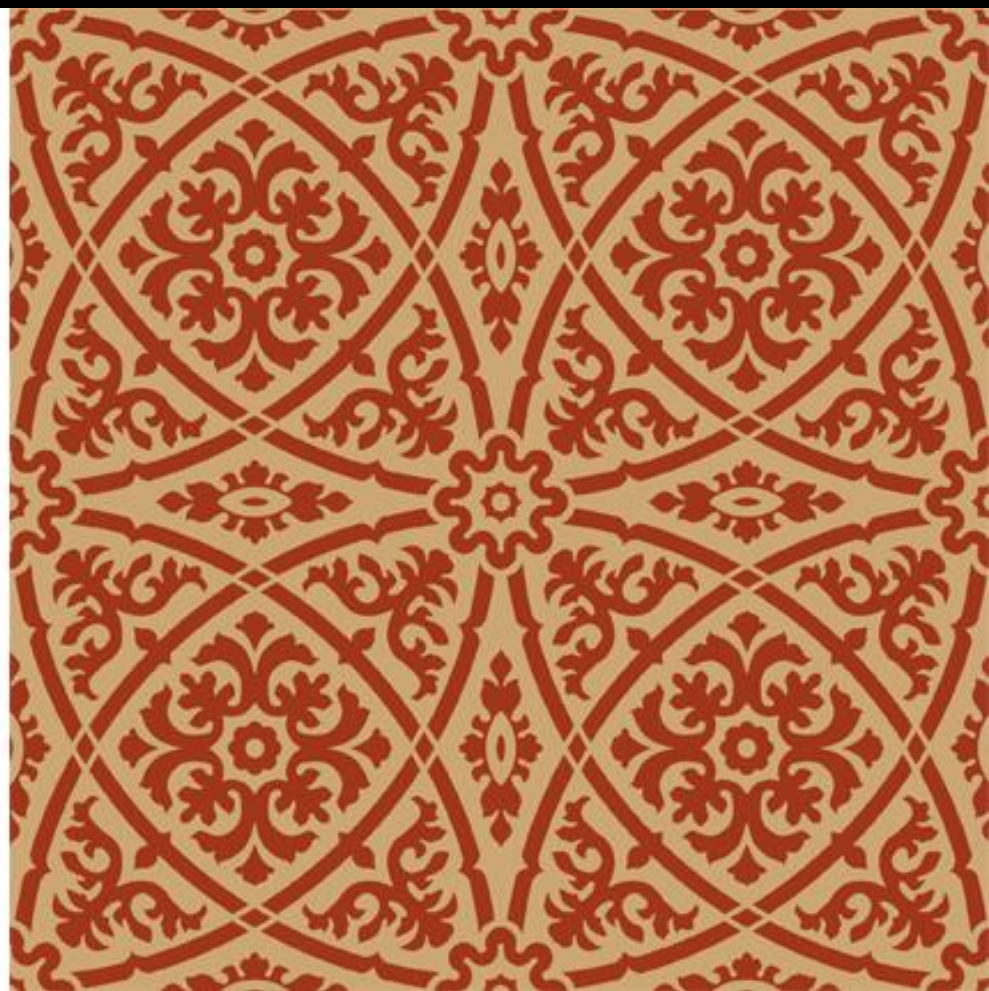
Patterned Carpet in Mezzanine and Corridors Replicated to Match Original

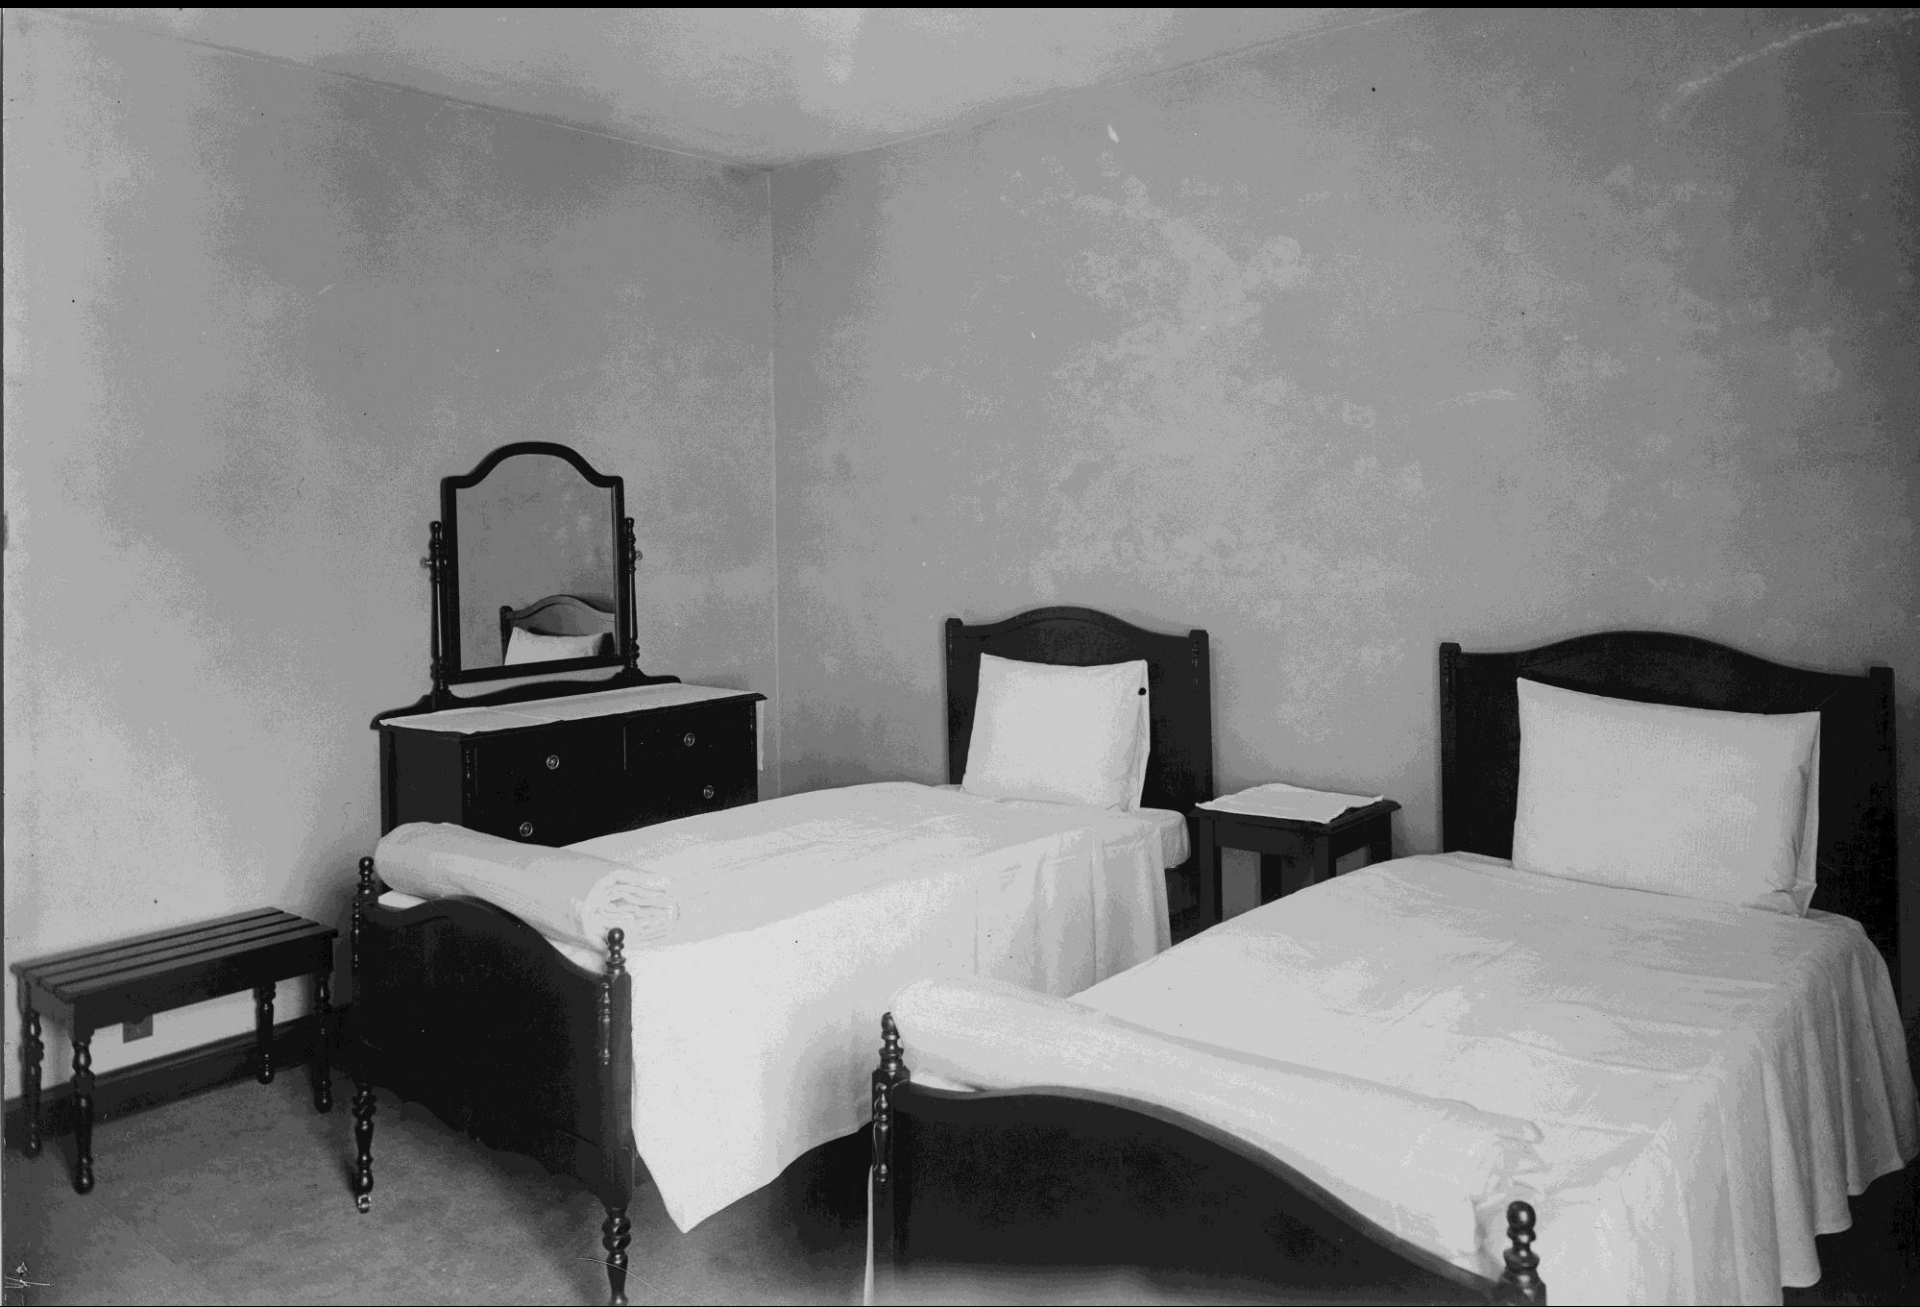
Historic Appearance of Hotel Room, Circa 1928

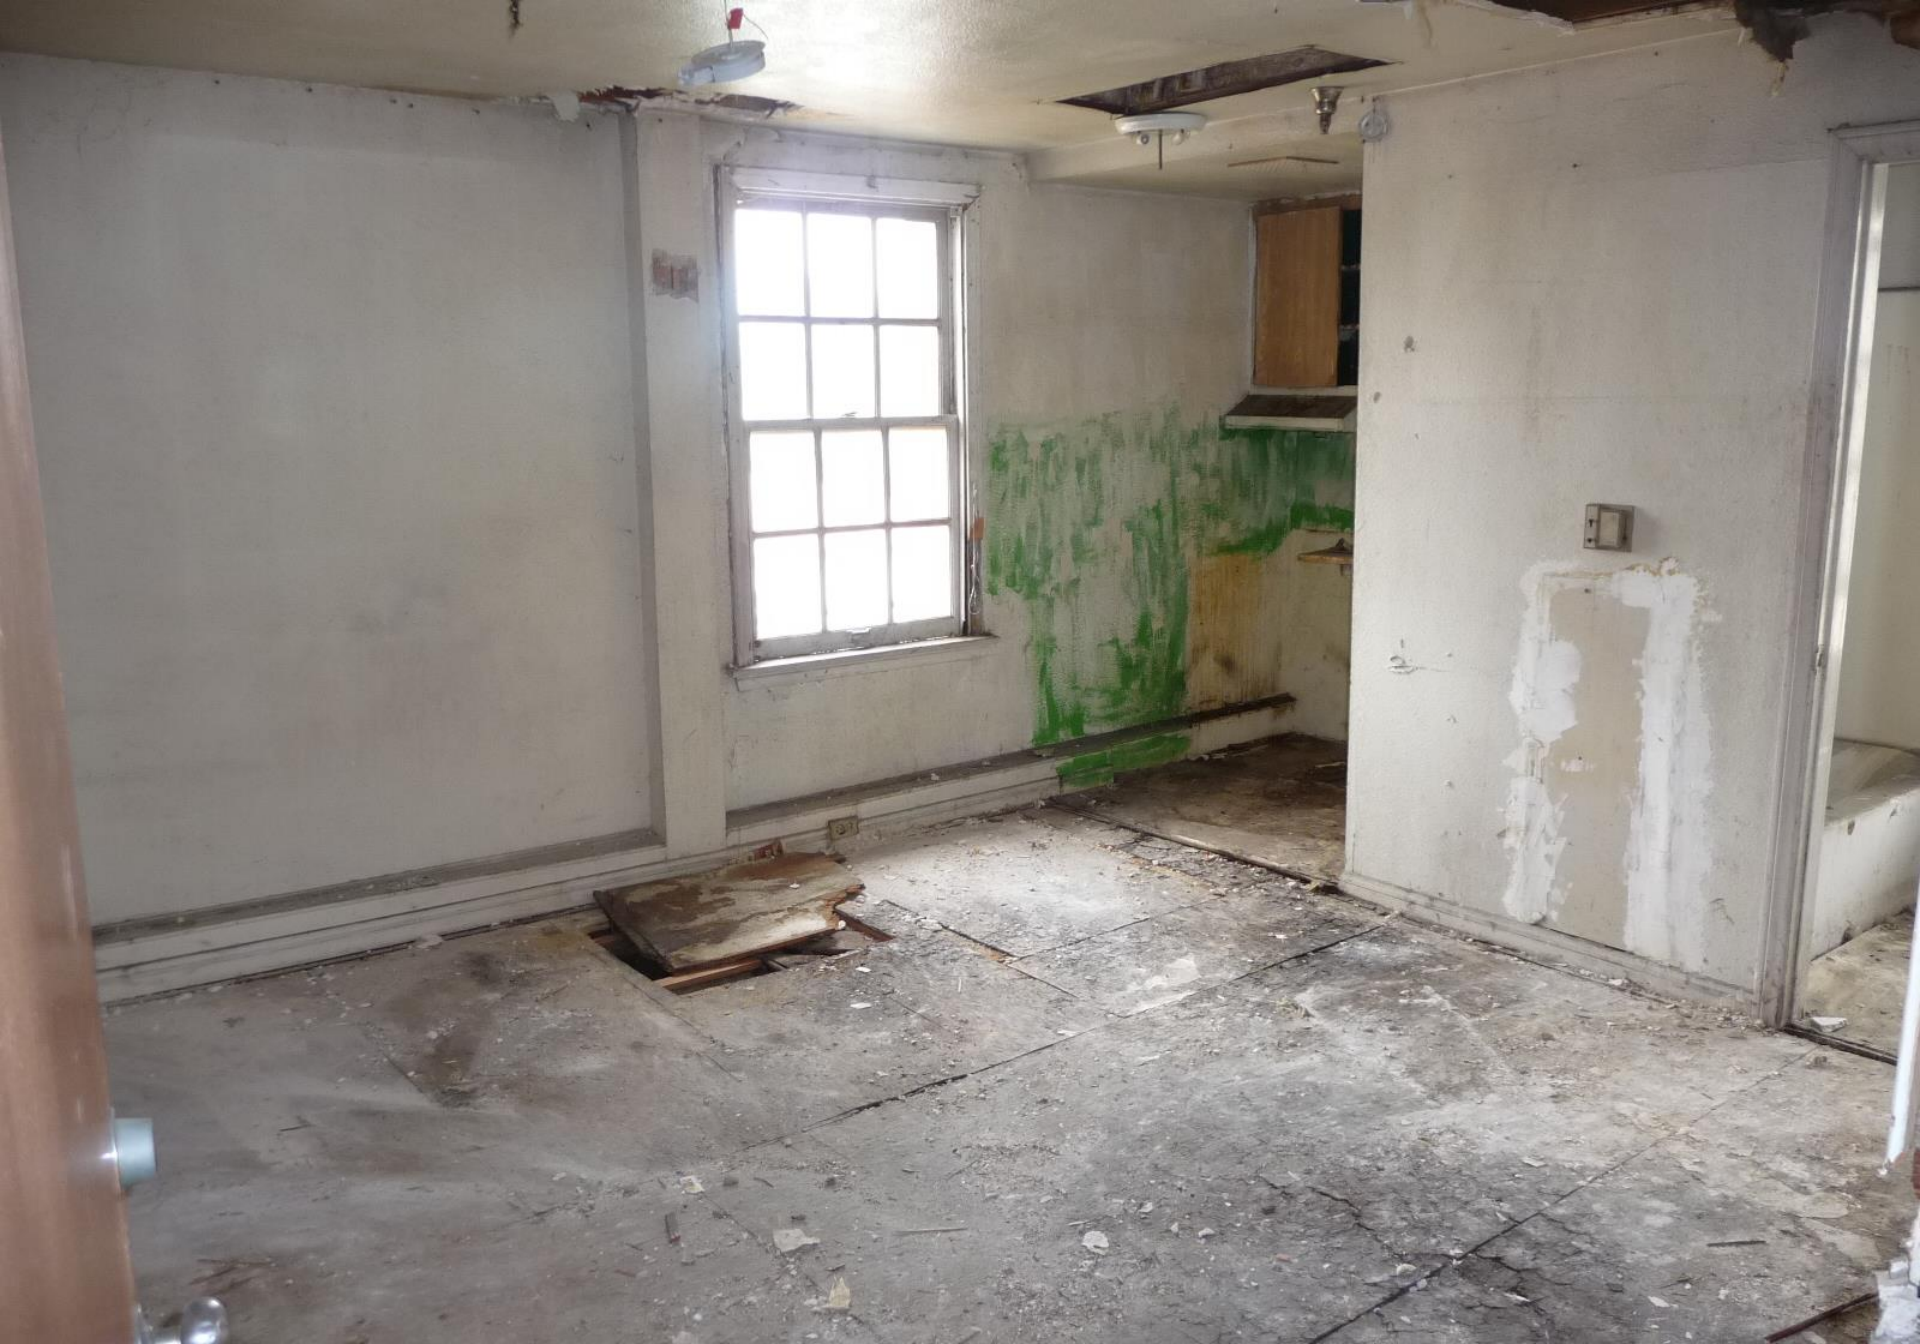
SRO Unit Before Rehabilitation, 2011

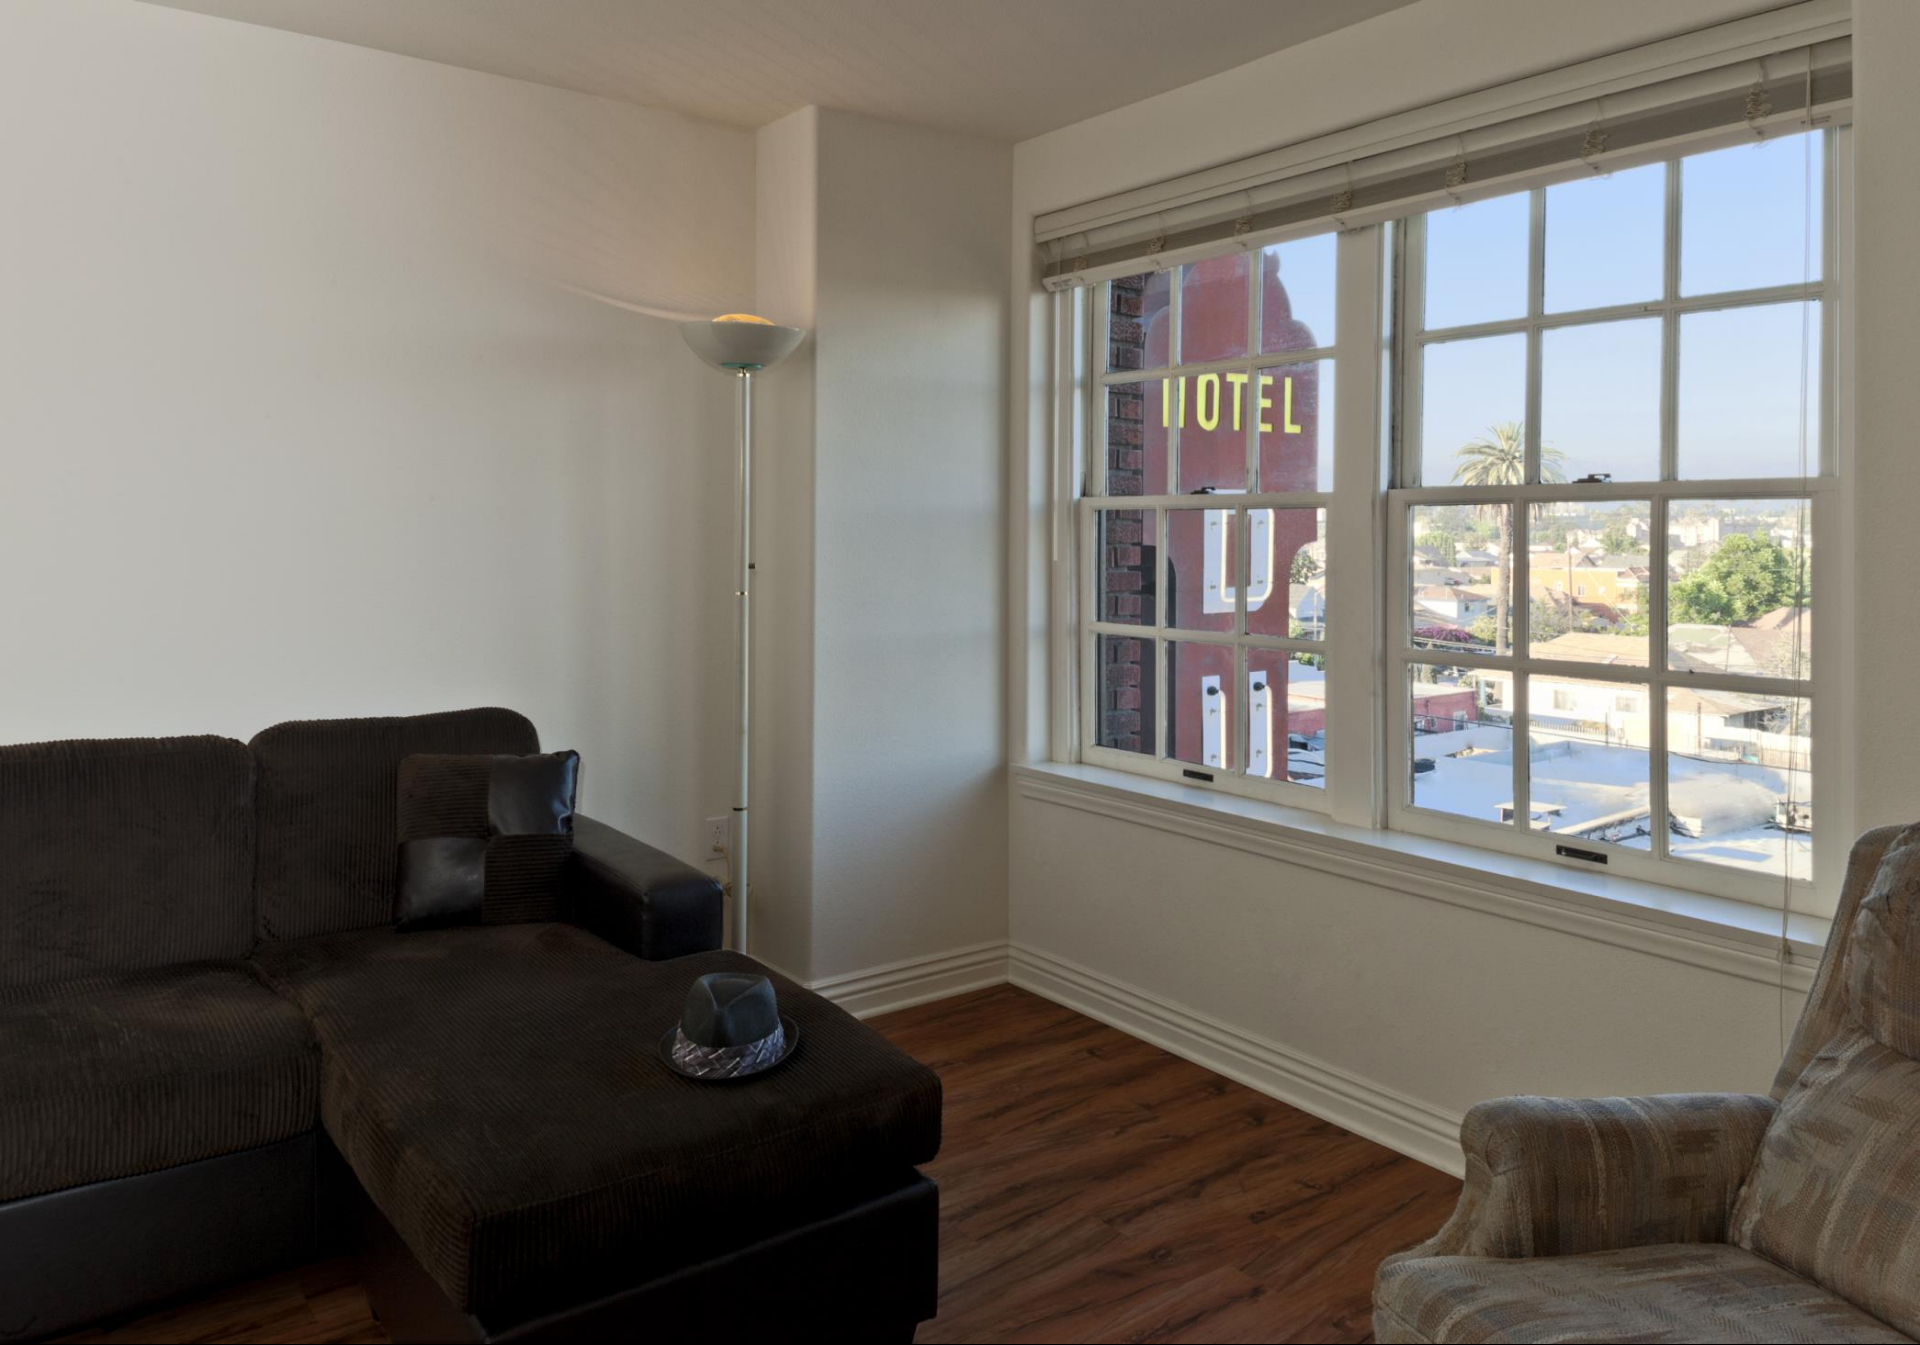
SRO Unit Converted into Apartment, **After** Rehabilitation, 2013

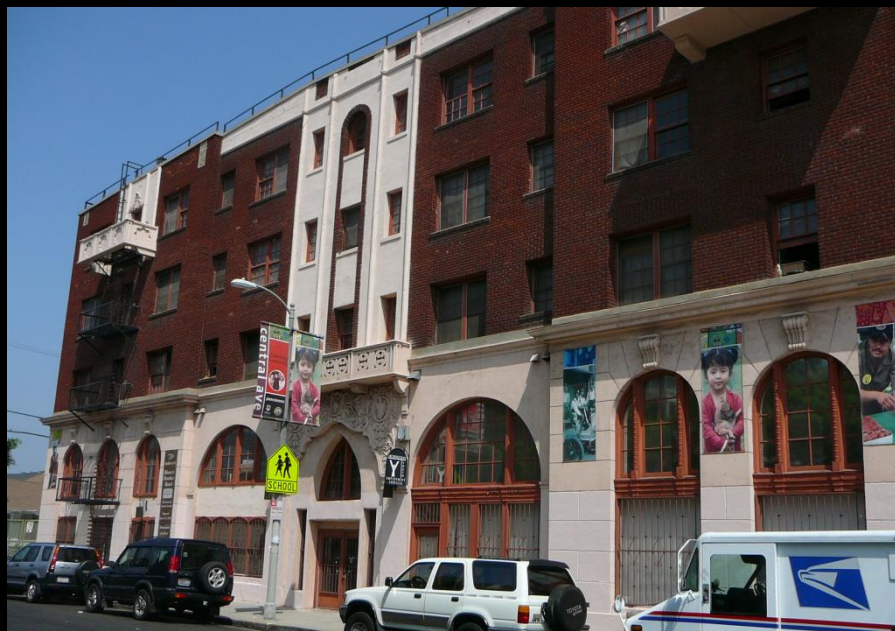
Secondary (South) Elevation, **Before** Rehabilitation, 2009

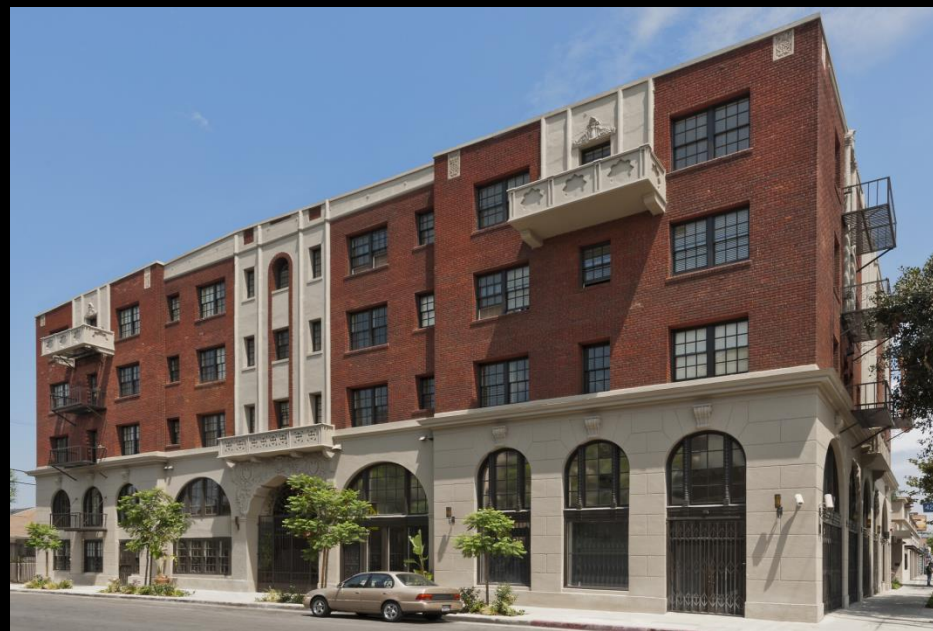
Restored and Enhanced Residential Entry,
Secondary (South) Elevation, **After** Rehabilitation, 2013

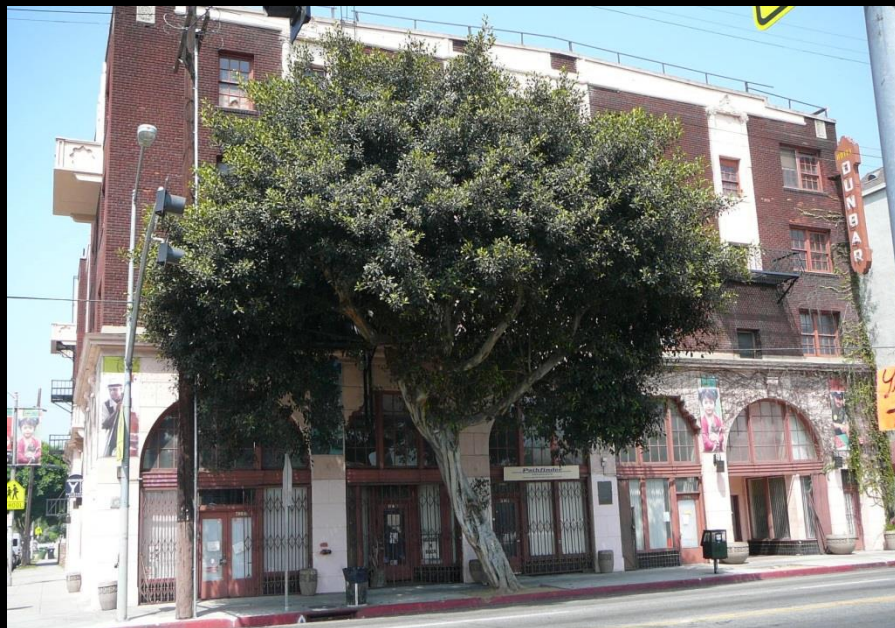
Primary (East) Elevation, **Before** Rehabilitation, 2009

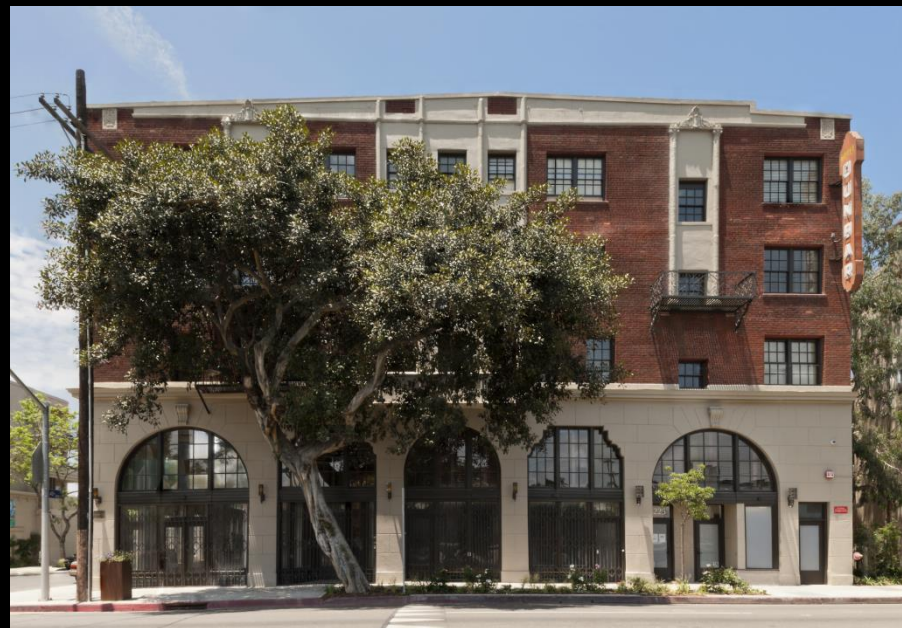
Primary (East) Elevation, **After** Rehabilitation, 2013
