Secretary of Interior Standards
Case Example Discussion

Case 1 The White House

Case 2 Showley Brothers Candy Factory

Case 3 Digital Media Arts Center Adaptive Reuse

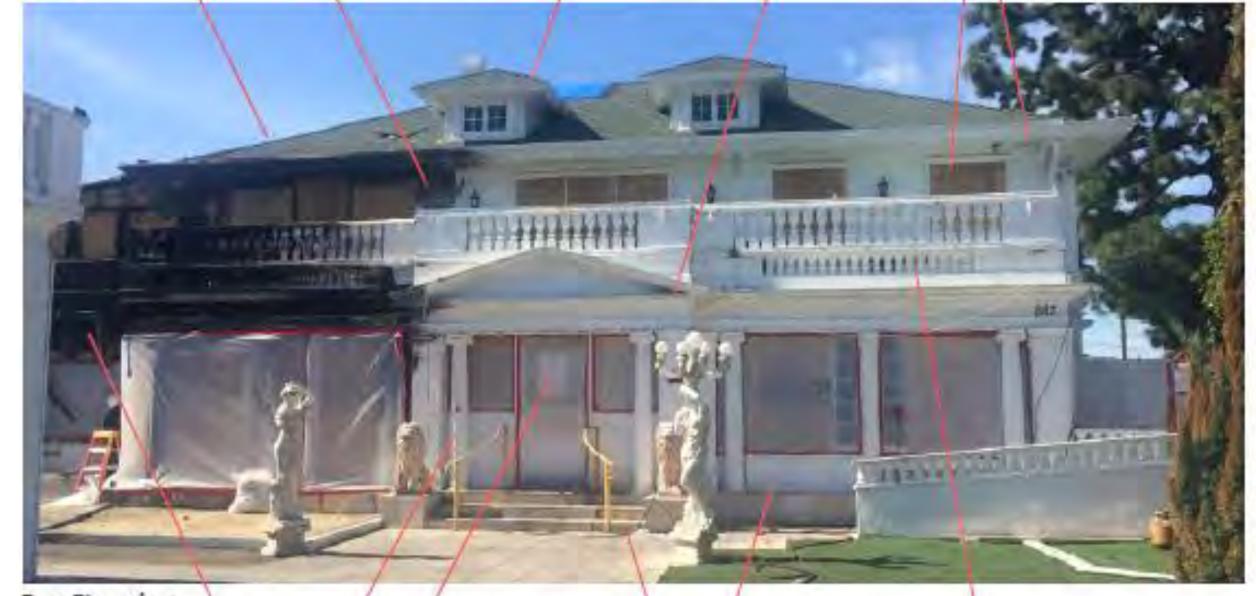
East Elevation

All wood siding throughout

> Low-pitched, hipped roof clad in shingles

Twin front roof dormers (incl. roofline, multilight wood windows, siding and trim) -

All single-light, double-hung wood windows and frames (incl. size, pattern, trim, and arrangement of openings)

All architectural trim at pediment and porch eaves (incl. cornice and dentil moldings) -

All architectural trim at eaves (incl. brackets, cornice moldings, and soffit trim)

Original porte cochere elements (incl. size, columns, lower balustrade, and eave trim,)

Full-width porch with central pediment

All (10) Ionic columns at front and sides of porch (incl. location, shaft, capital, and base)

Level (height) and extent of porch floor

Entry steps and side walls (incl. location, size and number of steps

Original balustrade, (lower portion only, incl. corner piers, balusters, and top rail)

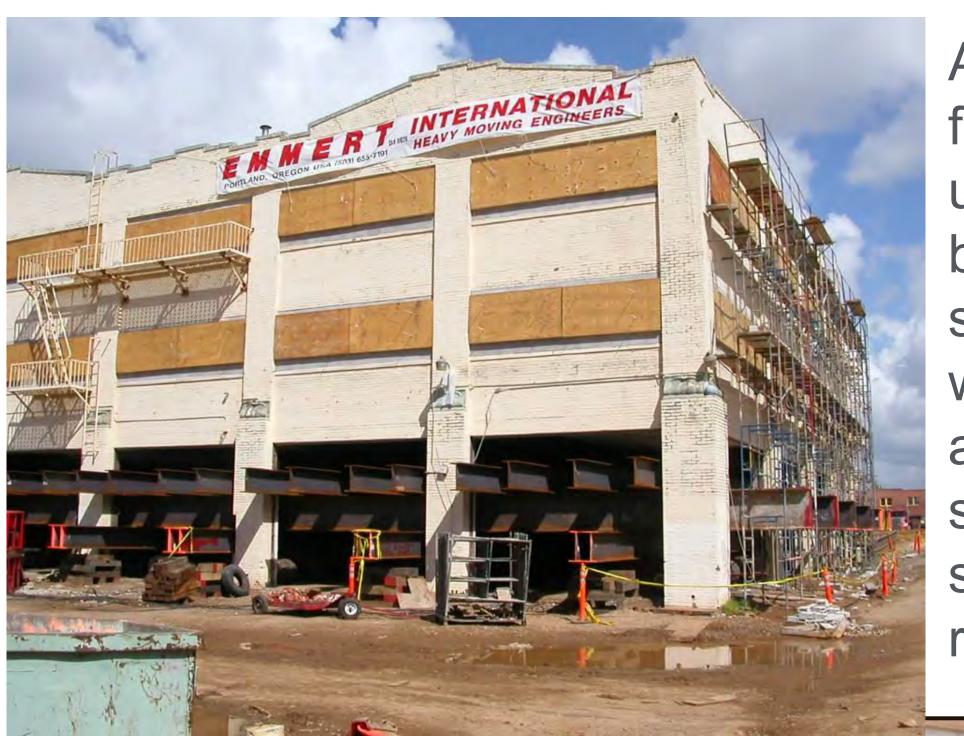
A steel supporting frame on dollies was used to carry the building to its new site. The first floor was disassembled and the bricks and storefronts were stored for later rehabilitation, 2004.

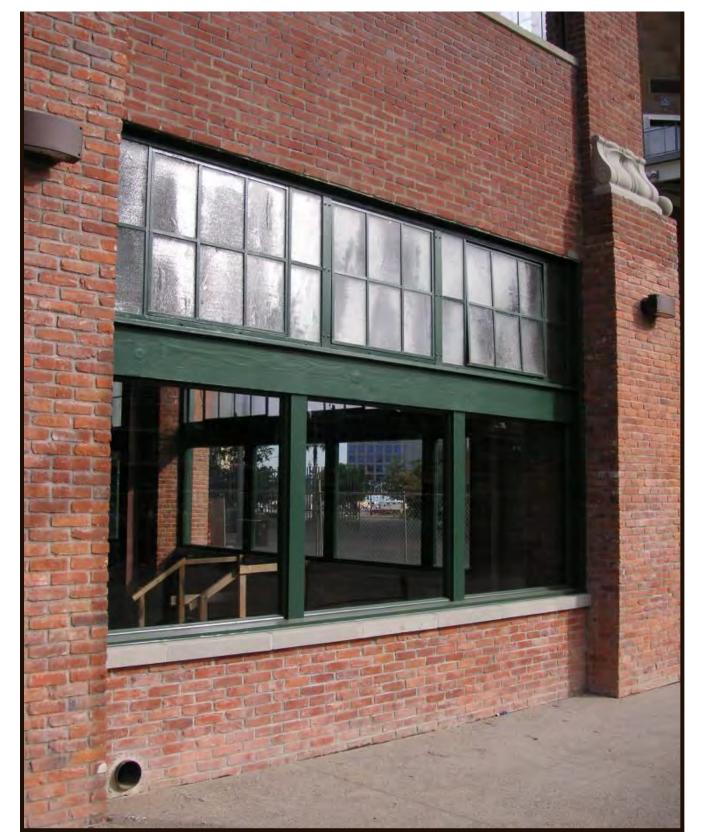
With the building on its new site, the original brick piers and historic storefronts were reconstructed.

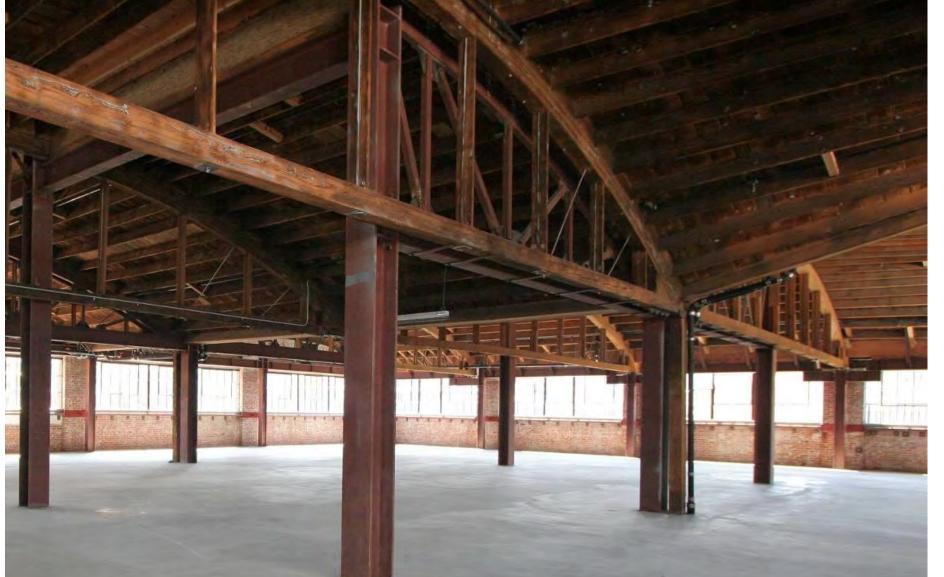
Originally built of unreinforced load-bearing masonry, a steel skeleton was carefully inserted to give the building additional strength and seismic stability. The historic timber members remain.

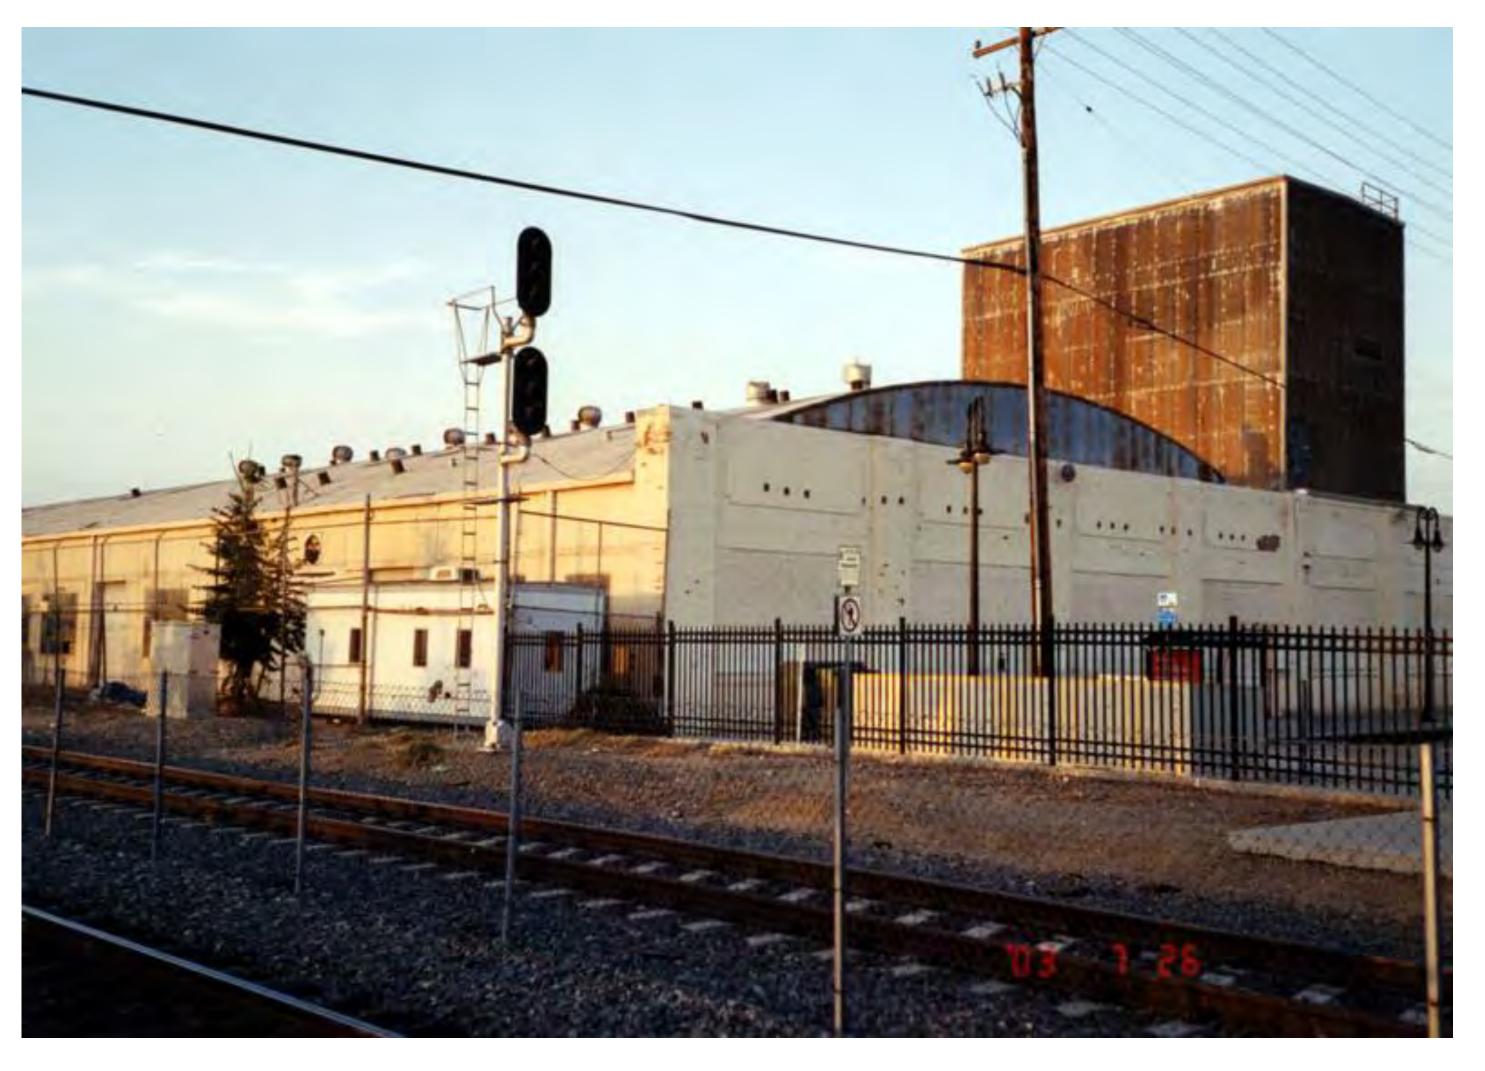
August 2012 – Before Construction

- Condition was poor.
- Roofing membranes were failing.
- URM walls did not meet seismic safety standards.
- Red brick walls had been painted at the exterior.
- High parapet at the corner built for signage had been previously demolished.
- Original steel casements had been replaced by concrete masonry infills.

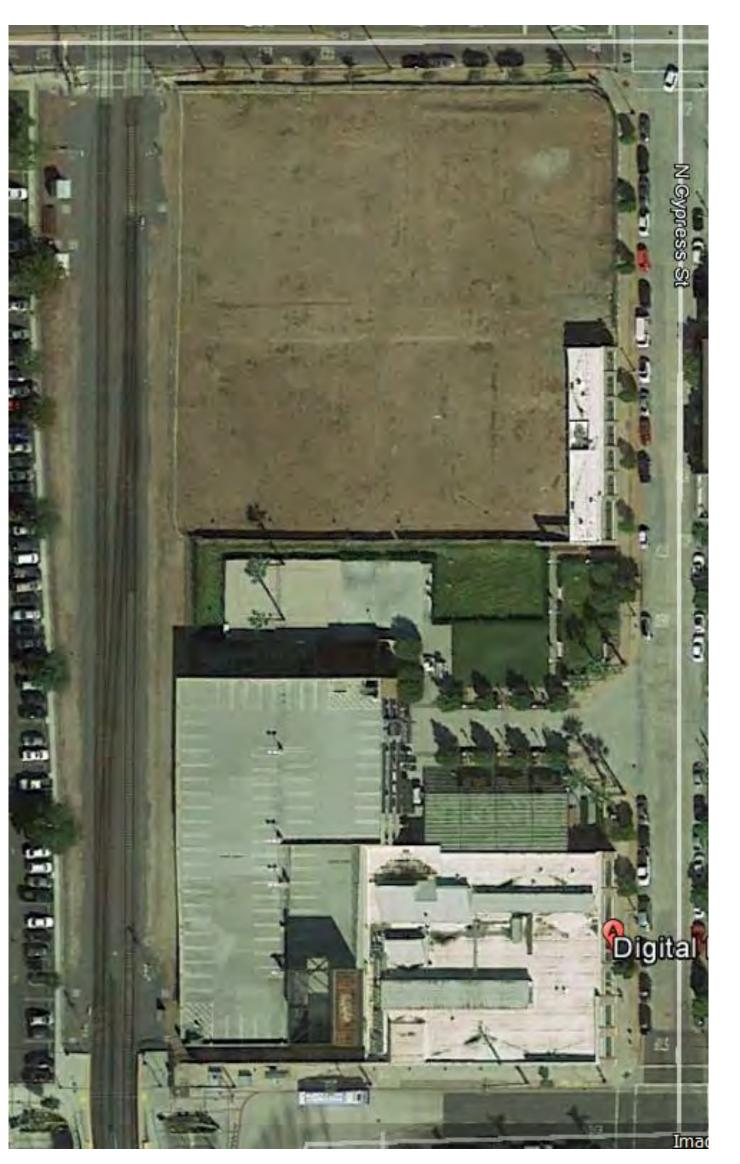
October 2016 – After Construction
