Secretary of Interior Standards
Case Example Discussion

Case 1 The White House

Case 2 Showley Brothers Candy Factory

Case 3 Digital Media Arts Center Adaptive Reuse

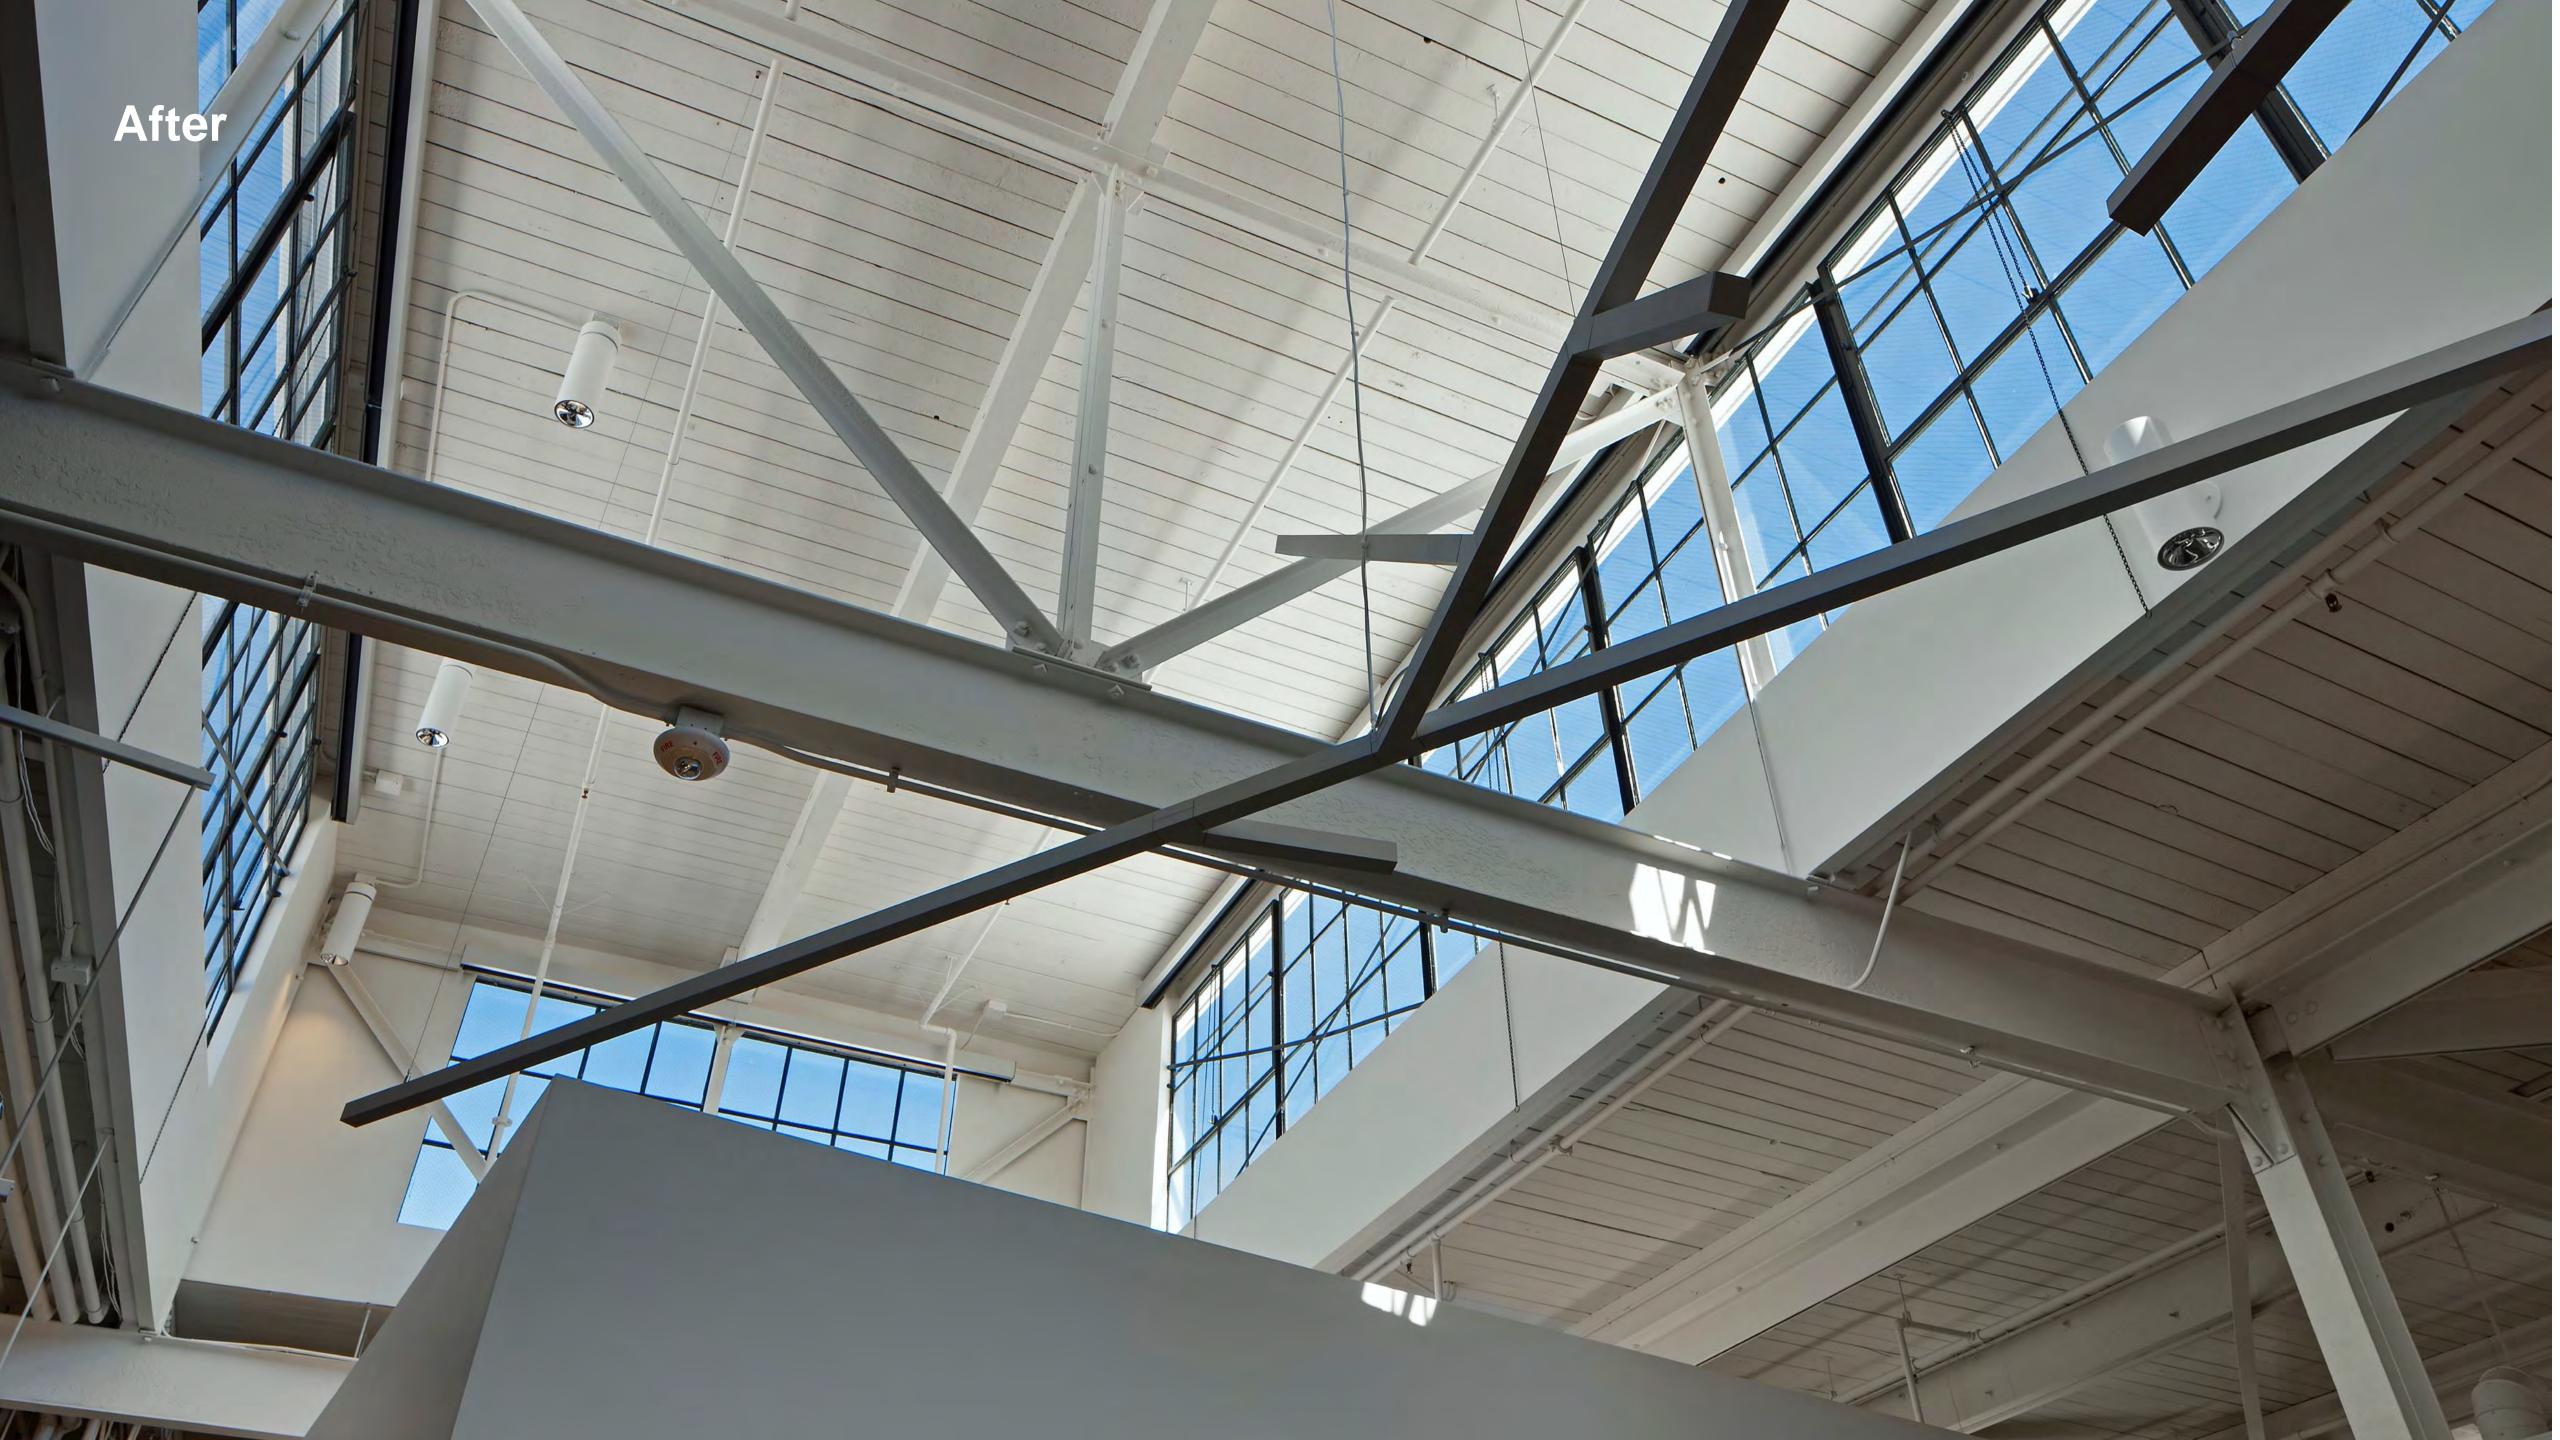
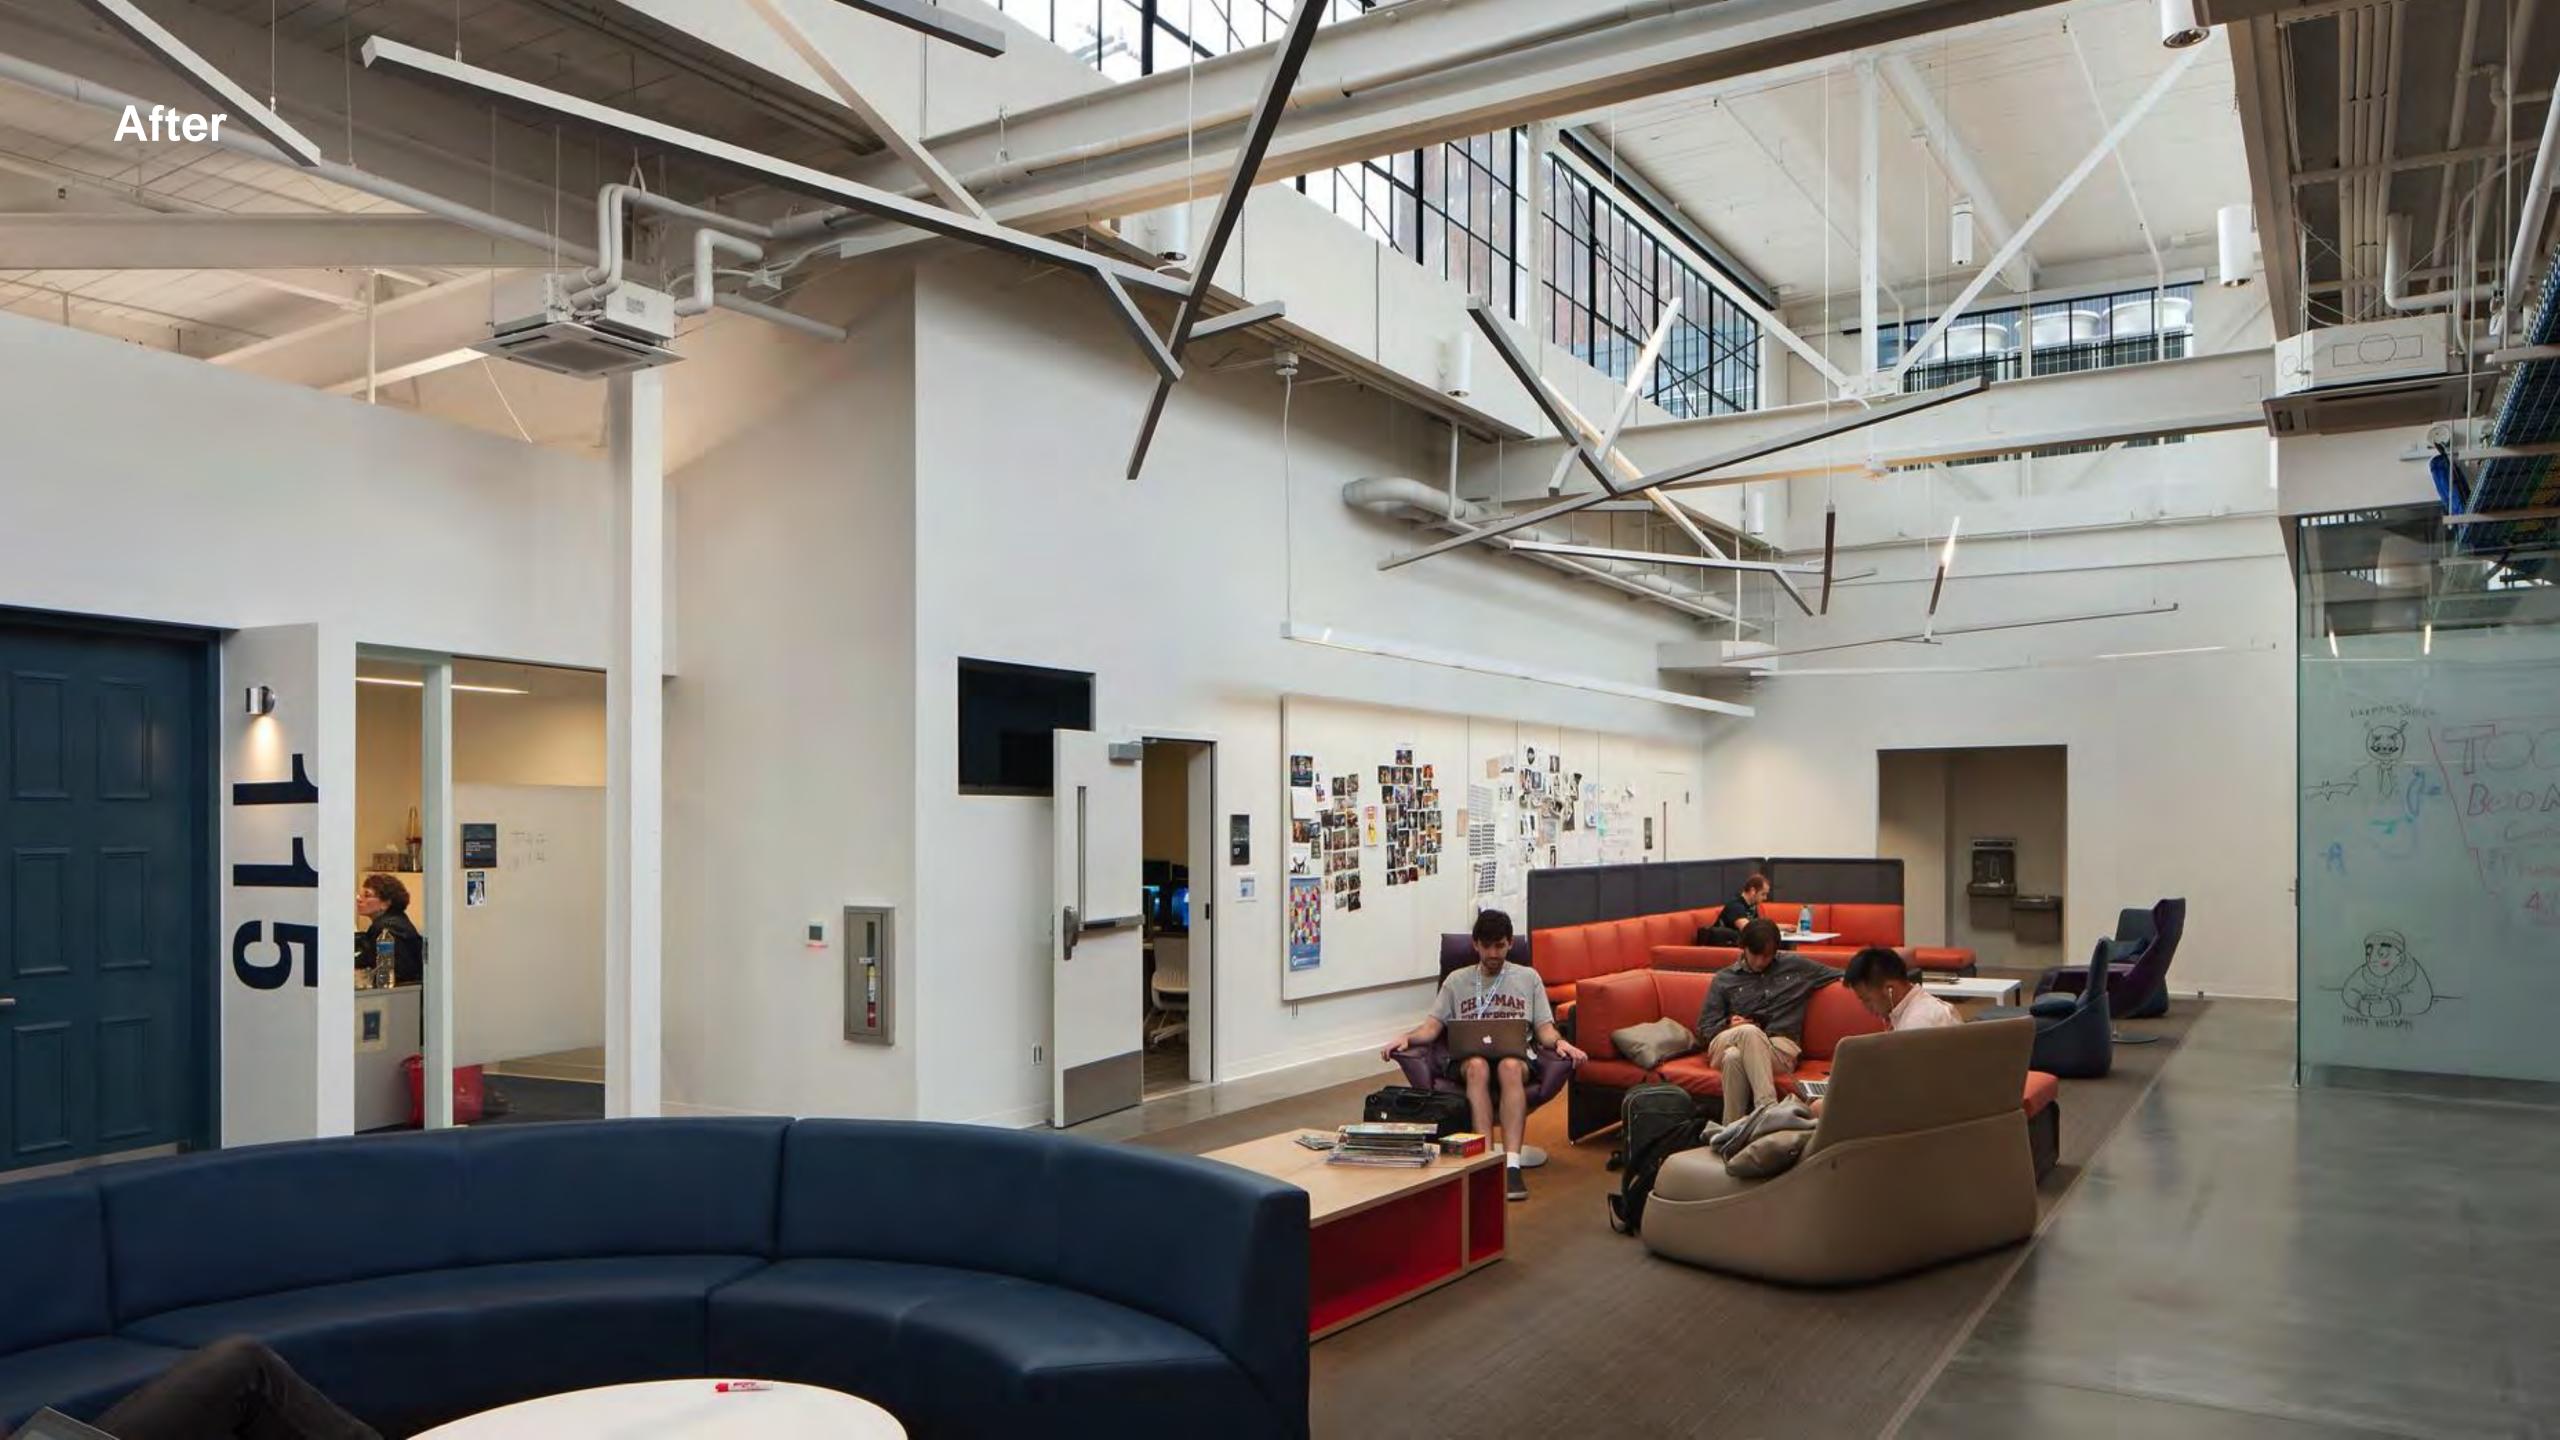
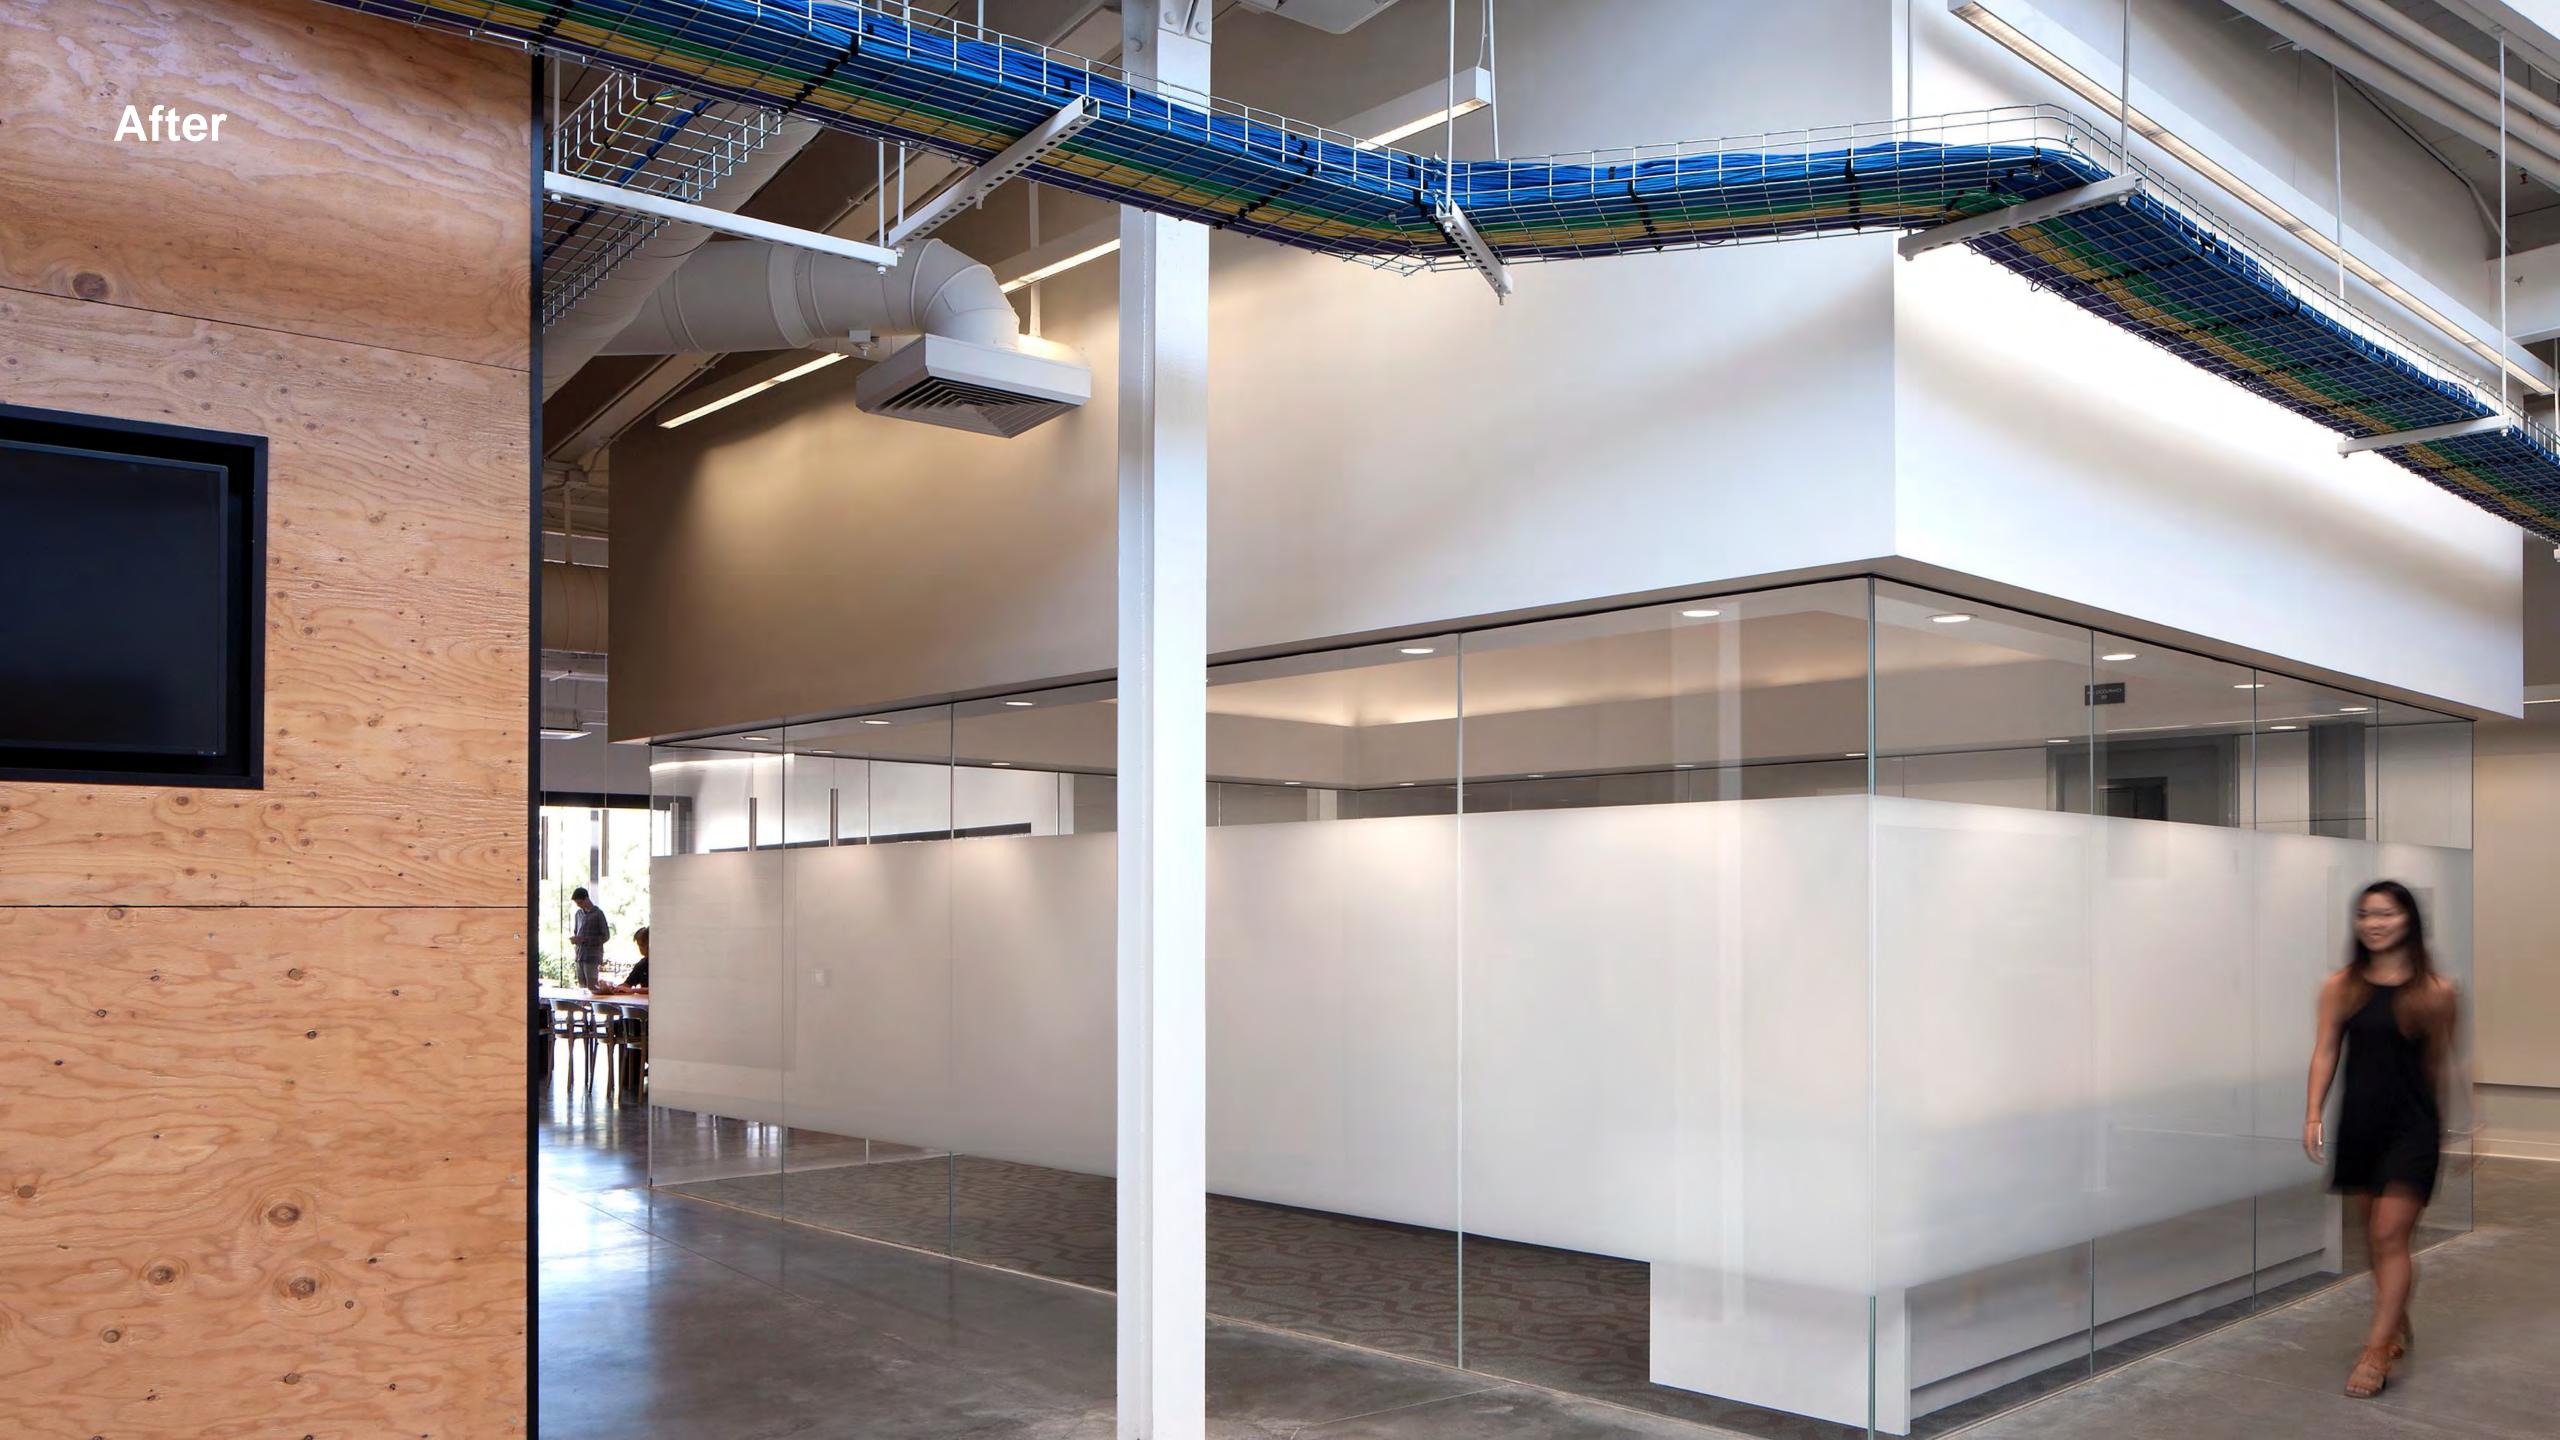
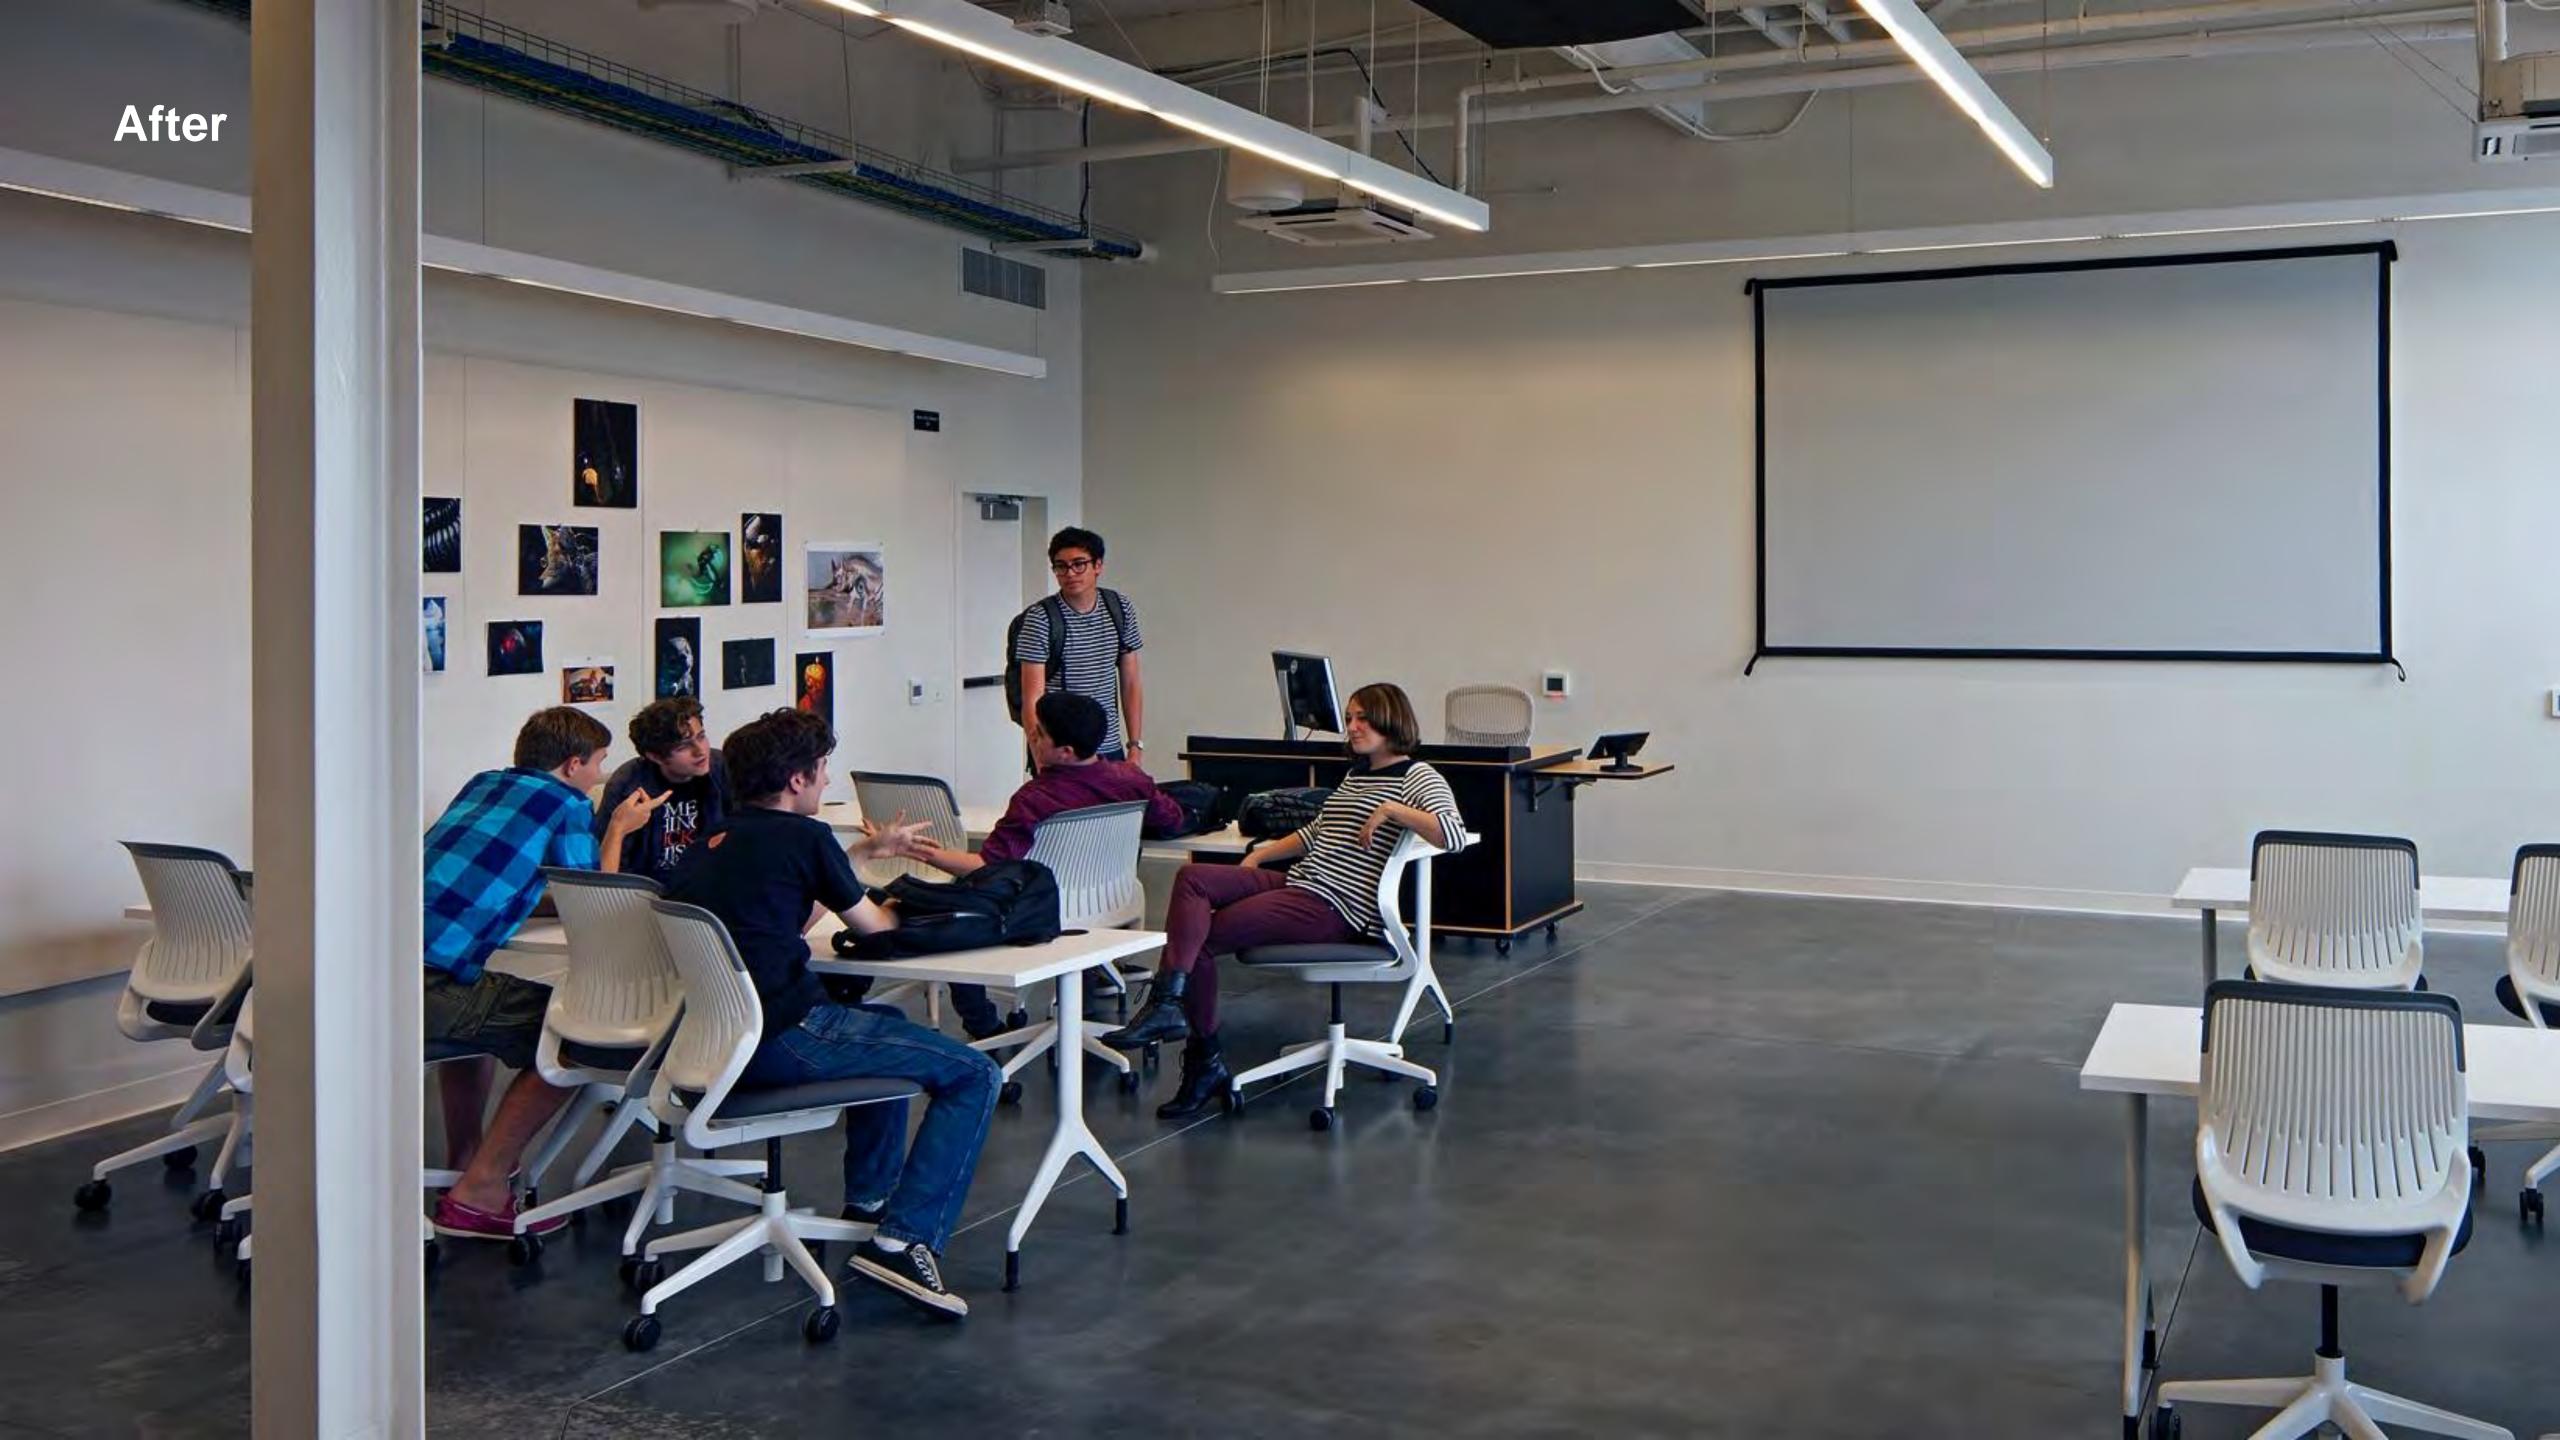
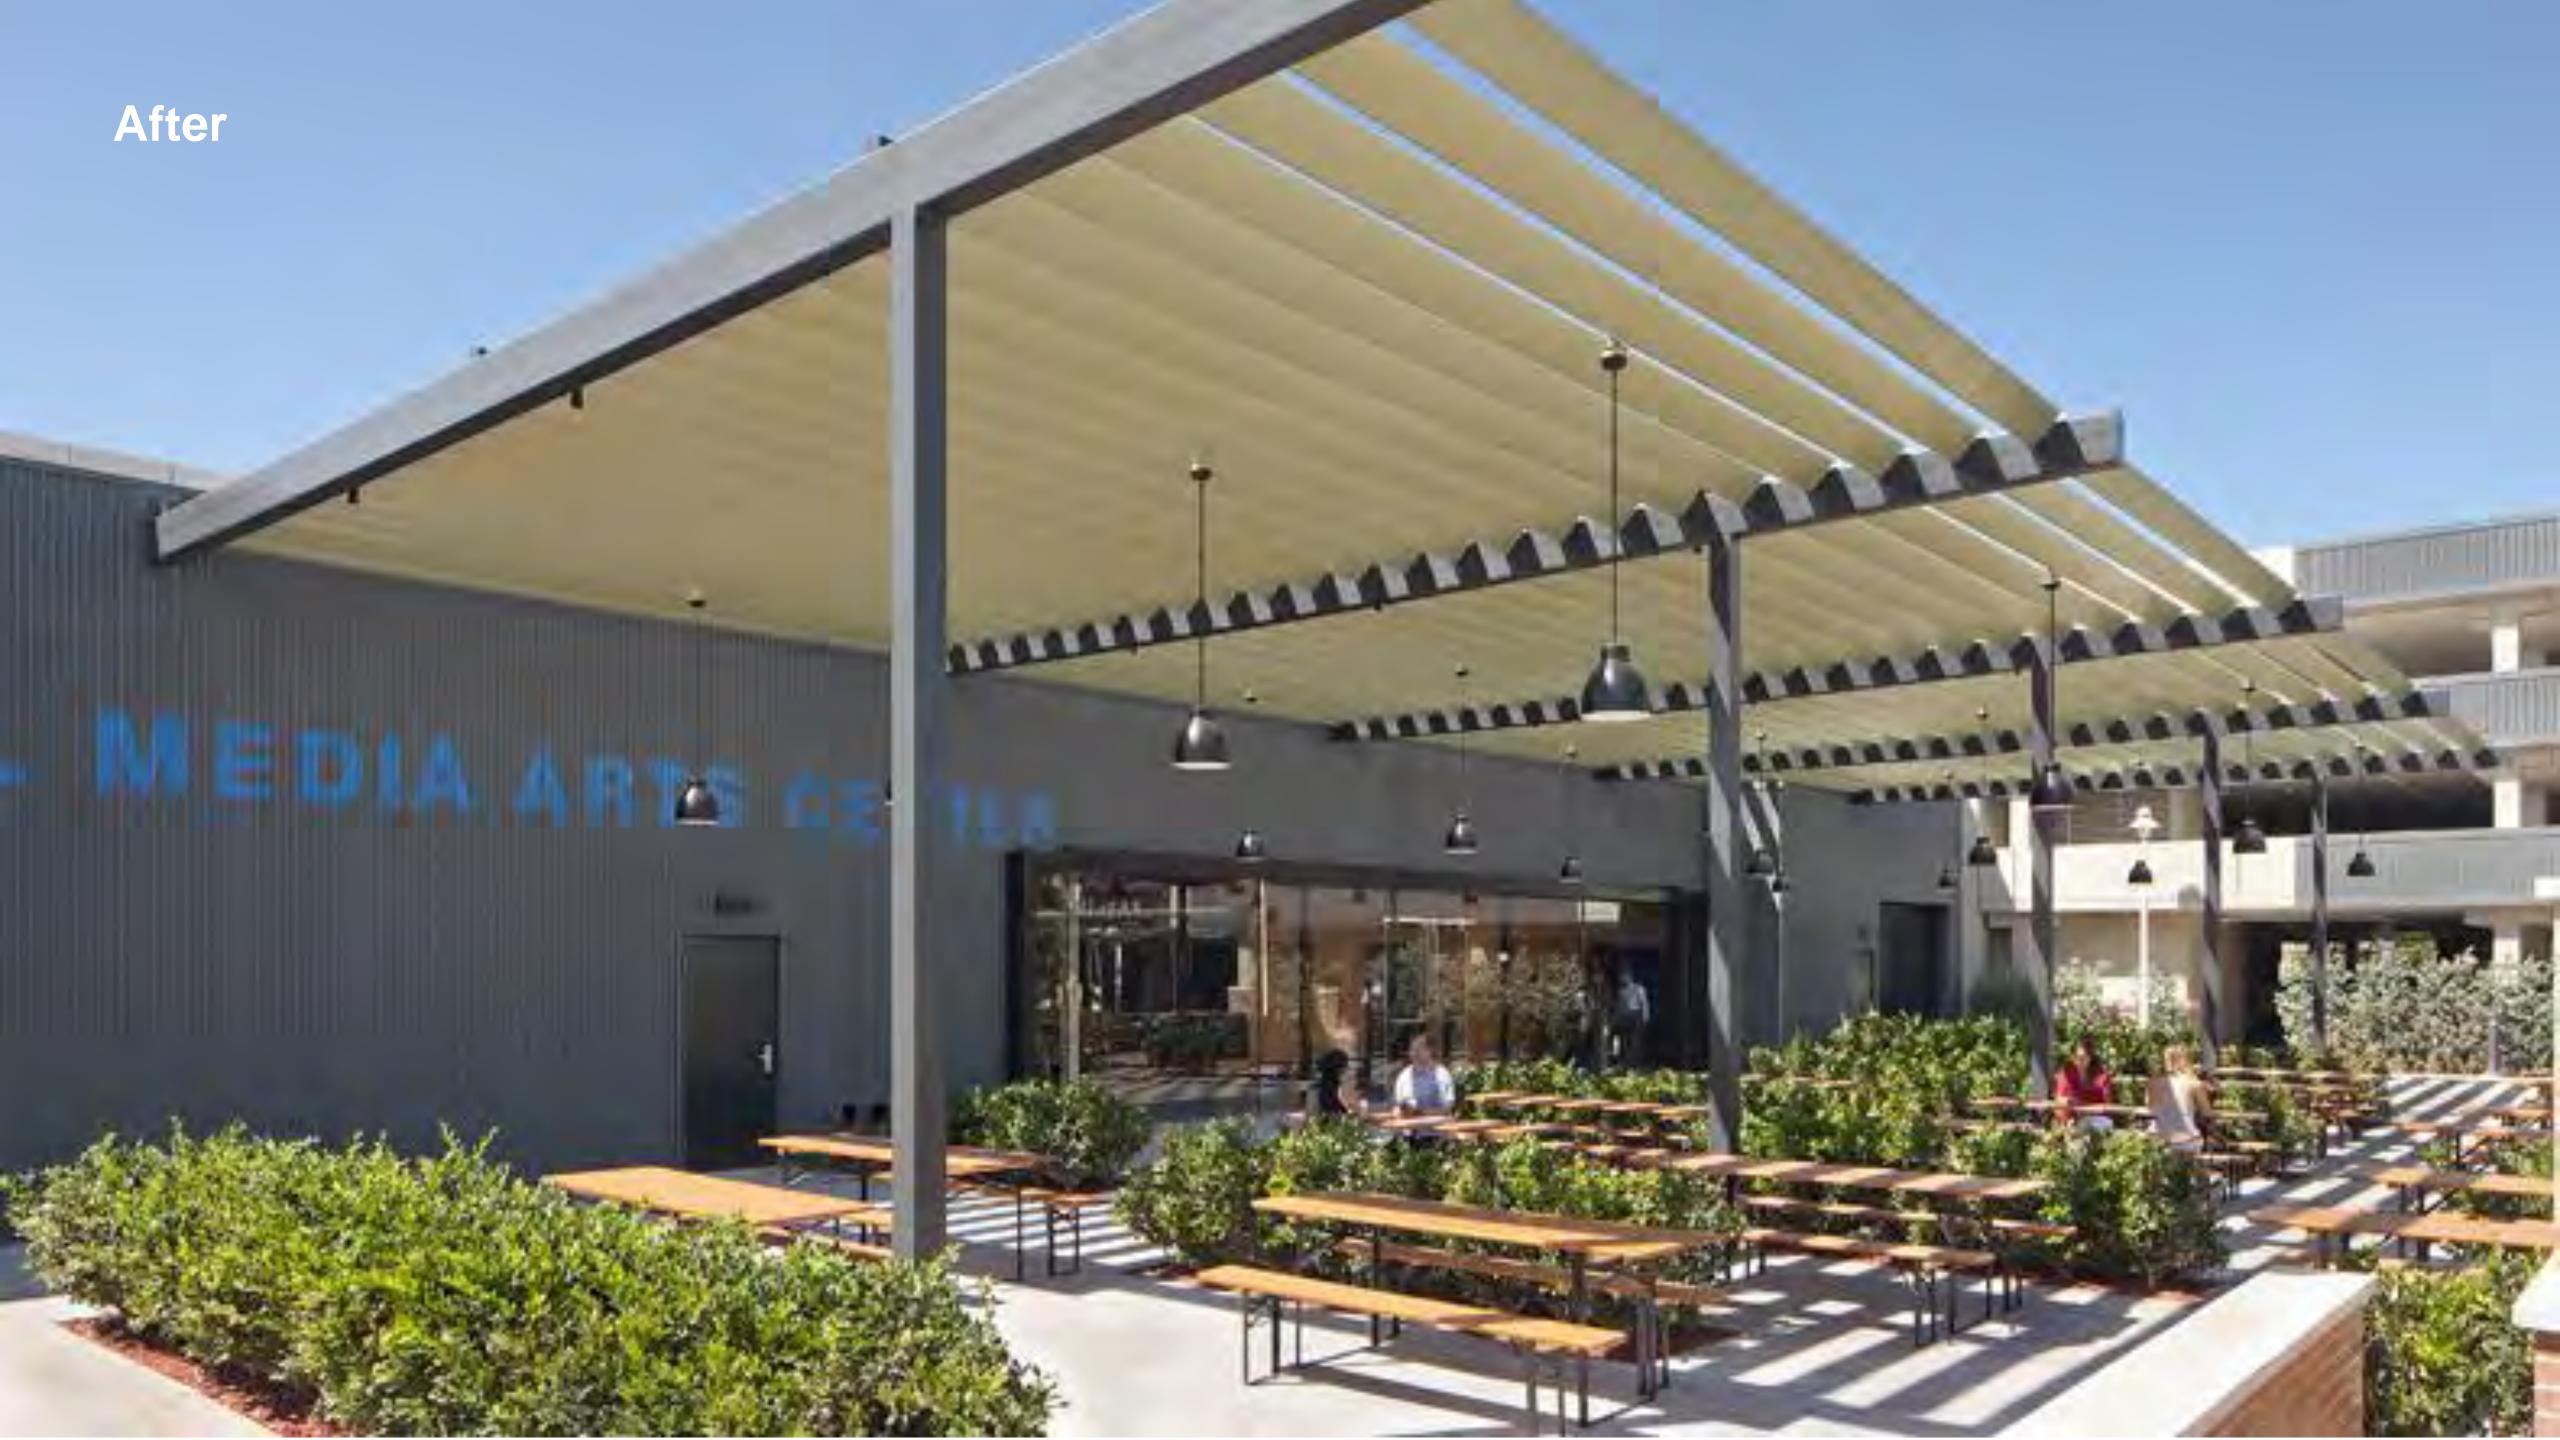
Digital Media Arts Center Existing Conditions

- Condition was poor.
- Roofing membranes were failing.
- URM walls did not meet seismic safety standards.
- Red brick walls had been painted at the exterior.
- High parapet at the corner built for signage had been previously demolished.
- Original steel casements had been replaced by concrete masonry infills.

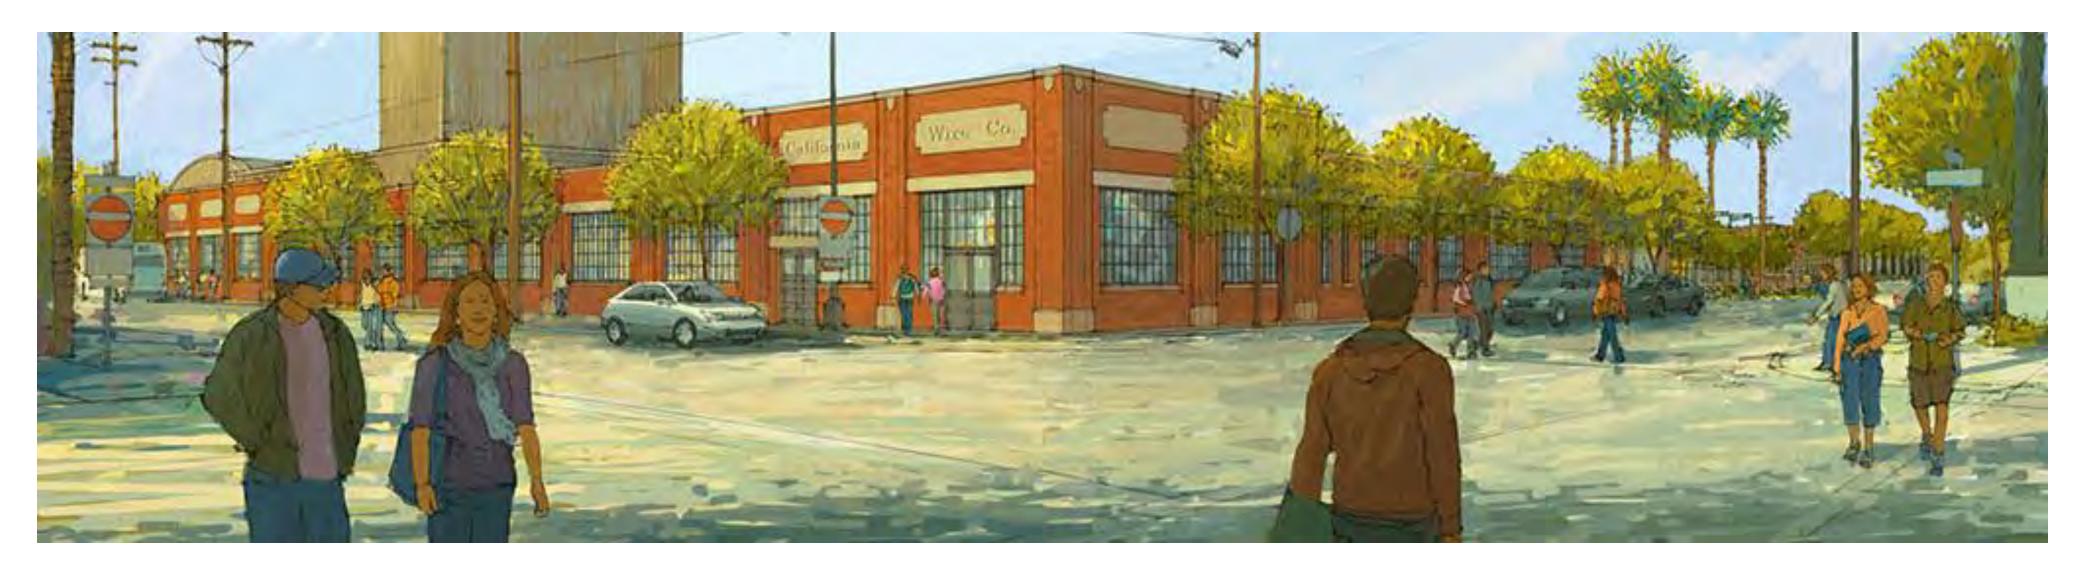
- Walls were repointed with cement and lime mortar formulated for lower compressive strength and tooled to simulate the original profiles.
- For seismic resiliency, shotcrete was added to interior surfaces.
- Reconstruction of a stepped up parapet at the street corner to mark the original entrance and provide a surface for replicating original signage seen in archival photographs
- Steel casement glazing was custom fabricated to closely match the frame and muntin profiles of original windows while accommodating insulated glass units.
- Additions: New locker and restroom building designed in an industrial character compatible with the proposed rehabilitated DMAC building and the surrounding neighborhood

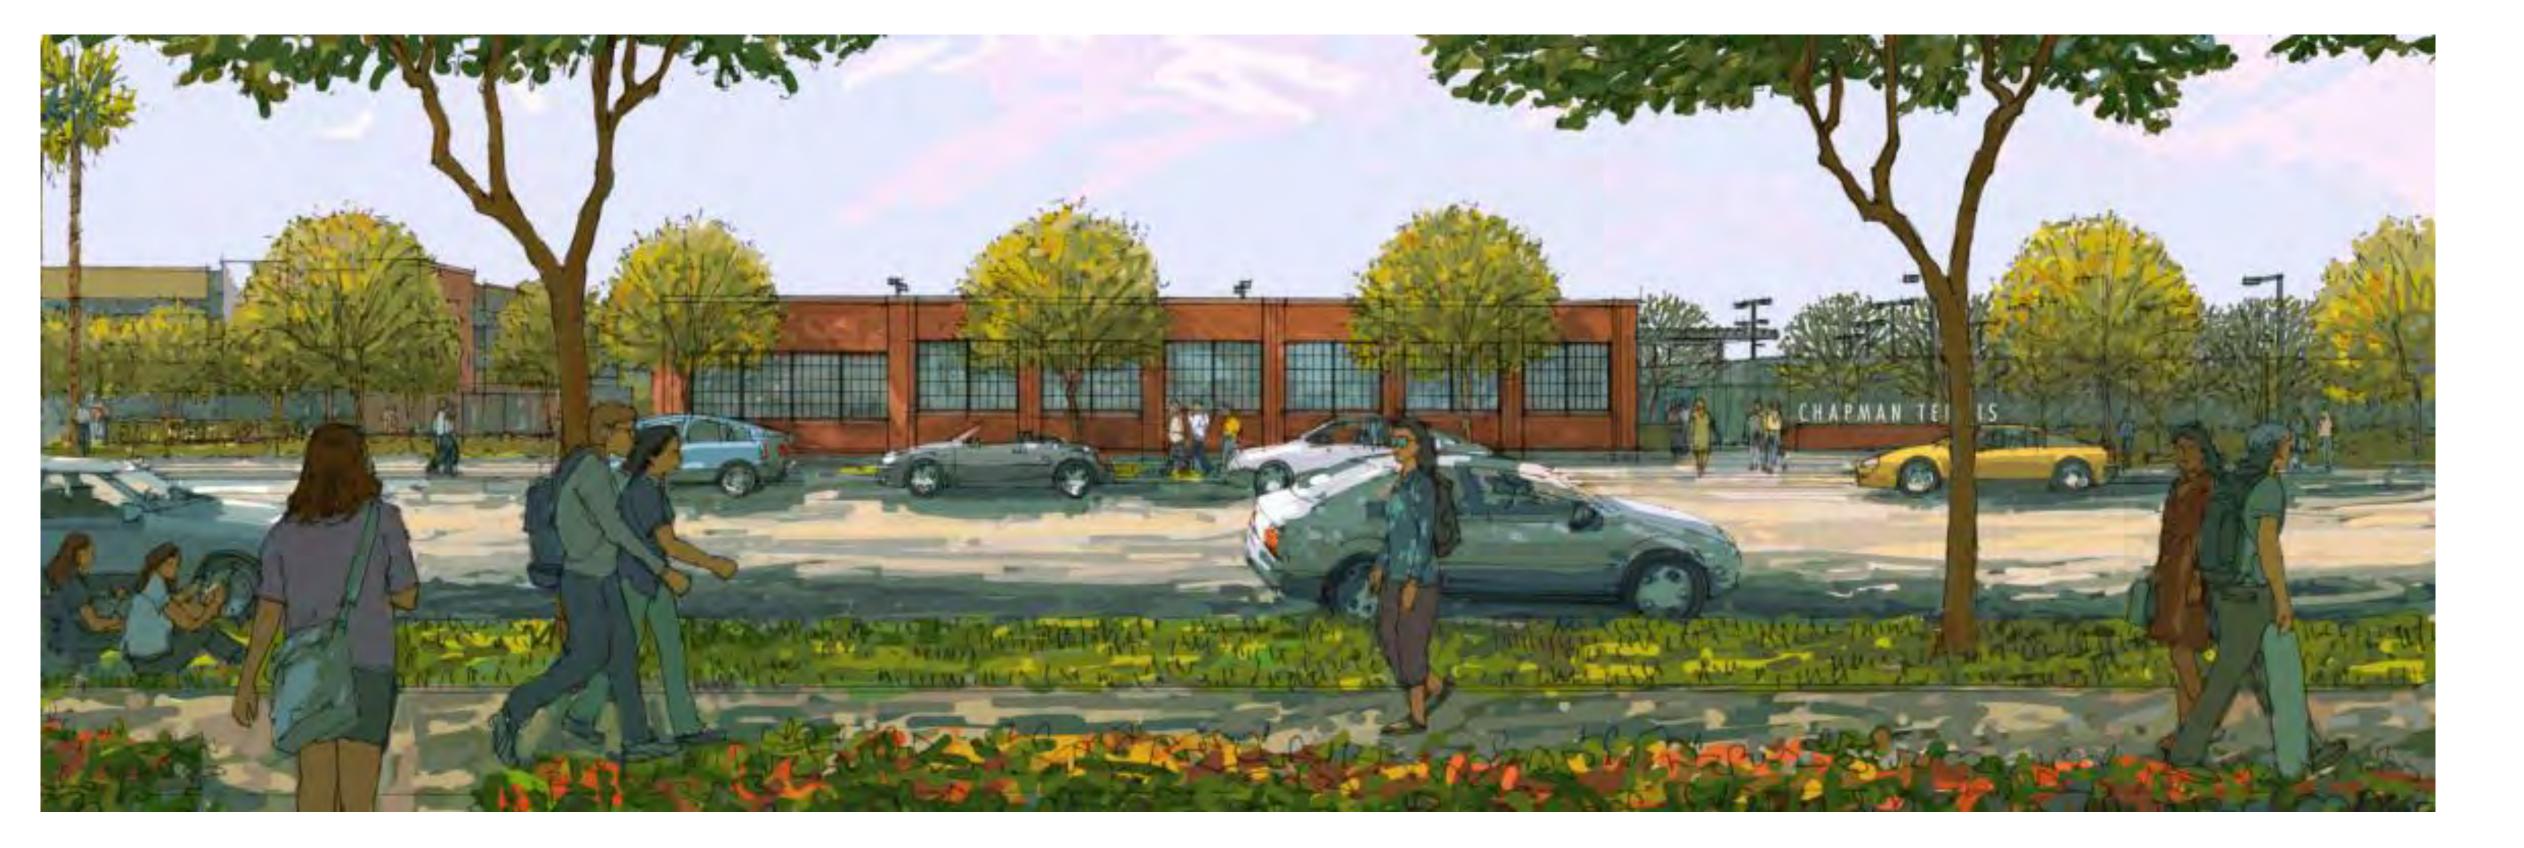
Erin J. Lastinger Tennis Center, Compatibility/Differentiation

- **Phase III** of the project was on the northern portion of the site (completion: fall 2017)
- Construction of seven (7) new lighted tennis courts and a 1,578 square foot locker and restroom building.
- Involves preserving and restoring a portion of the historic building façade along Cypress Street and a portion of the southern end of the building.
