# California Preservation Foundation 2017

## Stewardship of Stanford Buildings

Sapna Marfatia

Stanford University

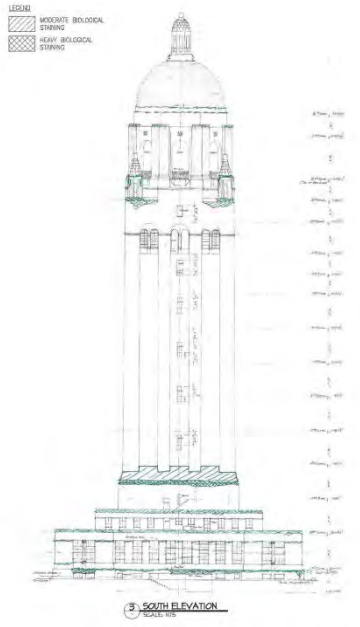
Figure 15- Pattern of staining occurring under pinacles.

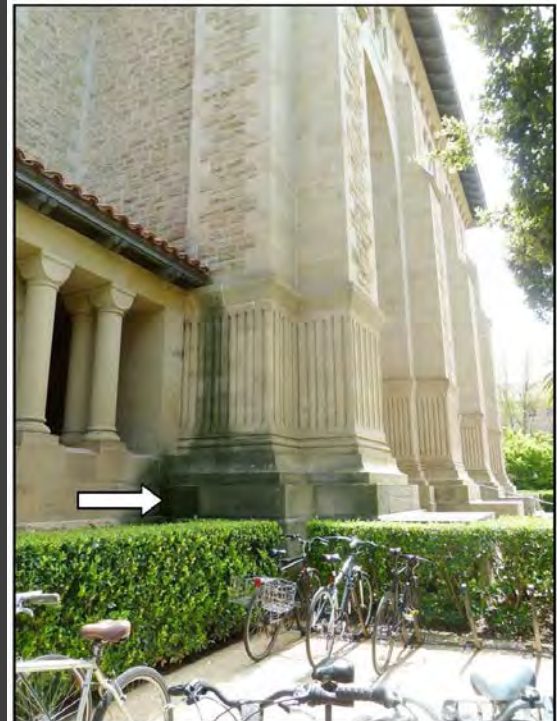
Sample Location II, at the base of the central projection north face, where it meets the north arcade wall. (ARG, 2012)

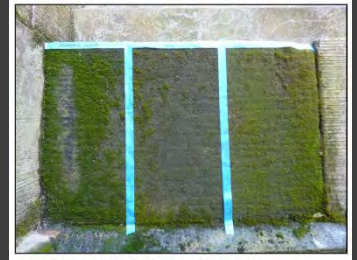
Area II, after pre-wetting and before application of biocides. (ARG, 2012)

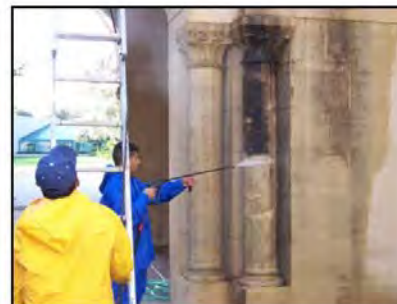
Previous cleaning conducted at Encina Commons. (Watten Company, 2006)

The cleaning trials took place in the same location as previous cleaning conducted by the Watten Company in 2006. Photographs provided by Watten document a similar pattern of organic growth and staining. This area also displays unevenness in the color of the cast stone substrate – evidence of previous repairs.

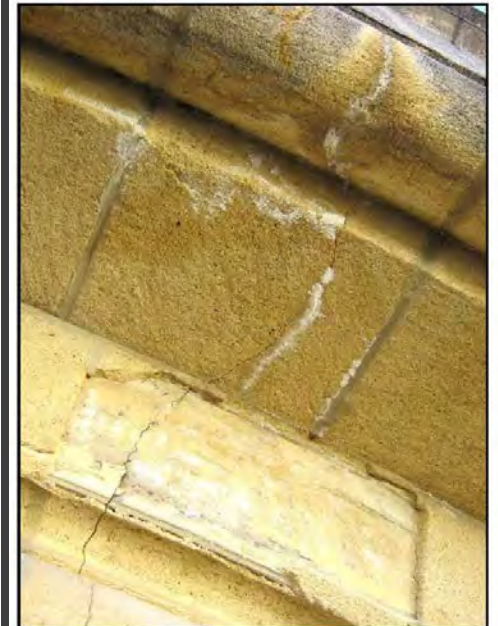
Plaster de-bonding is associated with cracking and efflorescence at the south tower arches. (ARG/CS, 2011)

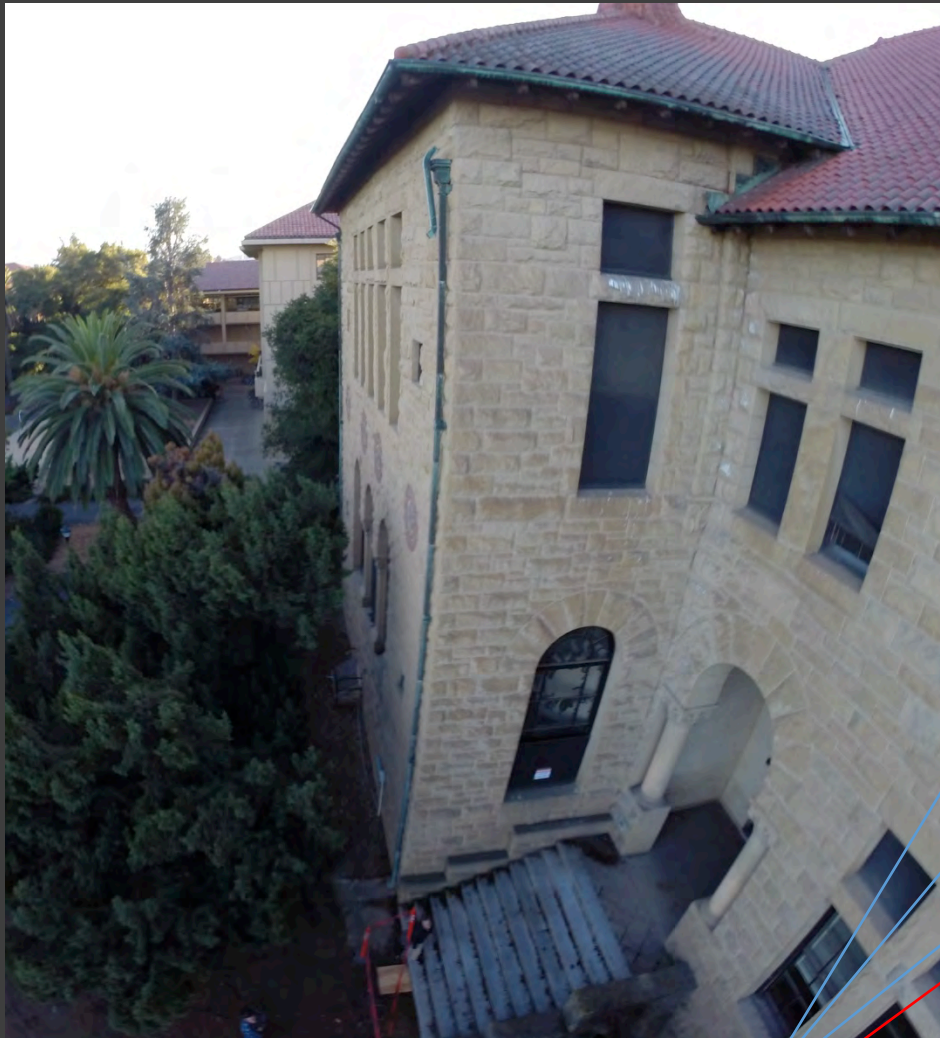
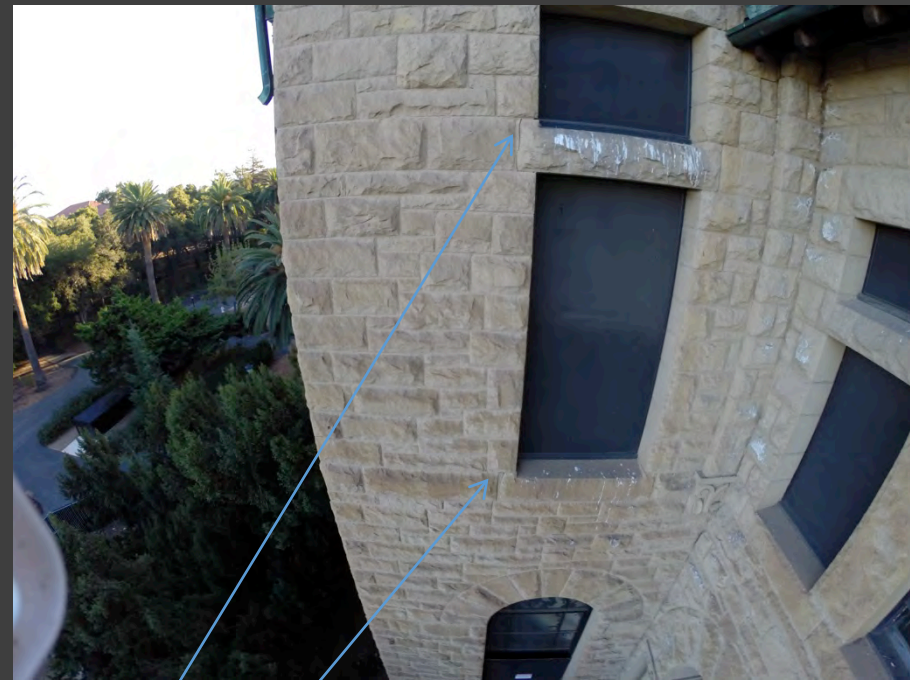
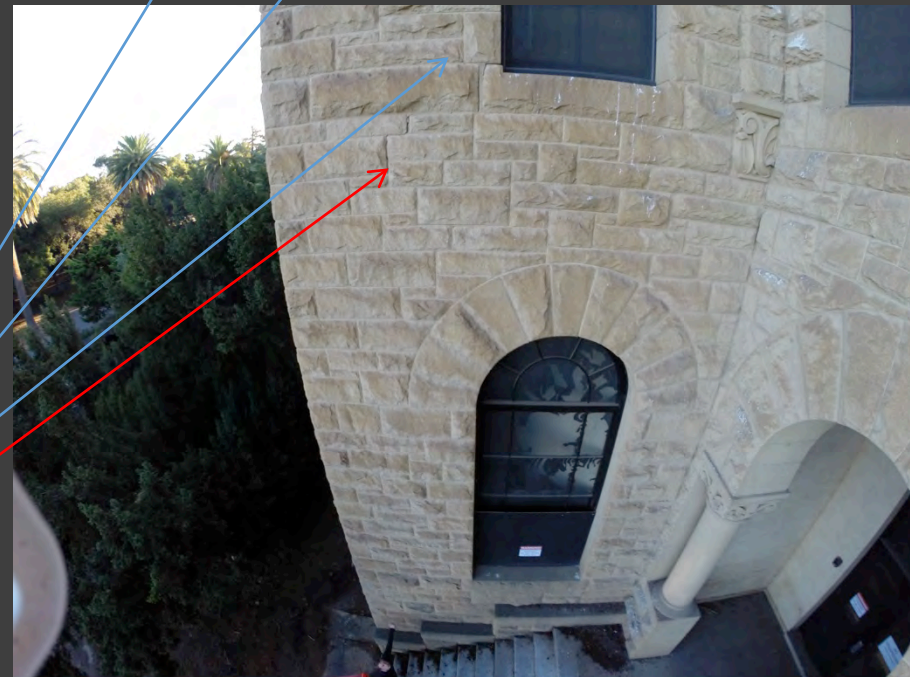
# Crack Inspection

Easy-to-see cracks around frames

Difficult-to-see crack in mortar
