HOME, SAFE HOME.

SEISMIC SAFETY & REHABILITATING HISTORIC HOMES

JULY 26, 2022 | WORKSHOP 2 SUPPLEMENTAL INFORMATION

WORKSHOP 2: IS 'COMPATIBLE' 'MATCHY-MATCHY'?

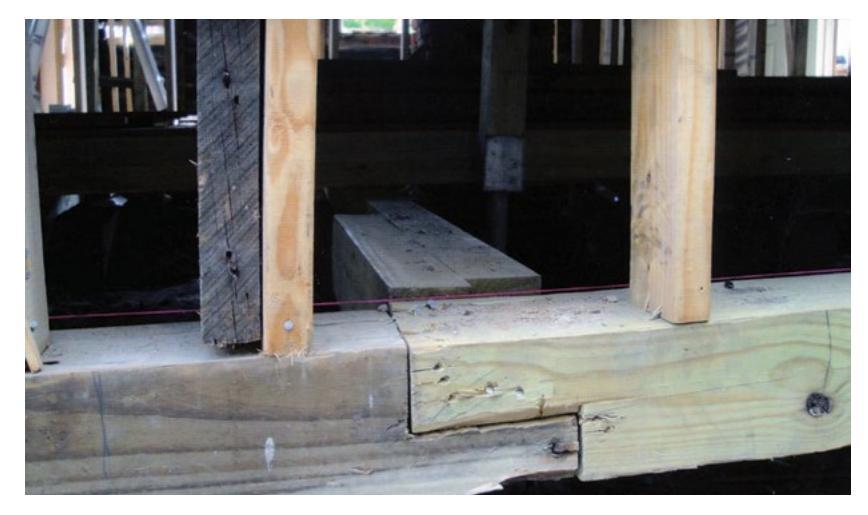
[33] Retaining as much as possible of the historic wood sill plate and replacing only the termite-damaged wood is always the preferred and recommended treatment.

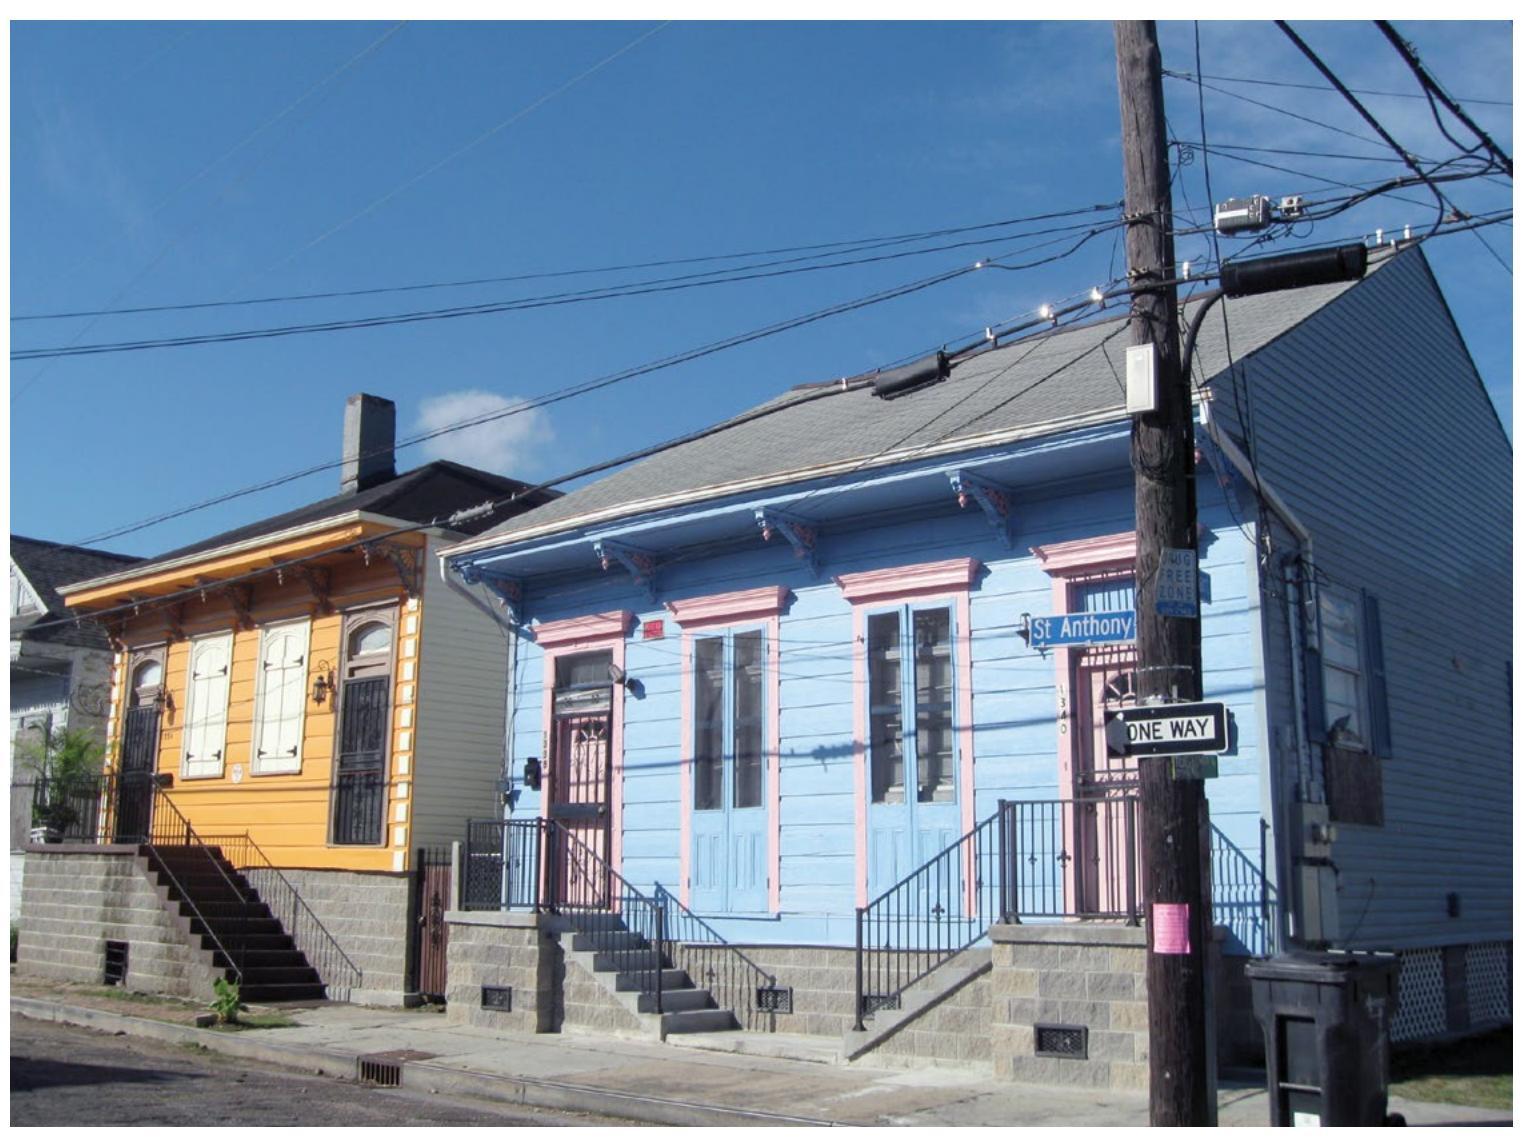
[60] In some instances, it may be necessary to elevate a historic building located in a floodplain to protect it. But this treatment is appropriate only if elevating the building will retain its historic character, including its relationship to the site, and its new height will be compatible with surrounding buildings if in a historic district. The house on the right, which has been raised only slightly, has retained its historic character. The house on the left has been raised several feet higher, resulting in a greater impact on the historic character of the house and the district.

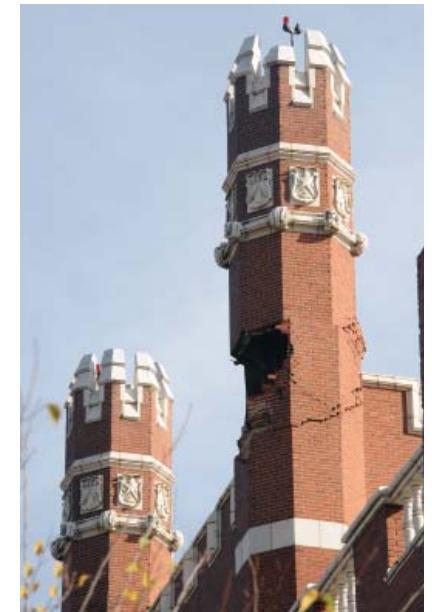
Figure 1. In 2011, a 5.6 magnitude earthquake substantially damaged all four turrets atop St. Gregory's University Benedictine Hall in Shawnee, Oklahoma. Photo: St. Gregory University.

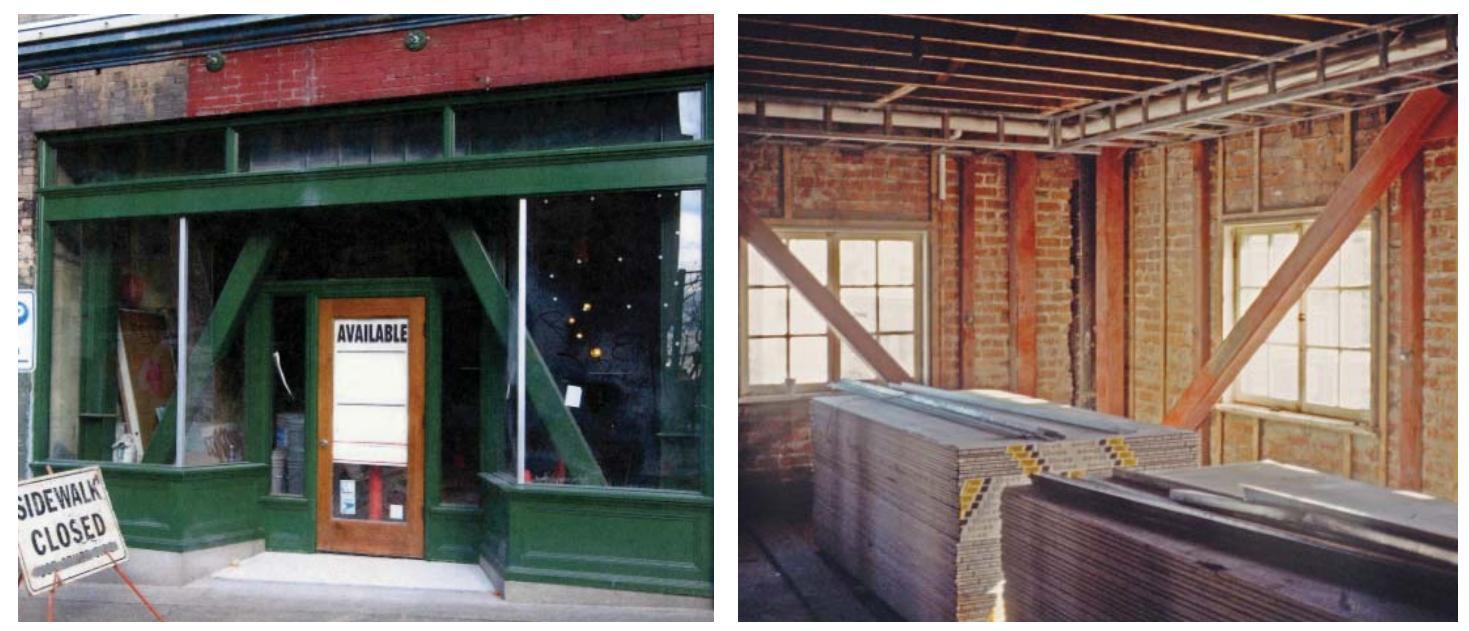
Figures 2-3. Standard approaches to seismic rehabilitation, such as adding diagonal bracing to reinforce window and storefront openings as seen in these photos, can be visually intrusive. Figure 2 (left). Figure 3 (right). Photo: Steade Craigo.

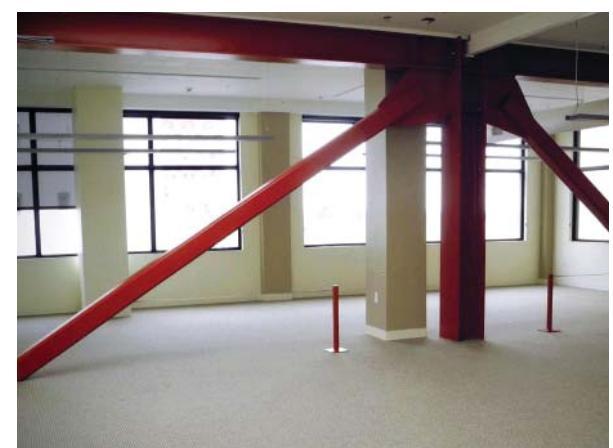
Figures 4-5. Using moment frames (horizontal and vertical steel members identified by the arrows) set back behind storefront openings as seen in Figure 4 (left), or placing brace frames (in red) away from the windows as illustrated in Figure 5 (right) are solutions that meet historic preservation goals. Figure 4. Photo: Elizabeth Hilton.

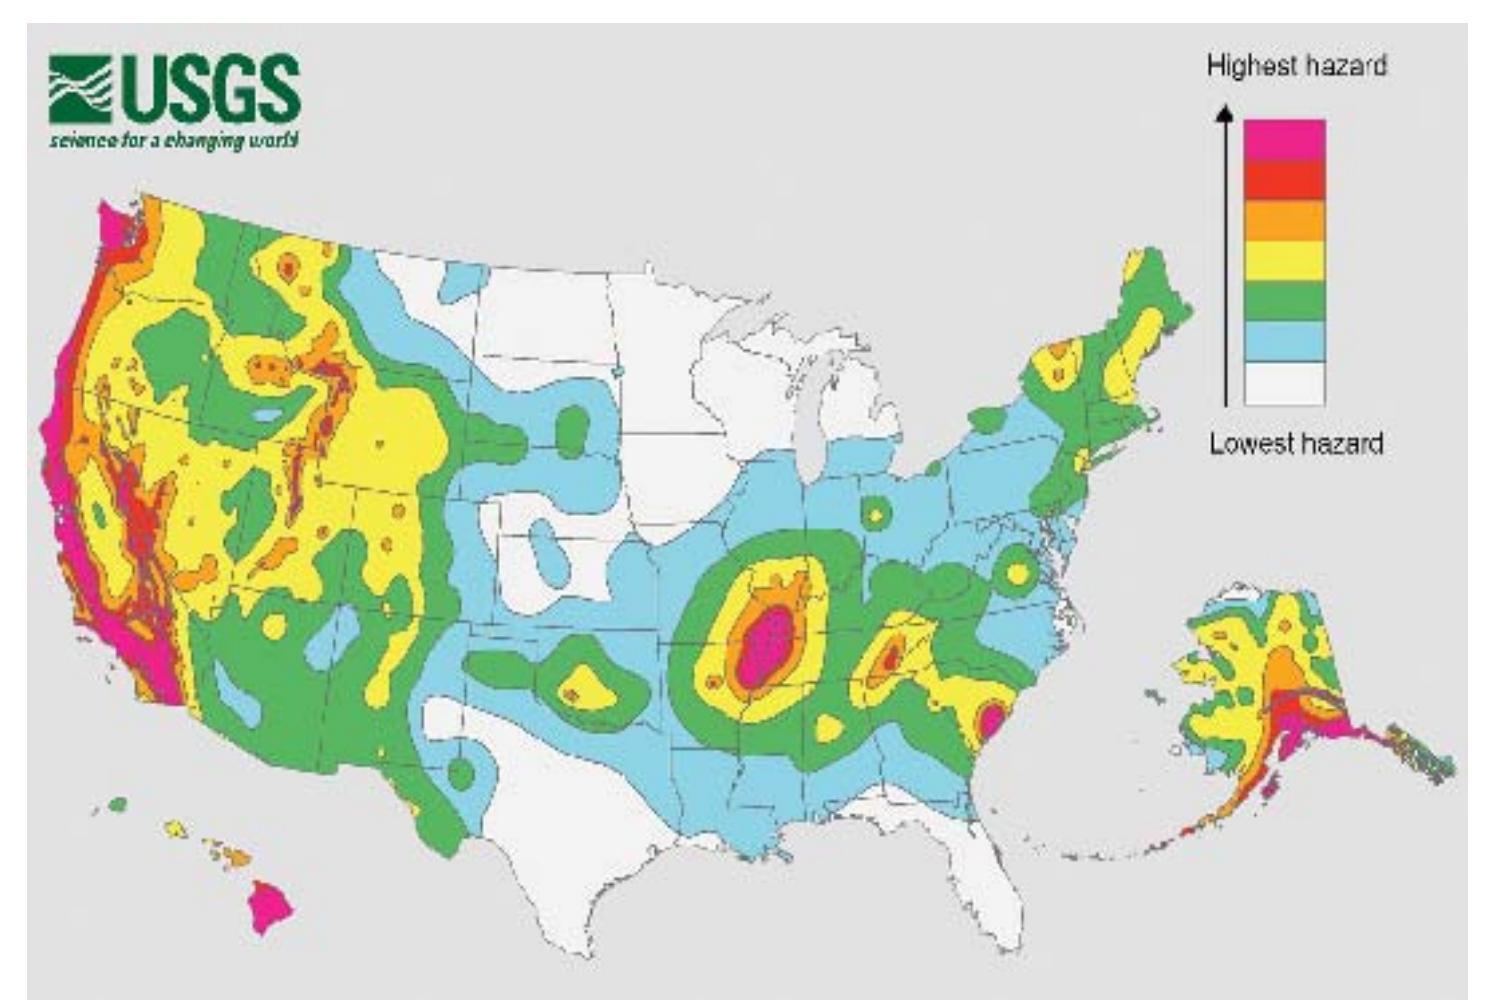
Figure 7. A simplified 2014 United States Geological Survey (USGS) seismic hazard map. Owners of certain classes of high-risk buildings in regions of high seismic activity are advised, and often required by local ordinances, to take immediate action in undertaking a comprehensive vulnerability assessment and make any necessary seismic rehabilitation measures. Owners of buildings in moderate seismic zones are advised to do further investigation of their building's exposure to earthquake risk, identify seismic rehabilitation needs, and consider mitigation of risks primarily due to nonstructural hazards. Owners of buildings in low seismic areas are advised to consider low-cost rehabilitation measures that protect against casualties and property loss, if such measures are found to be necessary, even though the potential occurrence of an earthquake might be low.

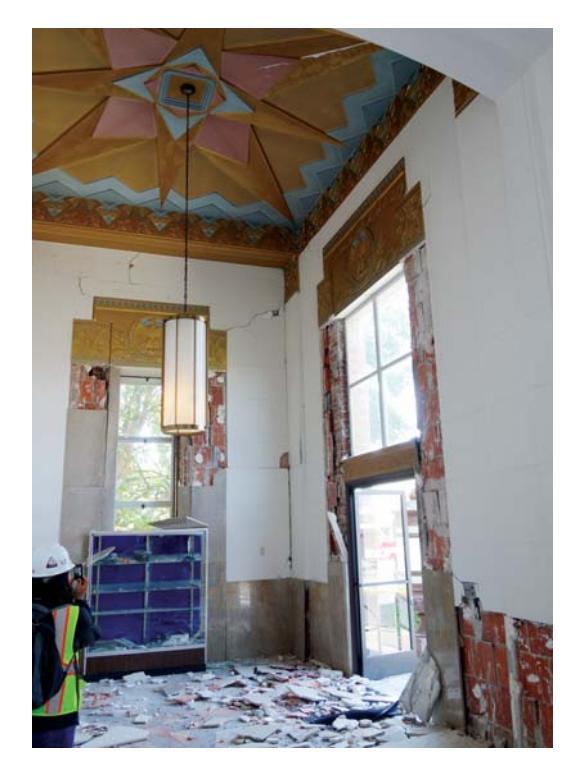
Figure 6. Failing nonstructural elements such as the stone-veneer window and door surrounds shown in this image can become a lifesafety hazard when they block or impede an exit path. Photo: Wiss, Janney, Elstner and Associates, Inc.

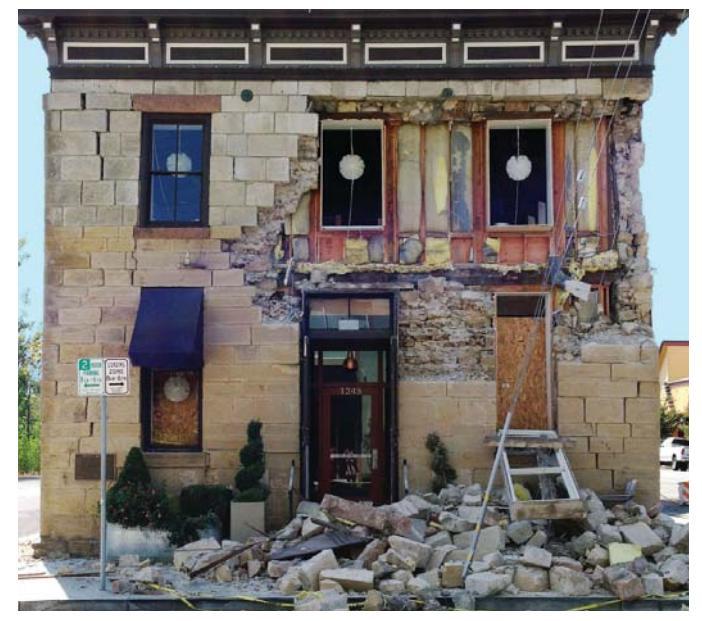
Figure 8. Unreinforced masonry buildings, such as this 1875 stone building damaged during the 2014 South Napa, California earthquake, can be particularly vulnerable to earthquake damage. Photo: Architectural Resources Group.

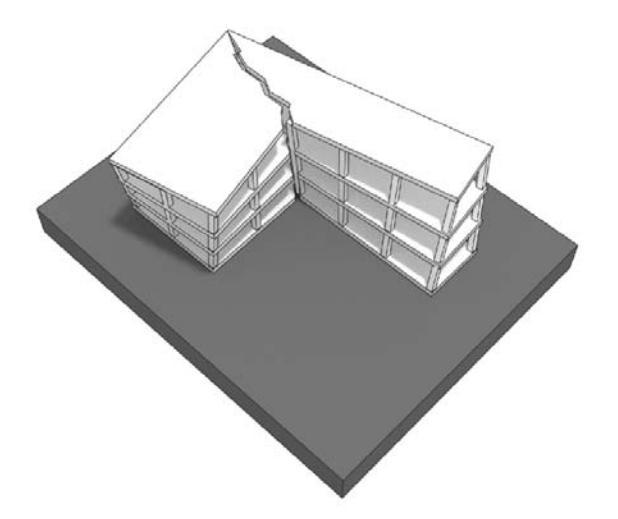
Figure 9. This image shows structural deformation due to stress concentration in structures with re-entrant corners, the inside corner where the two perpendicular exterior walls meet.

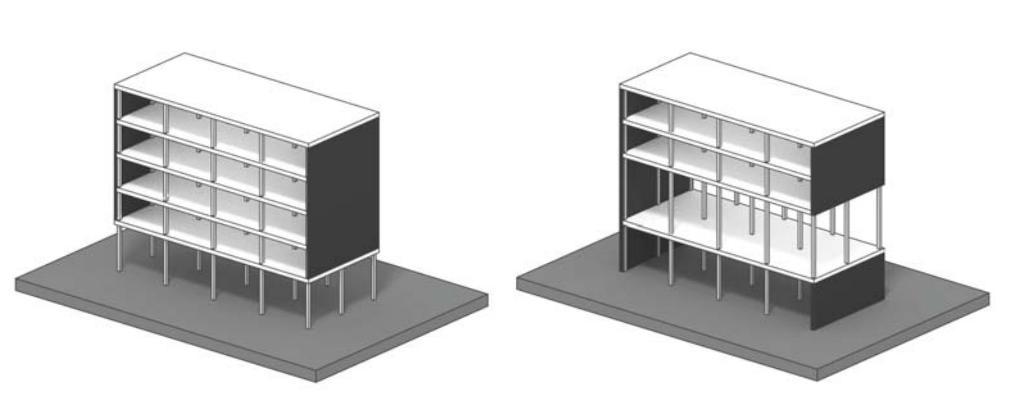
Figure 10. (left) Open first floor. Figure 11. (right) Double height second floor. These renderings show examples of "weak" or "soft" story irregularities.

Similarly, the more complex and irregular buildings are in elevation, the more susceptible they are to damage, especially tall structures. Other building features such as large ground-level storefront or garage openings, or floors with columns and walls running in only one direction, are commonly known as "soft" or "weak" stories, which increase the seismic vulnerability of historic buildings (Figures 10 and 11).

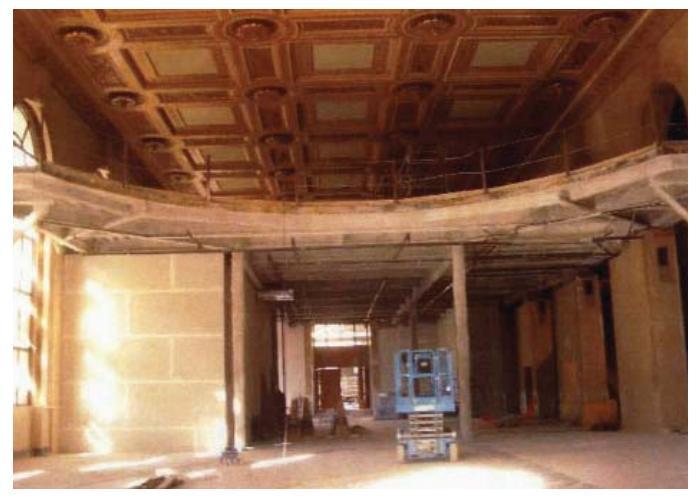
Figure 12. A mezzanine was added to the original banking hall of this 1921 former bank building as a seismic strengthening measure. Subdividing such an important character-defining space can result in a severe loss to a building's historic integrity.

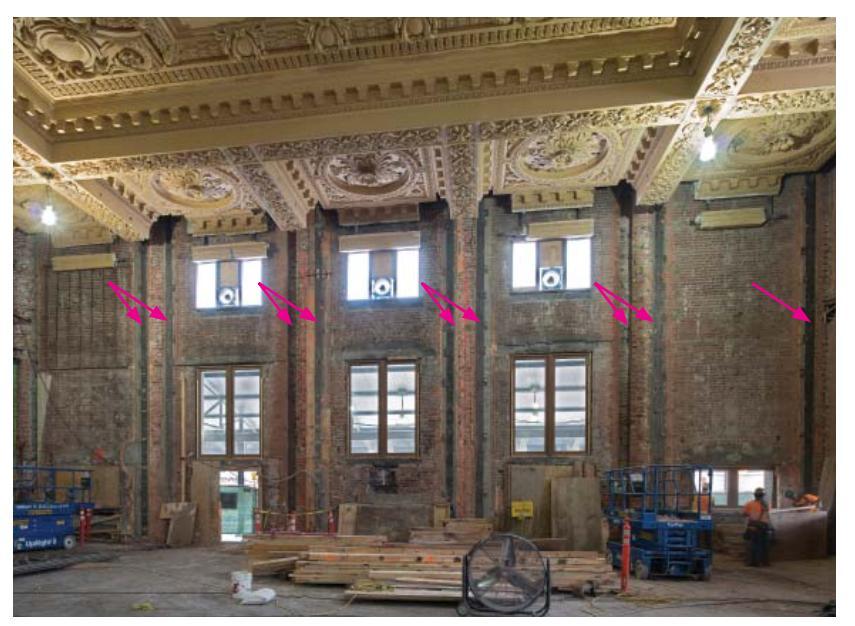
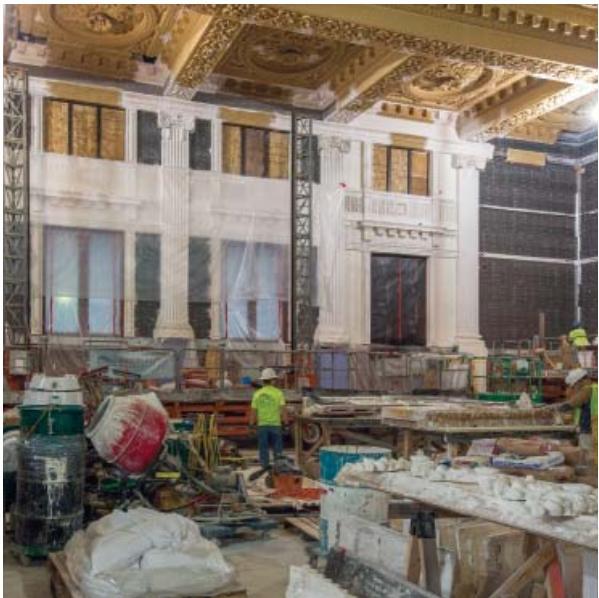
Figures 13-14. Vertical steel reinforcement members were inserted and grouted into the walls of the main waiting room in Seattle's historic 1906 King Street Railroad Station to strengthen them (top left). To replace the original plaster ornamentation, molds were made to cast new replacement plaster elements as shown on this work-in-progress photo (top right). Photos: John Stamets.

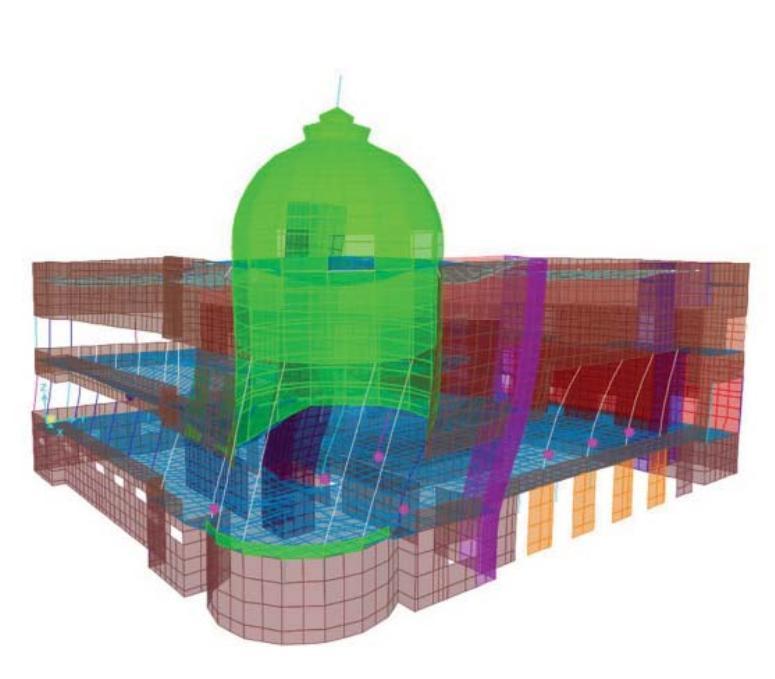
Figure 16. Computer modelling is a useful analytic tool that helps assess the strengths and weaknesses of a building and evaluate different seismic strengthening options. Three-dimensional dynamic analysis is required for a number of different structures located in certain seismic zones.

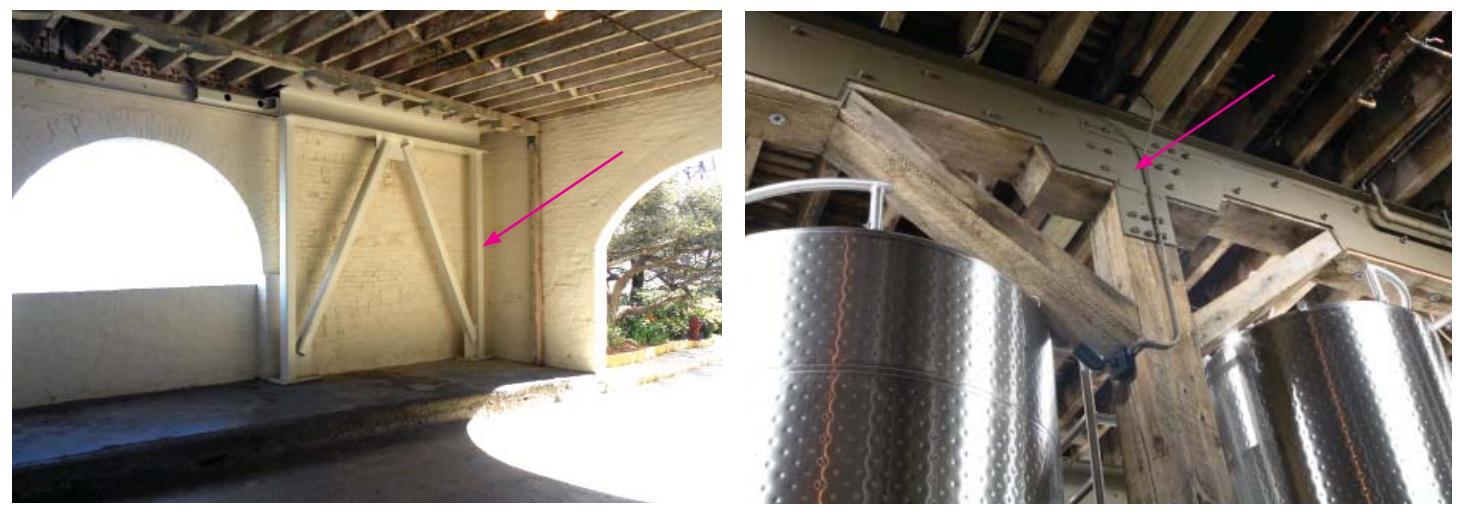
Figures 17 and 18. Careful placement of the new structural reinforcement, painted to match the surrounding building elements, if left exposed, minimizes its visual impact. New added structural elements may be left exposed when their visibility does not impair the historic character of the building. Figure 17 (left). Photo: Jason Hagin. Figure 18 (right). Photo: Architectural Resources Group.

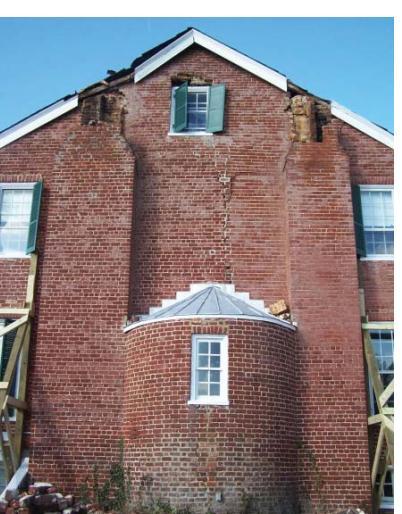
Figure 19. Chimneys are common nonstructural features susceptible to earthquake damage, even in zones of low-to medium-seismic activity as shown on this building in Virginia damaged in a 2011 earthquake.

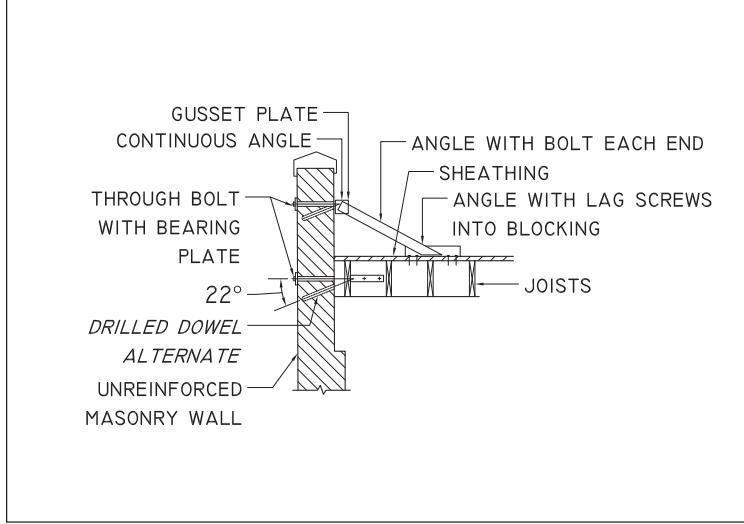
Figure 20. Bracing parapet walls, as illustrated in the typical detail drawing on the left, and as installed in the image on the right, helps avoid hazards from falling debris.

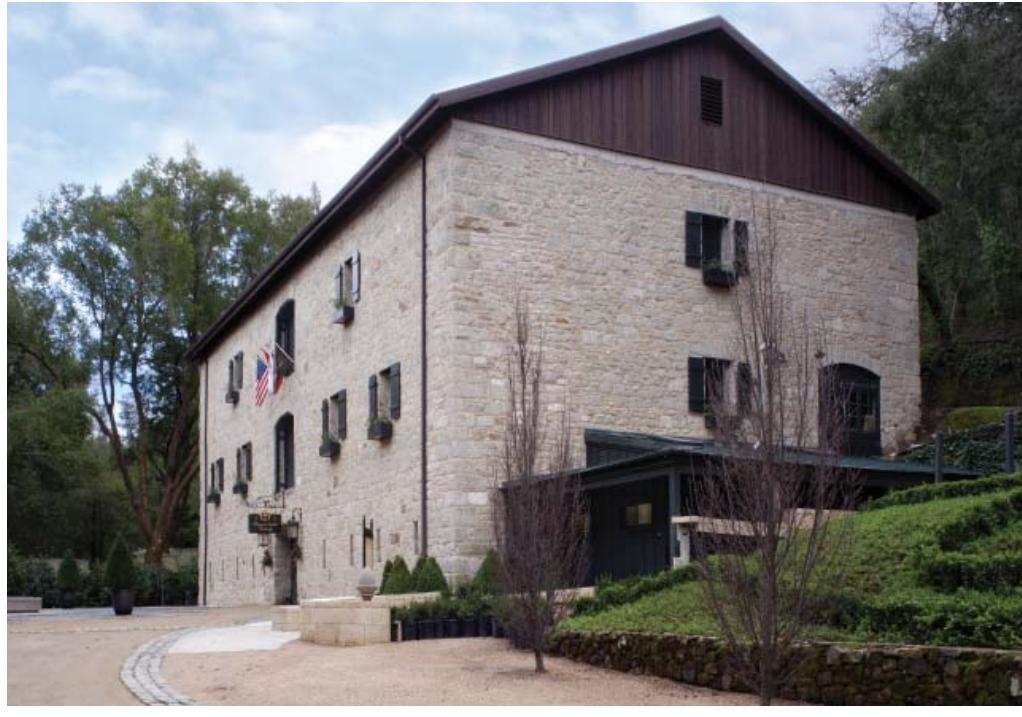
Figure 21 Historic wine cellar building in Napa, California.

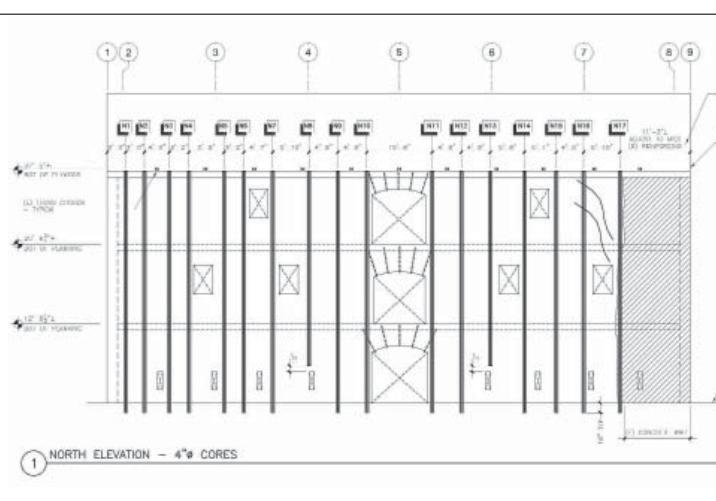
Figure 22. Drawing of the wine cellar's front wall showing the locations of the center cores for continuous steel reinforcement rods to be inserted and grouted in place.

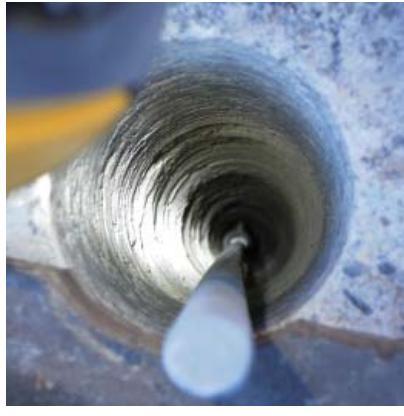
Figure 23. View of one of the center cores drilled down through the wall.

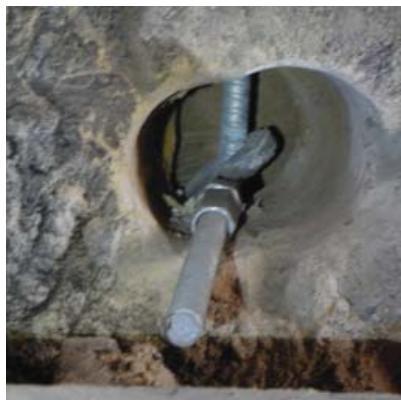
Figure 24. Eye bolts used to anchor the floor to the wall.

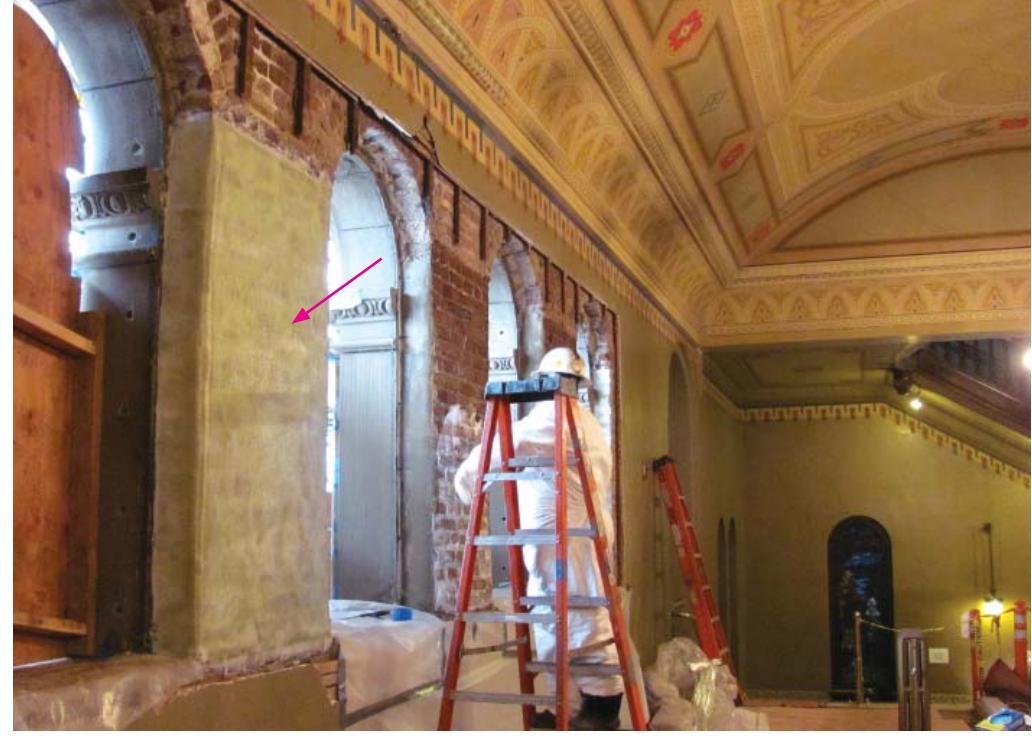
Figure 26. Epoxy-embedded fiberglass mesh is being bonded to the back of the brick pilasters of this 1906 unreinforced masonry building. New finishes matching the appearance and detailing of the original finishes will be applied over the mesh. Photo: Wiss, Janney, Elstner and Associates, Inc.

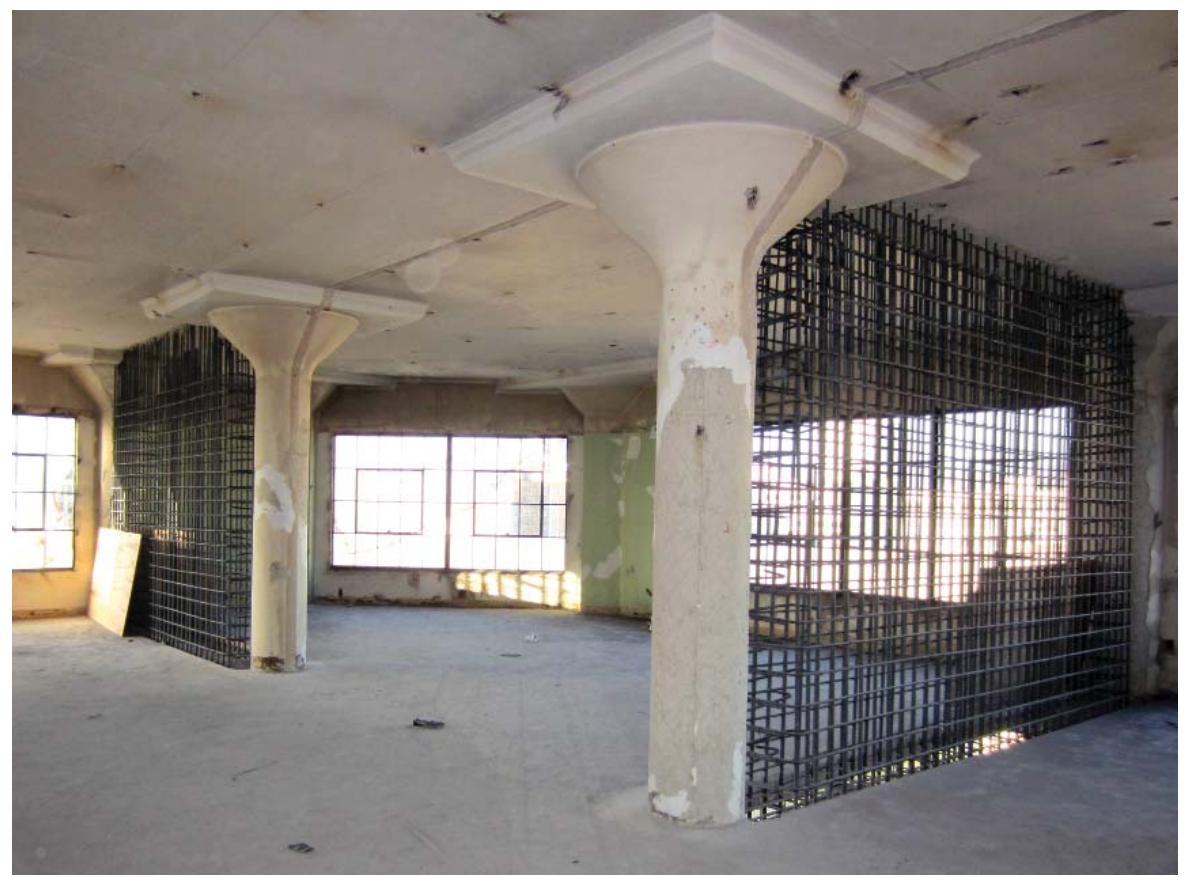
Figure 28. Steel reinforcement for the new sheer walls, perpendicular to the windows, is being installed in this concreteframe building. Photo: Robert Chattel.

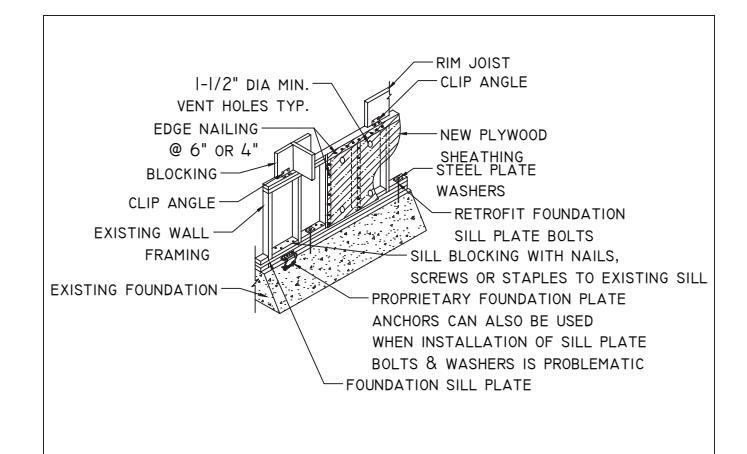
Figure 29. Cripple-wall reinforcement. Simple approaches such as nailing plywood between crawlspace studs, bolting sill plates to the foundation, and strapping the cripple wall to the floor above can make a dramatic difference in protecting a building from seismic damage.

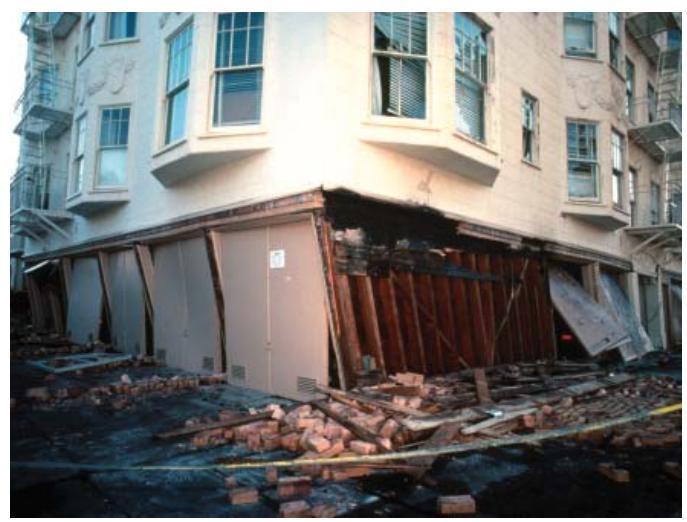
Figure 30. Large perimeter openings and a limited number of interior partitions on the ground floor can create a "weak story" condition that makes buildings particularly vulnerable to earthquake damage. Photo: USGS.
