HOME, SAFE HOME. SEISMIC SAFETY & REHABILITATING HISTORIC HOMES

SEISMIC RETROFIT BASICS

Workshop #3 | August 30, 2022

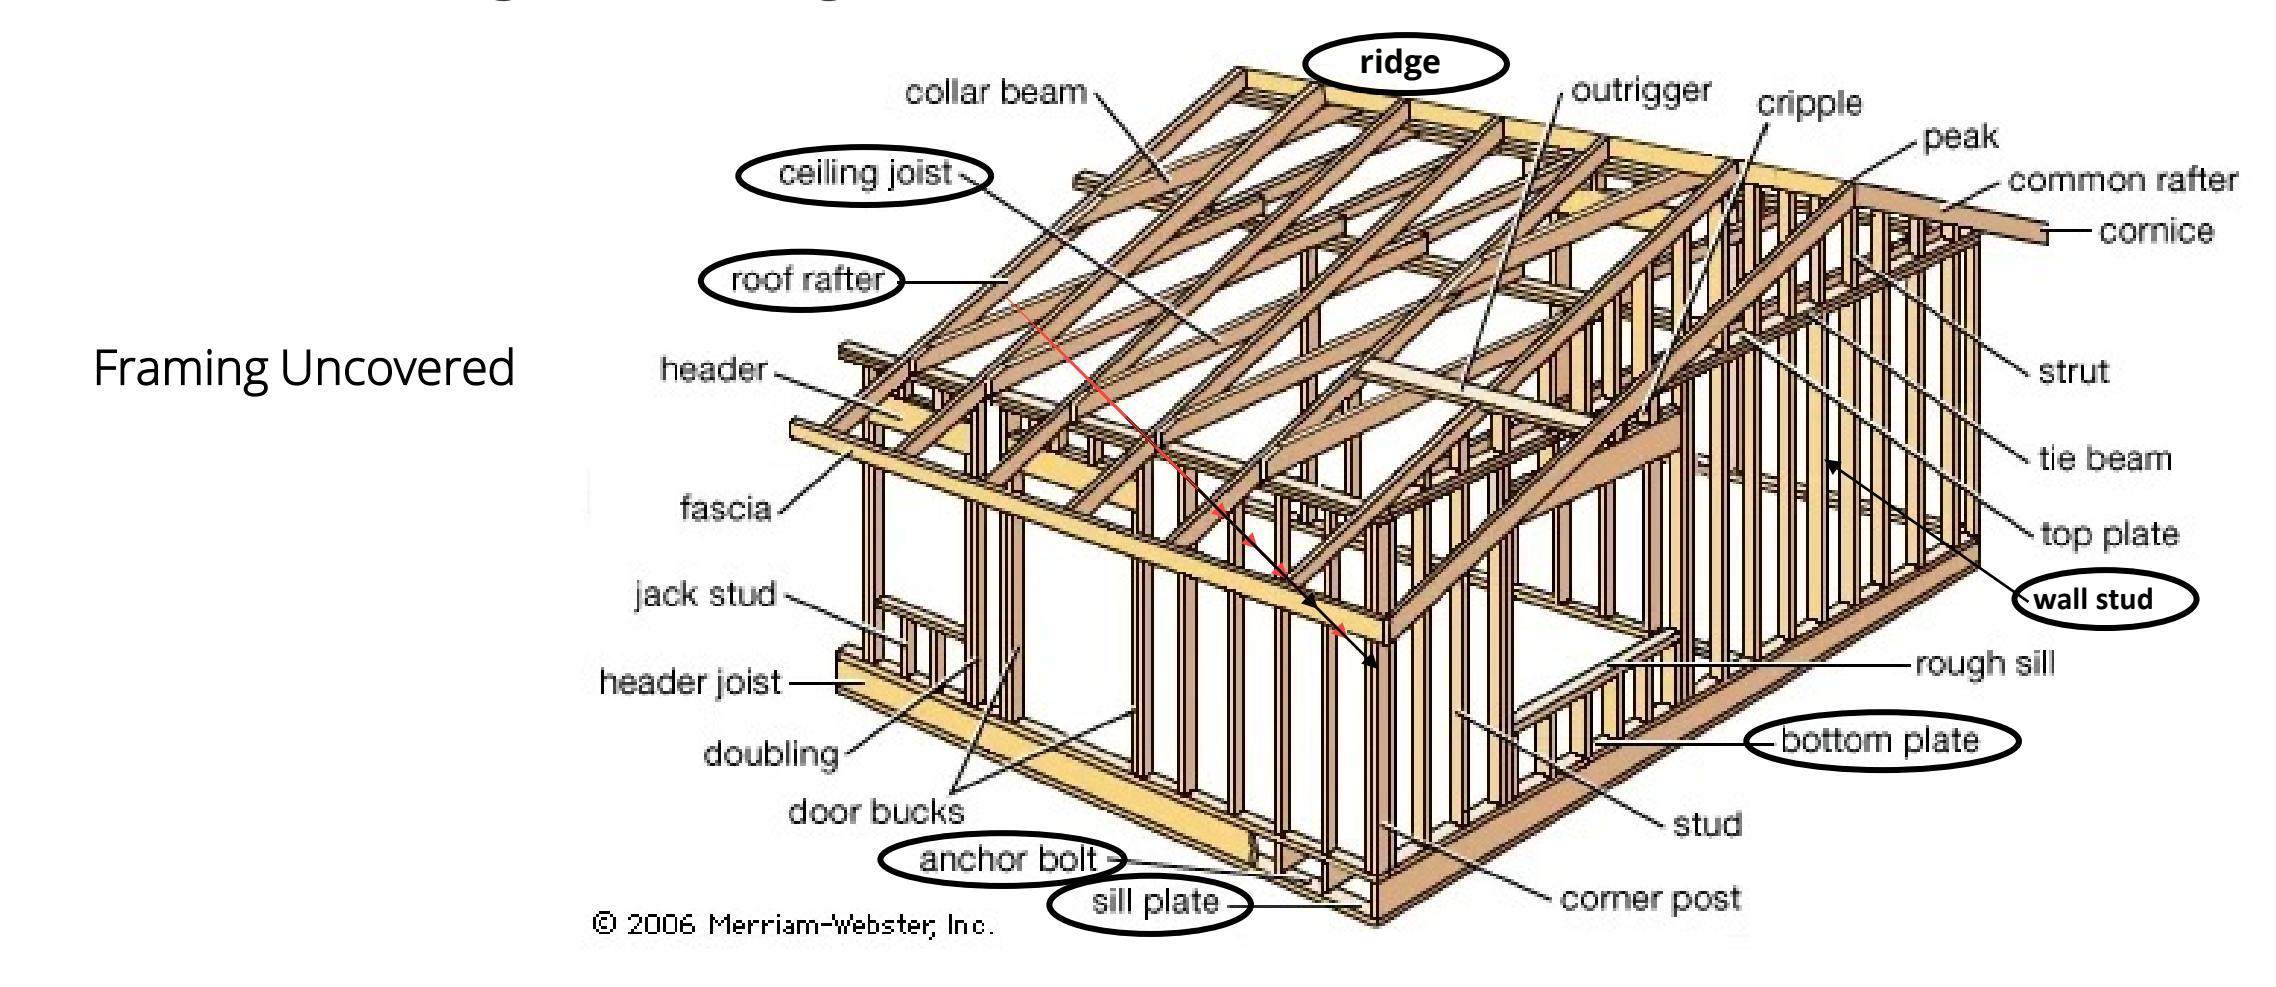
Common Construction Types For Single-Family Dwellings: Wood Frame – Light Framing

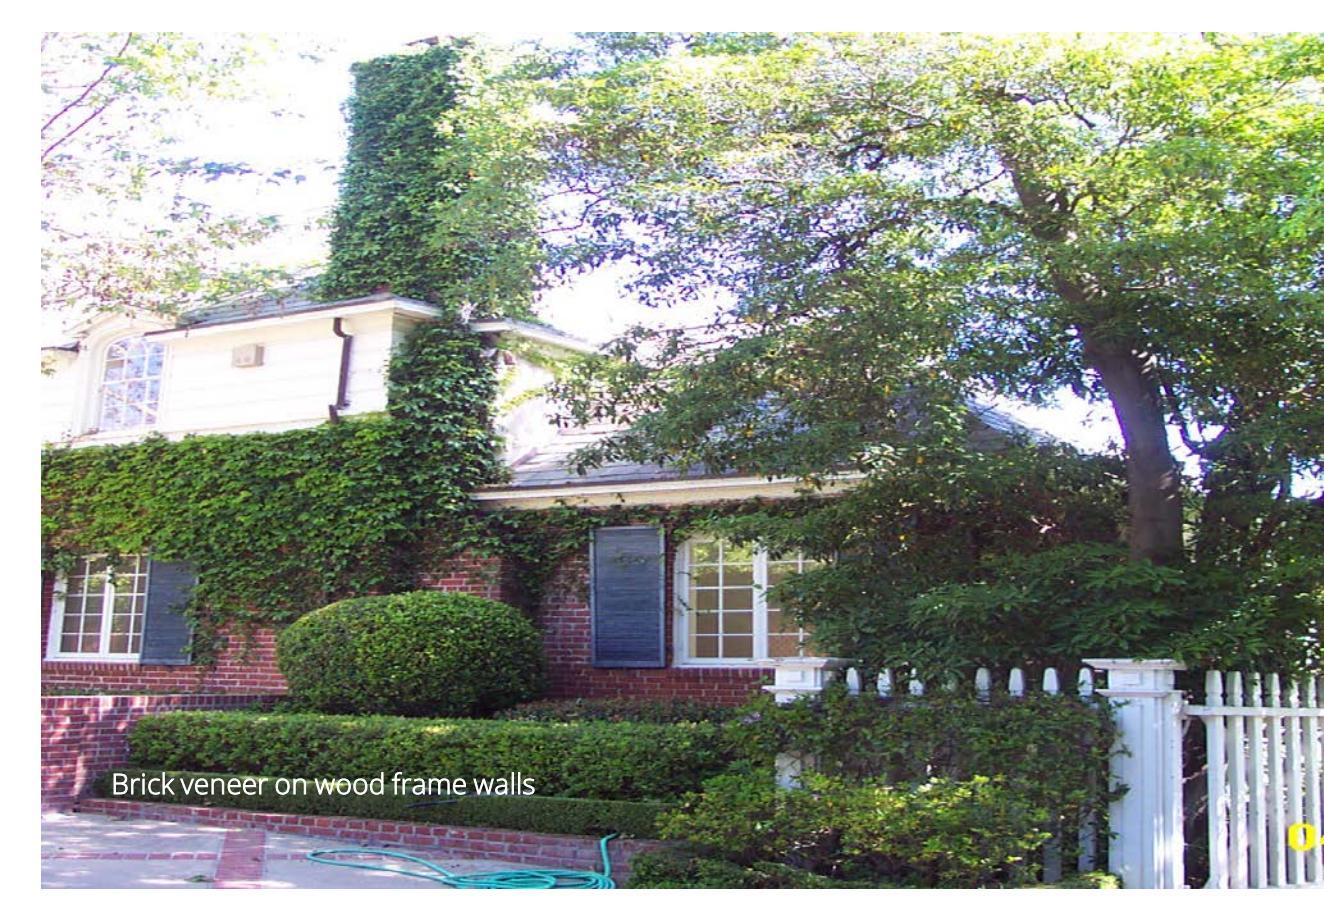
Common Construction Types For Single-Family Dwellings: Wood Frame with Brick Veneer

- Investigating the wall from the interior will reveal whether it is wood stud or full brick construction.
- Drilling into the wall will help determine the construction.

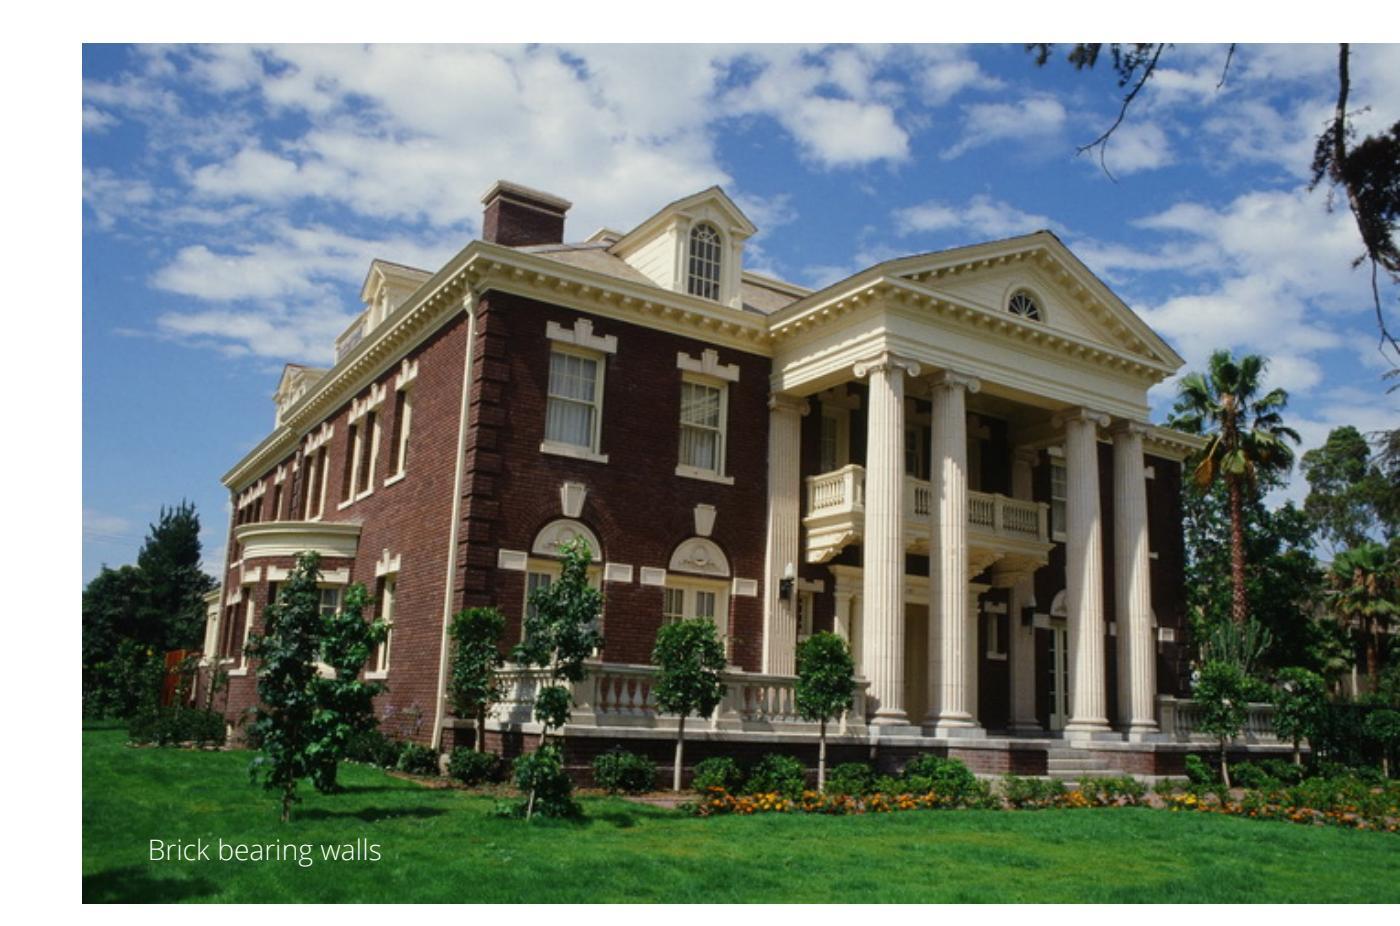
Common Construction Types For Single-Family Dwellings: Masonry Bearing Wall: Brick

- To detect brick, drill a hole through interior plaster to determine dimension to face of brick. Try measuring at a window
- Walls might be visible in attic
- Measure at door or window openings but this may not be accurate with all furring.

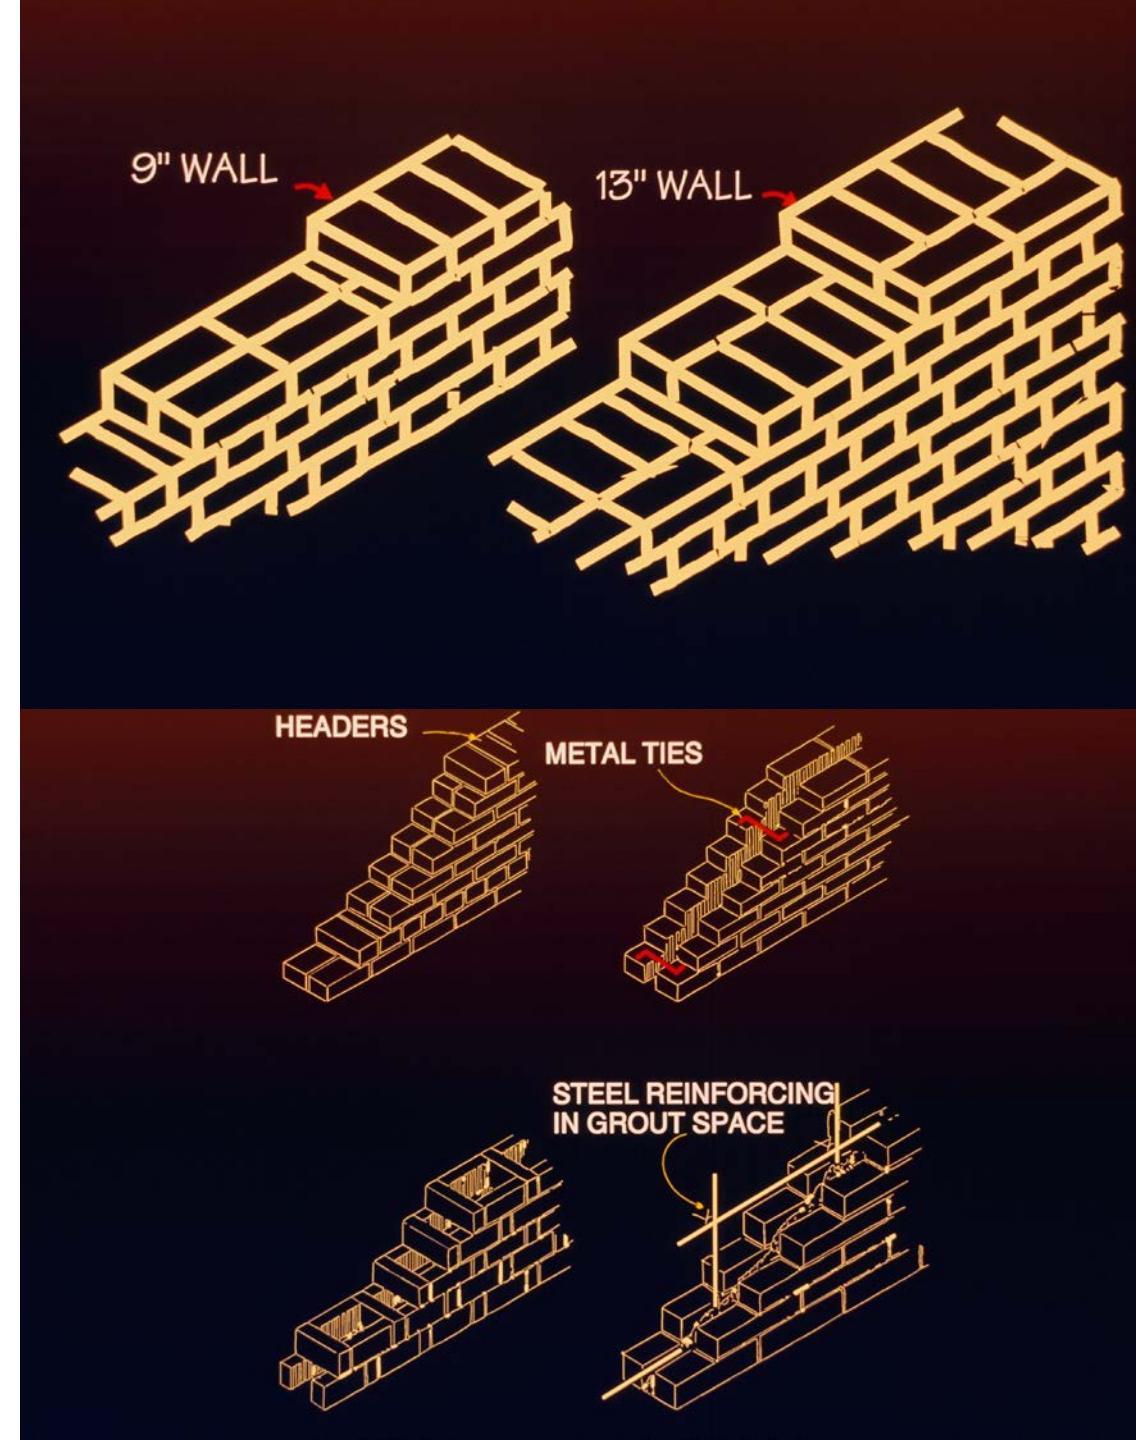
Brick Bearing Walls Construction Details

Masonry bearing wall: Brick

- Perimeter walls consist of brick masonry usually 2 to 3 wythes
- In older homes, walls typically have no embedded reinforcing bars
- Floors and roof are supported directly by the brick "bearing" walls

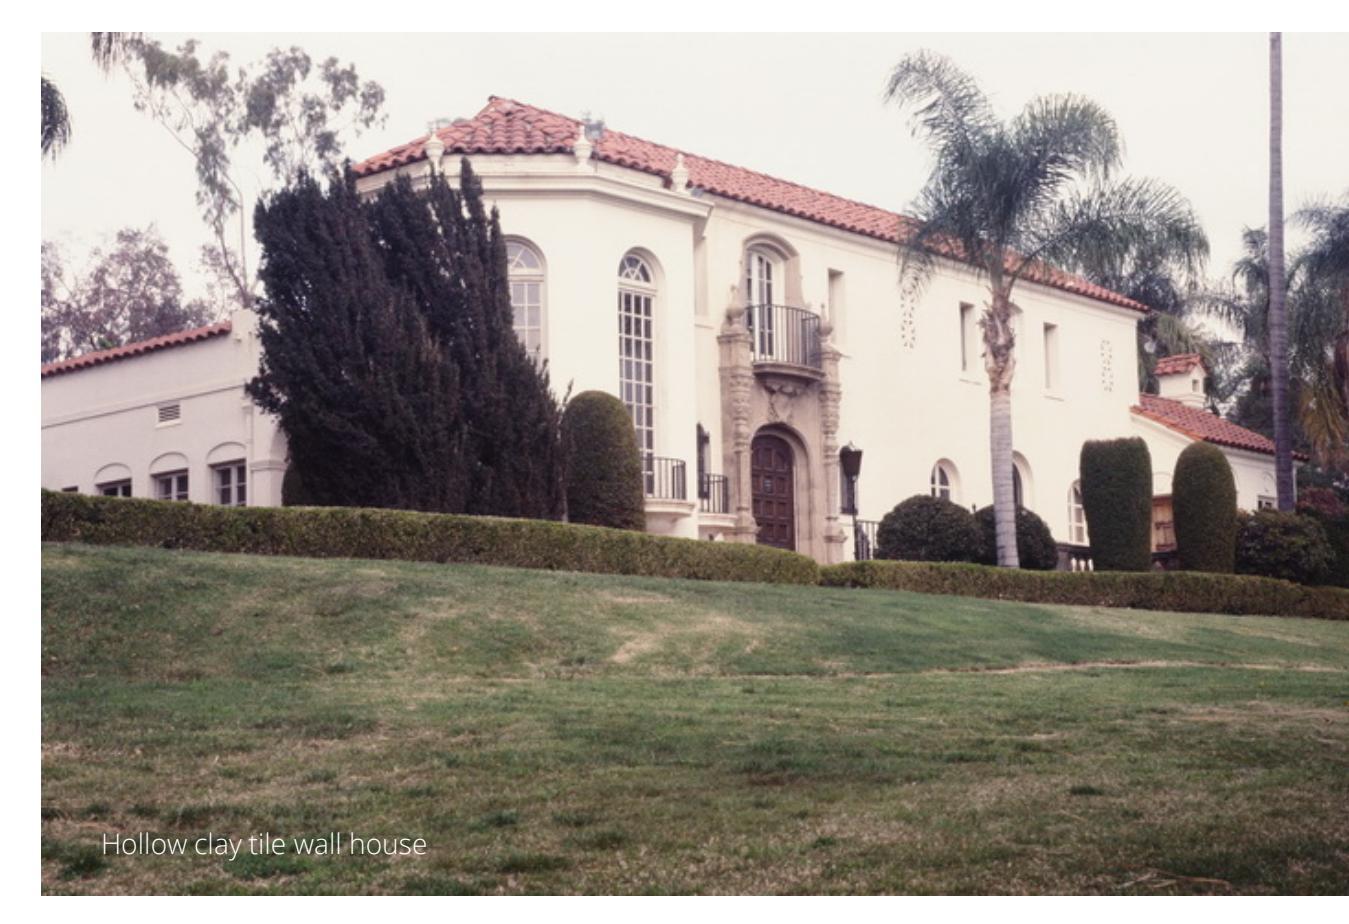
Masonry bearing wall: Concrete Masonry Units (CMU) /Hollow Clay Tile (HCT)

- To detect, drill a hole through interior plaster to determine dimension to face of CMU or HCT
- Walls might be visible in attic
- Perimeter walls consist of CMU or HCT often in 2 to 3 layers (Wythes)
- HCT walls have no reinforcing bars
- Floors and roof are supported directly by the CMU or HCT "bearing" walls
- HCT is a terra cotta (reddish) material with stucco exterior finish

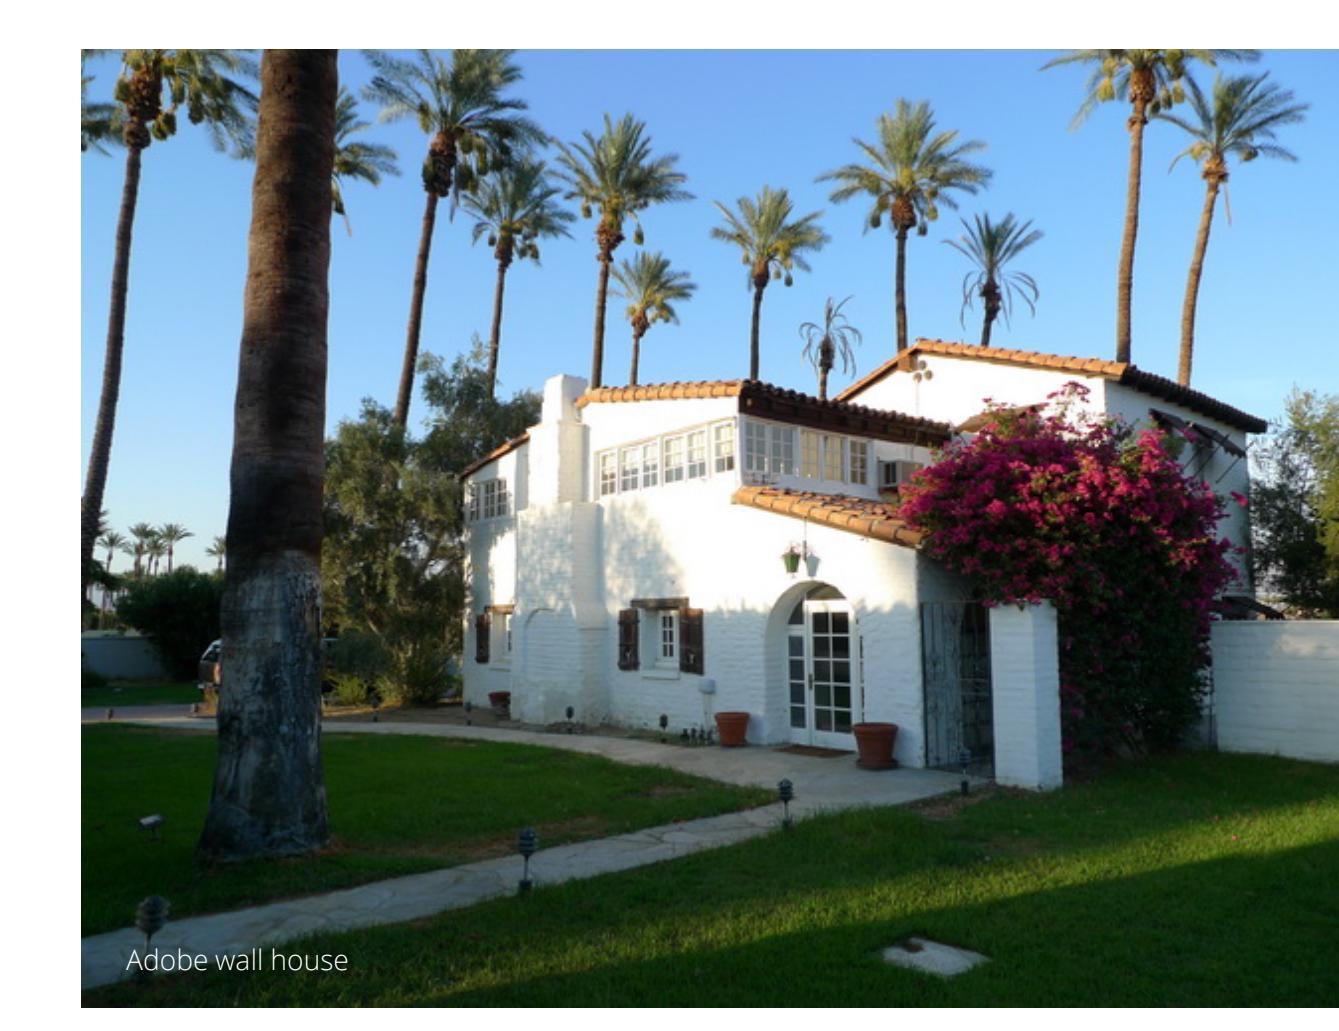
Masonry bearing wall: Adobe

- Adobe construction was used through the 1950's and used in many area today
- Adobe units are larger than brick or block.
 Walls are thicker than other materials (18"+) and may be one or two wythes thick.
- Floors and roof are supported directly by the adobe "bearing" walls

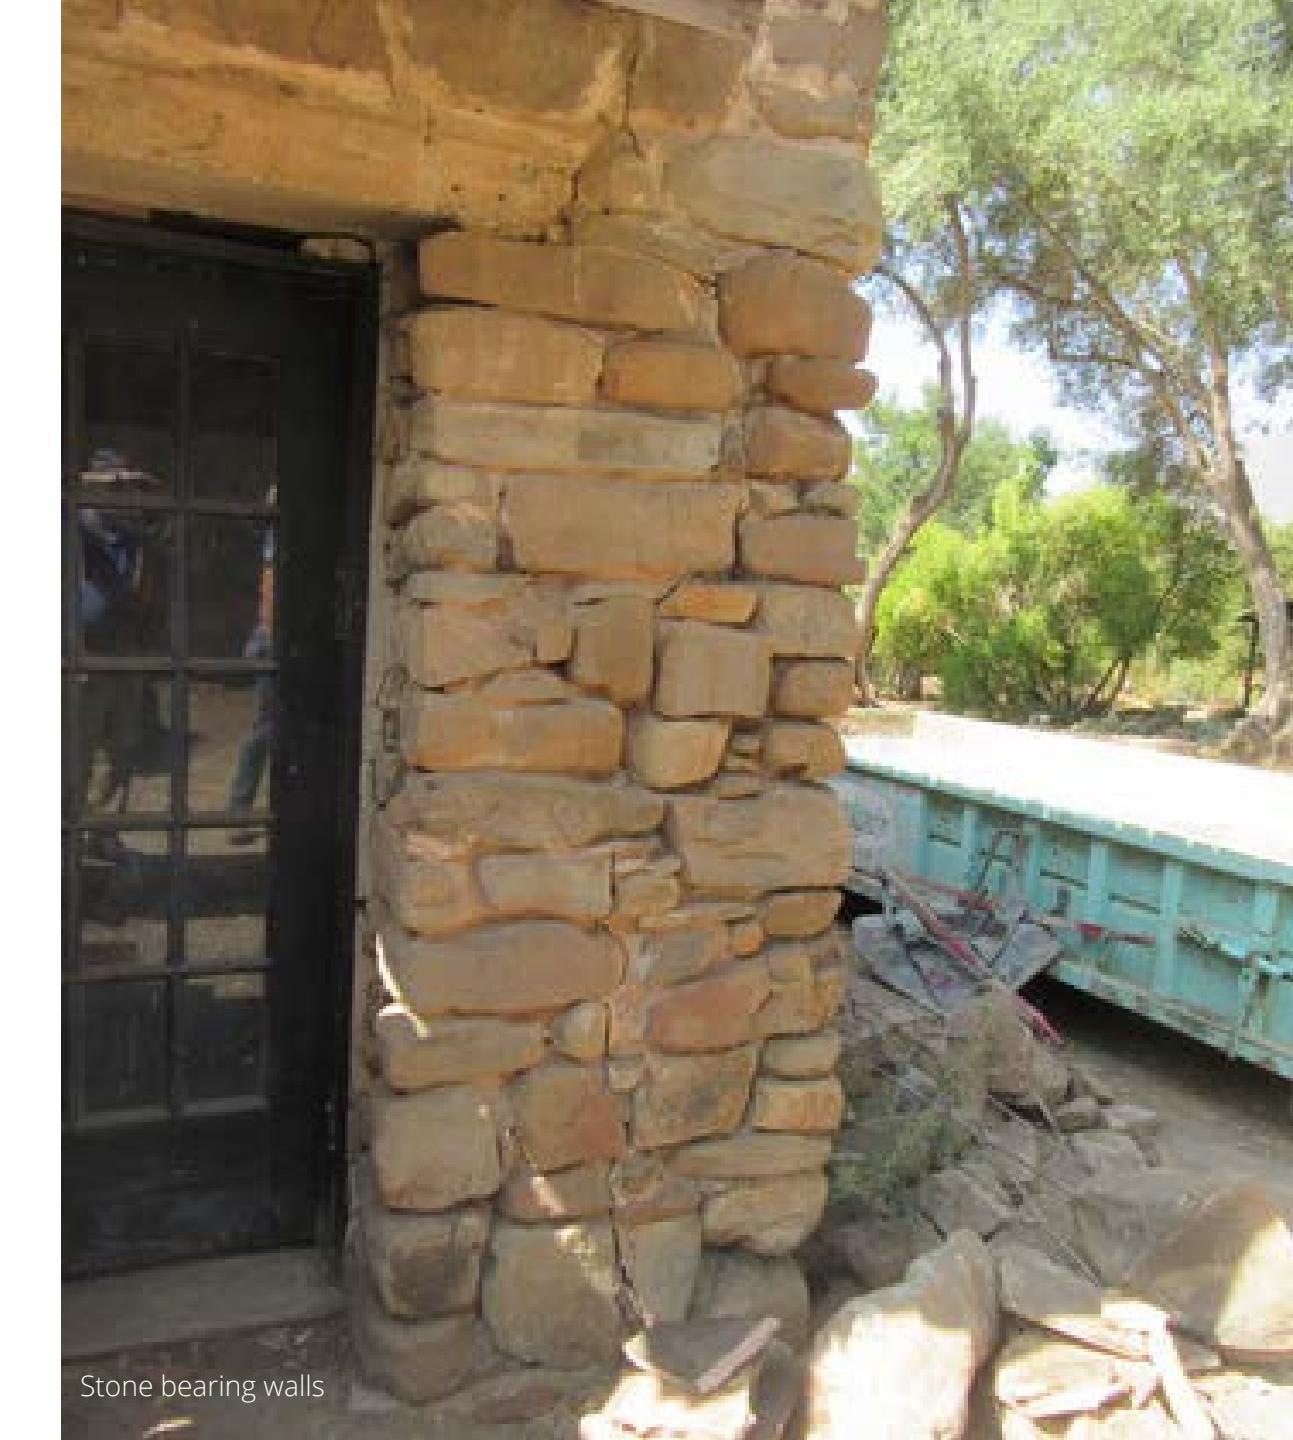
Masonry bearing wall: Stone

- Stone wall construction is fairly rare
- Units will vary in size
- Usually stone units are visible, and walls are thicker than other materials
- Floors and roof are supported directly by the stone "bearing" walls

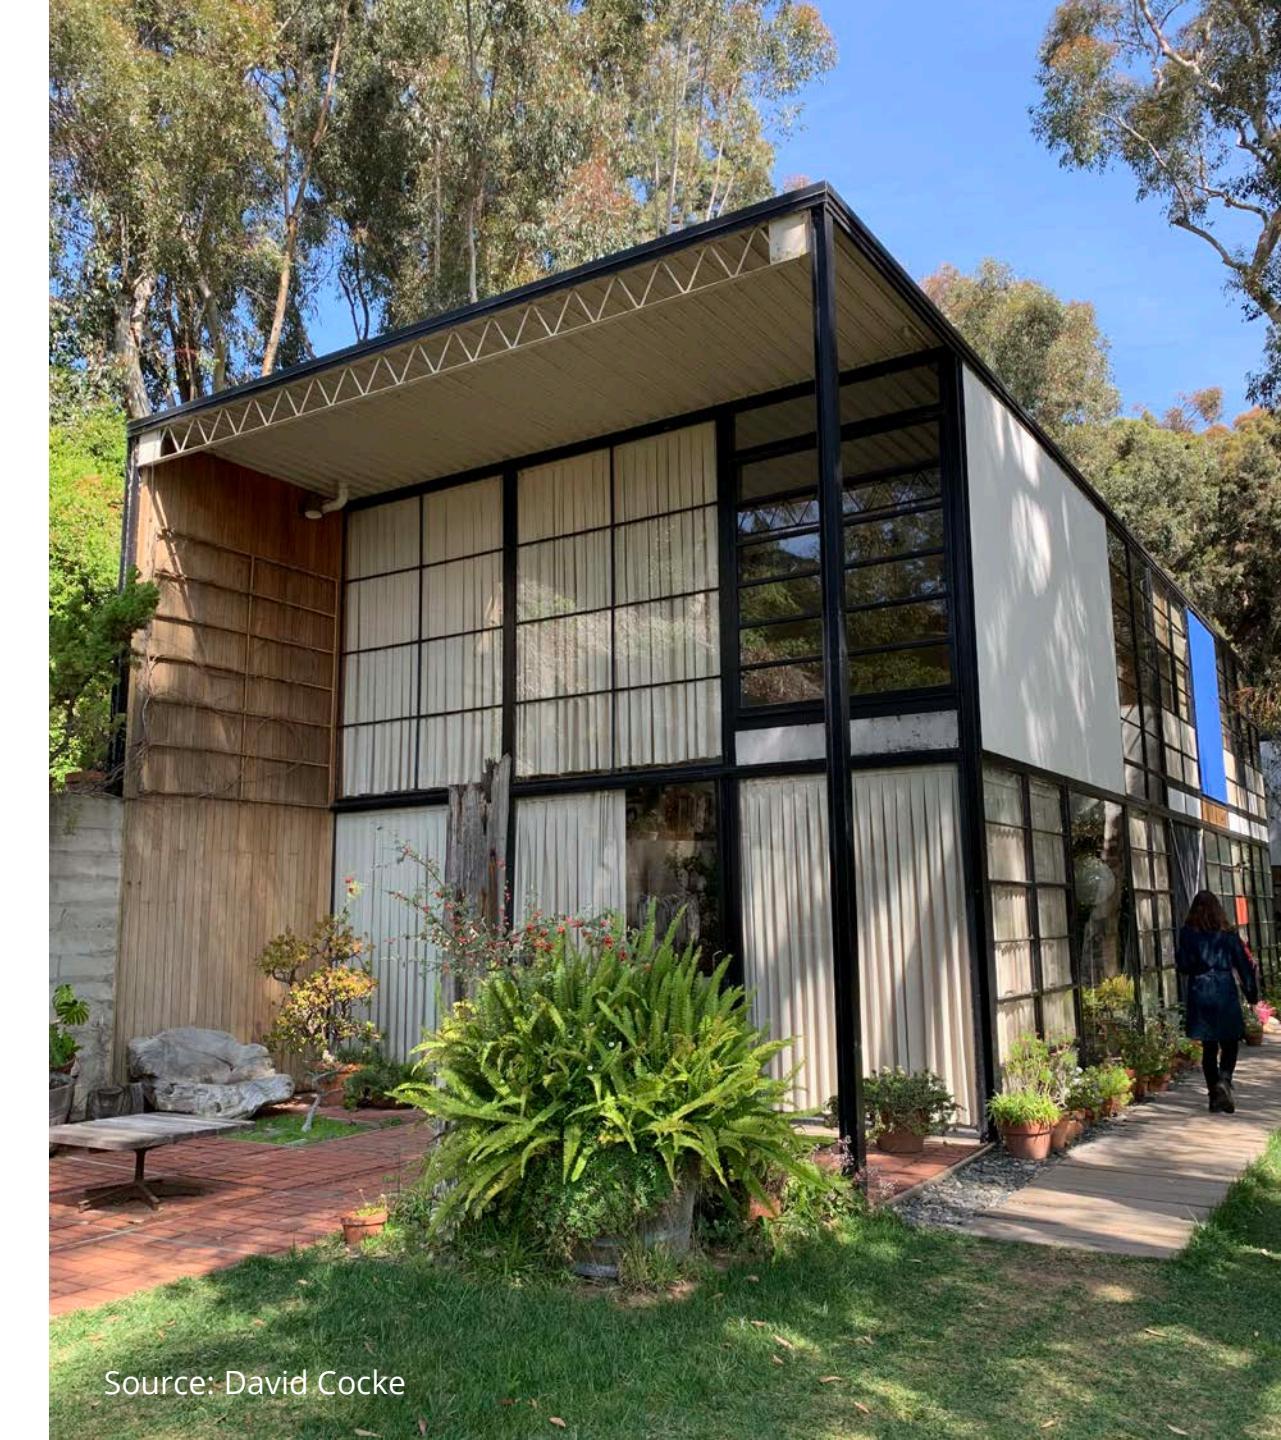
Steel frame/post & beam

- Became more popular in mid-Century
- Generally steel framing is visible
- Some "infill" wood stud walls may be present

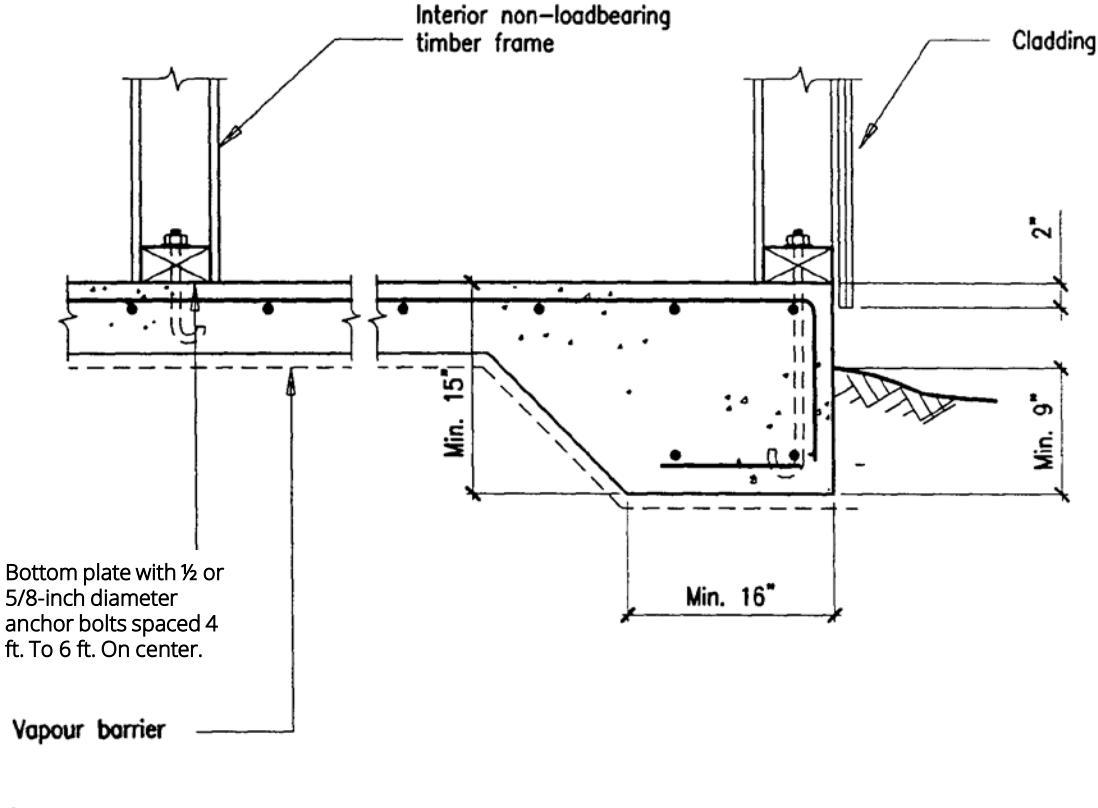
Foundations: Slab on grade

- No crawlspace, floor is directly on grade
- Can usually tell by stomping or heel-drop.
- Slab is very unforgiving vs wood floor will bounce a little and sound hollow
- Walls and floors are sitting directly on floor slab

Not always bolted in older construction

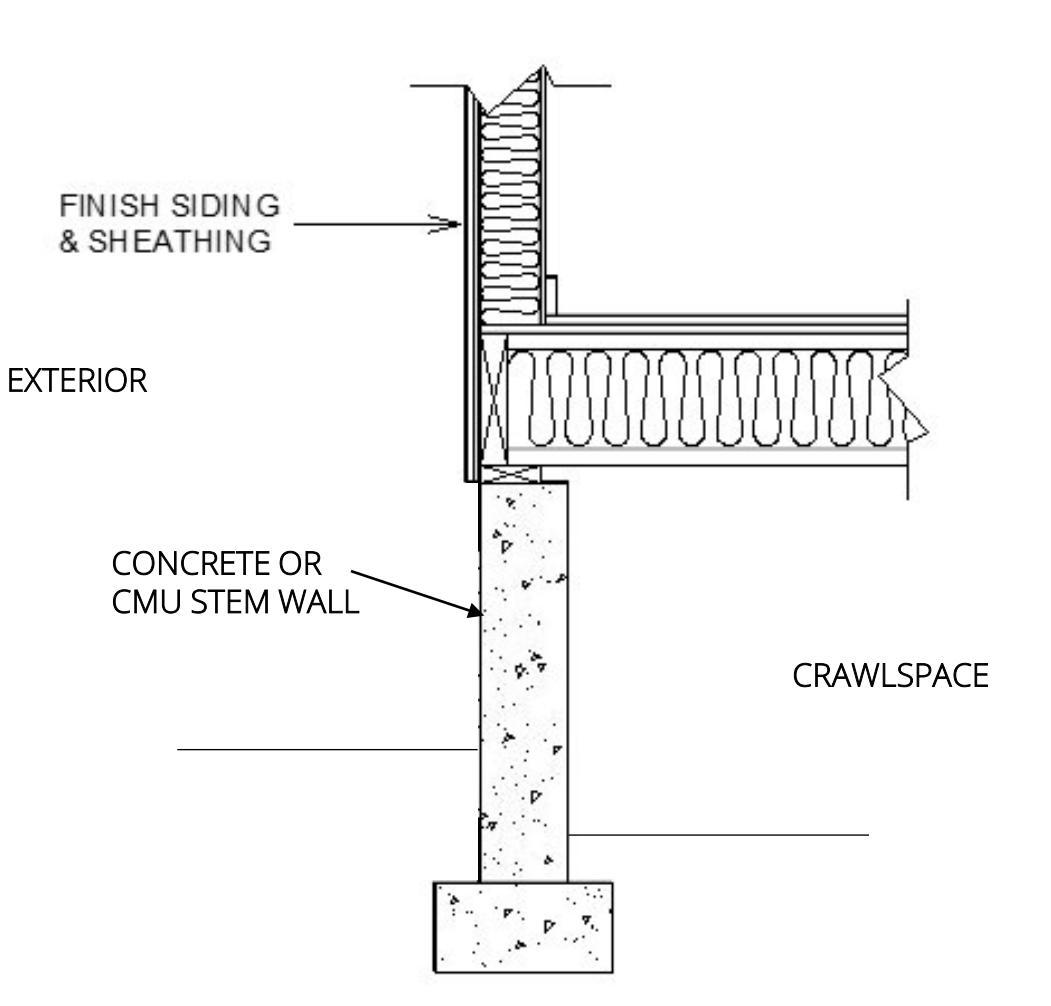
Foundations: Stem walls

- Wood framed floor over crawlspace
- Look in crawlspace for...
- Concrete or masonry (brick or block) stem walls extend up from foundation to bottom of floor framing
- No vertical wood framing between the foundations and the floor framing

Not always bolted or reinforced

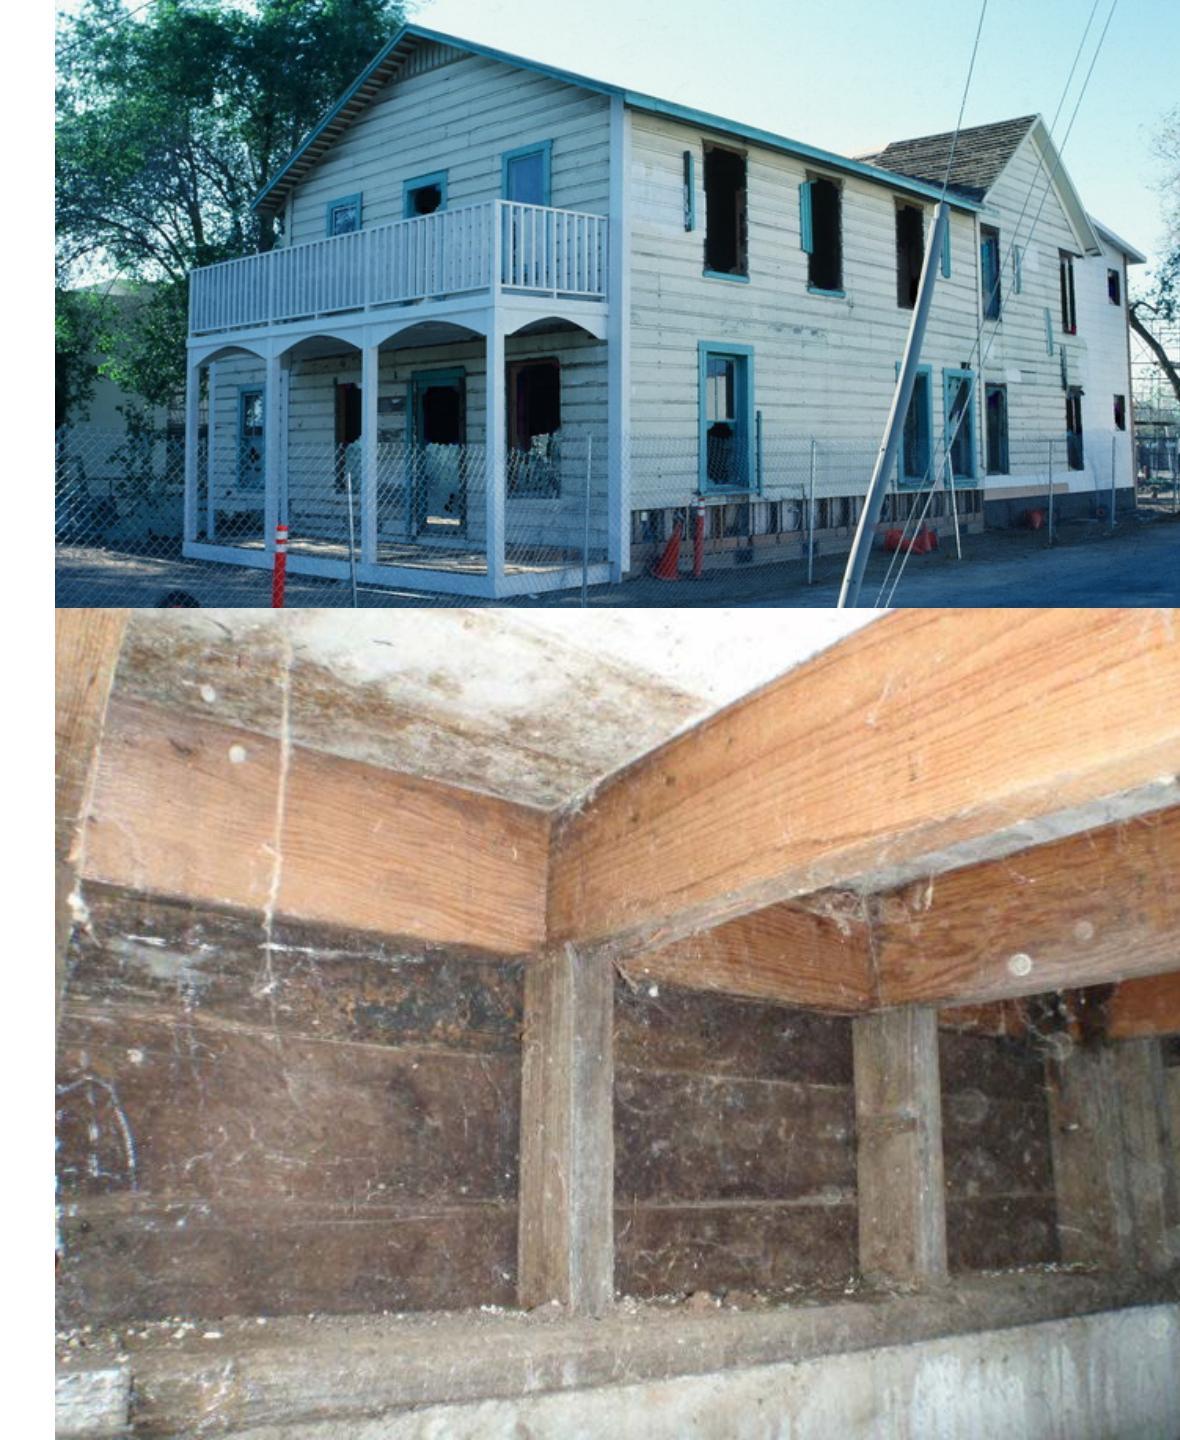
Wood frame foundations: Cripple walls

- Similar to concrete or masonry stem walls except vertical wood framing between the top of foundations and the floor framing
- In older houses, there is typically no sheathing or diagonal bracing of cripple walls between top of foundation and floor framing
- Short studs below the first floor line can topple, causing the house to fall off its foundation or posts.

Not always braced with sheathing and bolted to foundations

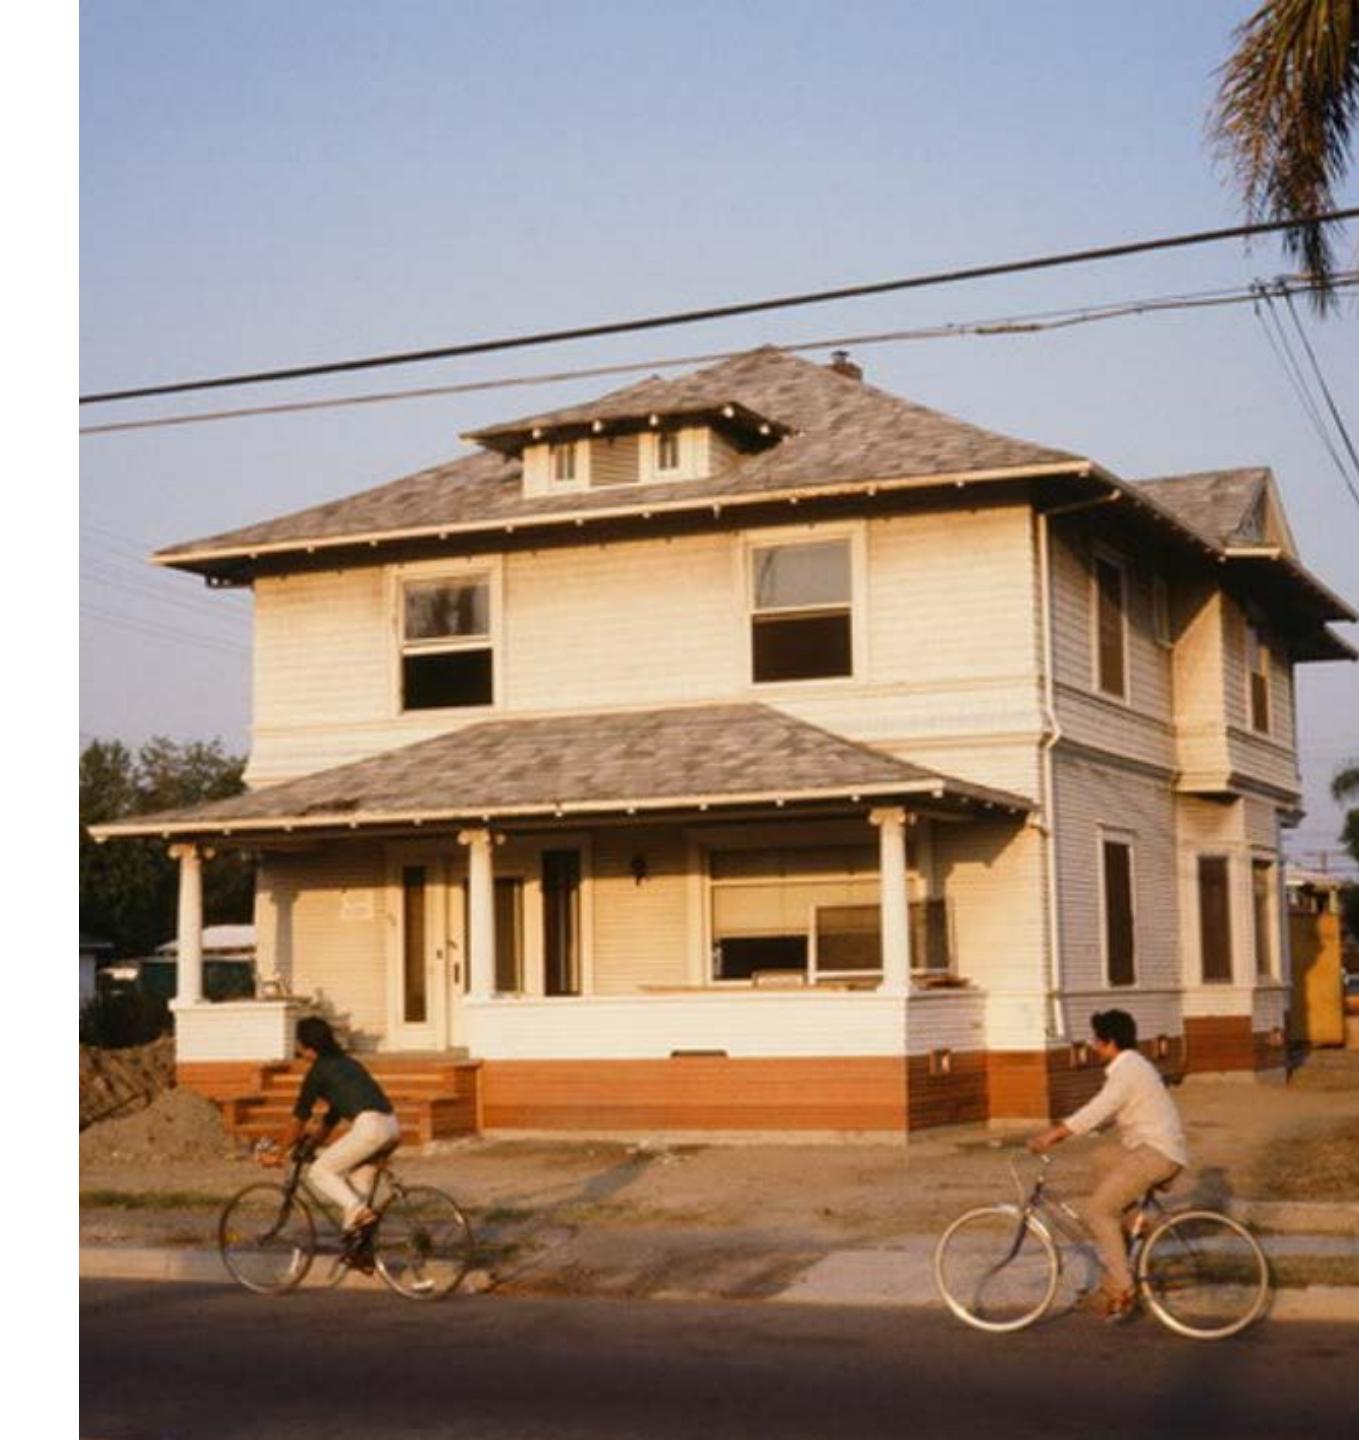
Cripple stud bracing - example

Example: wood framed house with retrofitted cripple walls from exterior side.

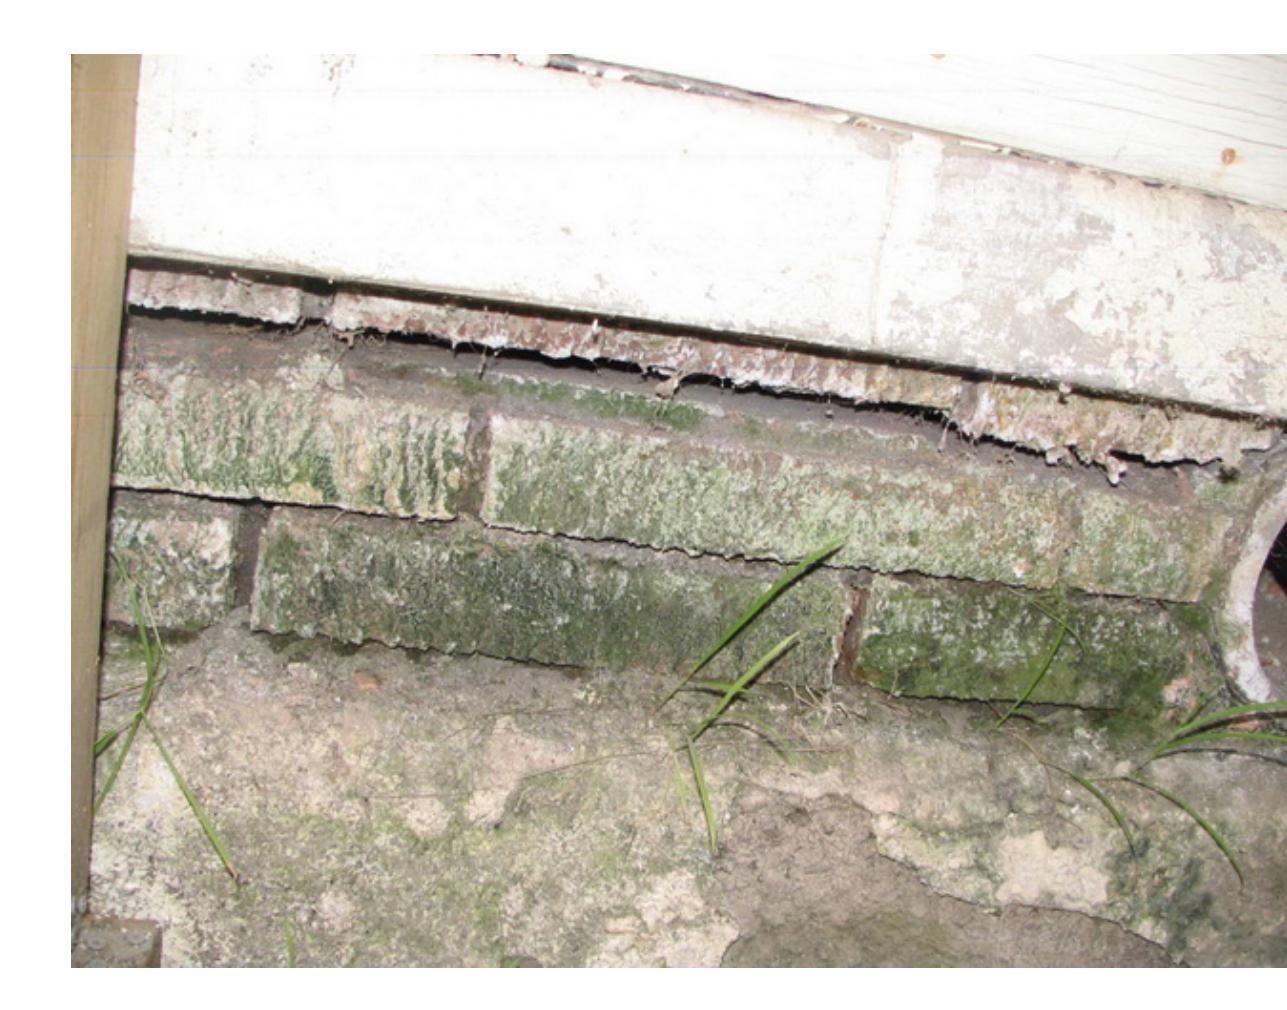
Wood frame foundations: Brick and Stone foundations

- Look in crawlspace for....
- Brick or stone foundation and stem walls instead of concrete
- In older homes, typically there are no reinforcing bars are embedded in brick or stone

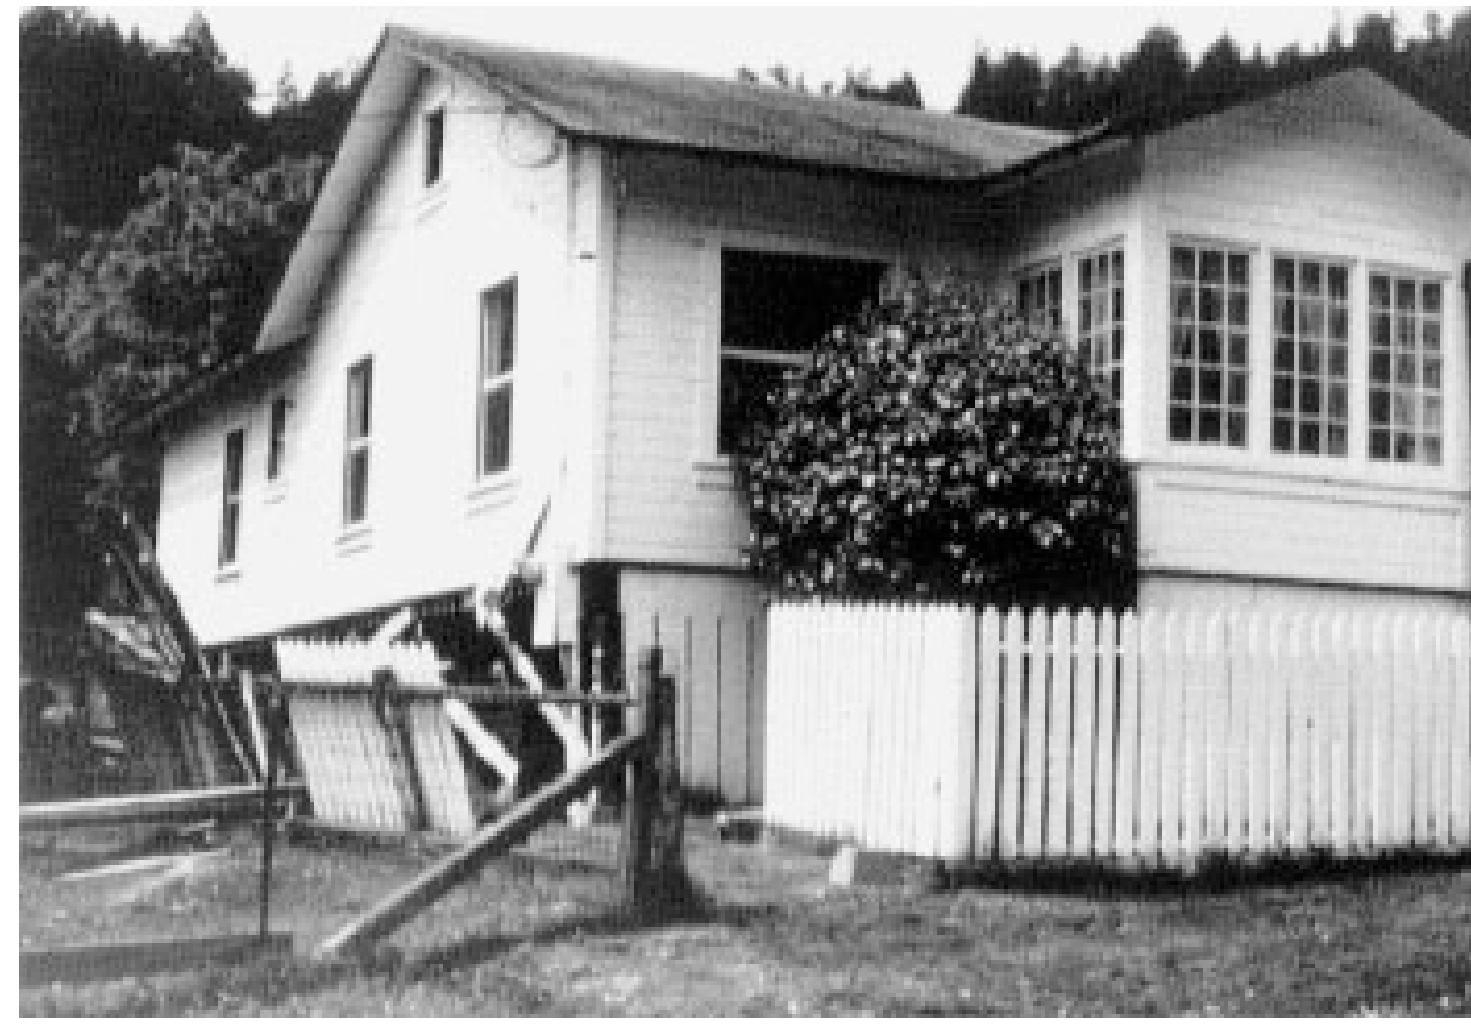
Wood frame foundations: Posts and individual footings

- Post and beam foundations
- Unbraced walls and posts beneath house can lose stability if shaken
