HOME, SAFE HOME. SEISMIC SAFETY & REHABILITATING HISTORIC HOMES

SEISMIC RETROFIT BASICS

Workshop #3 | August 30, 2022

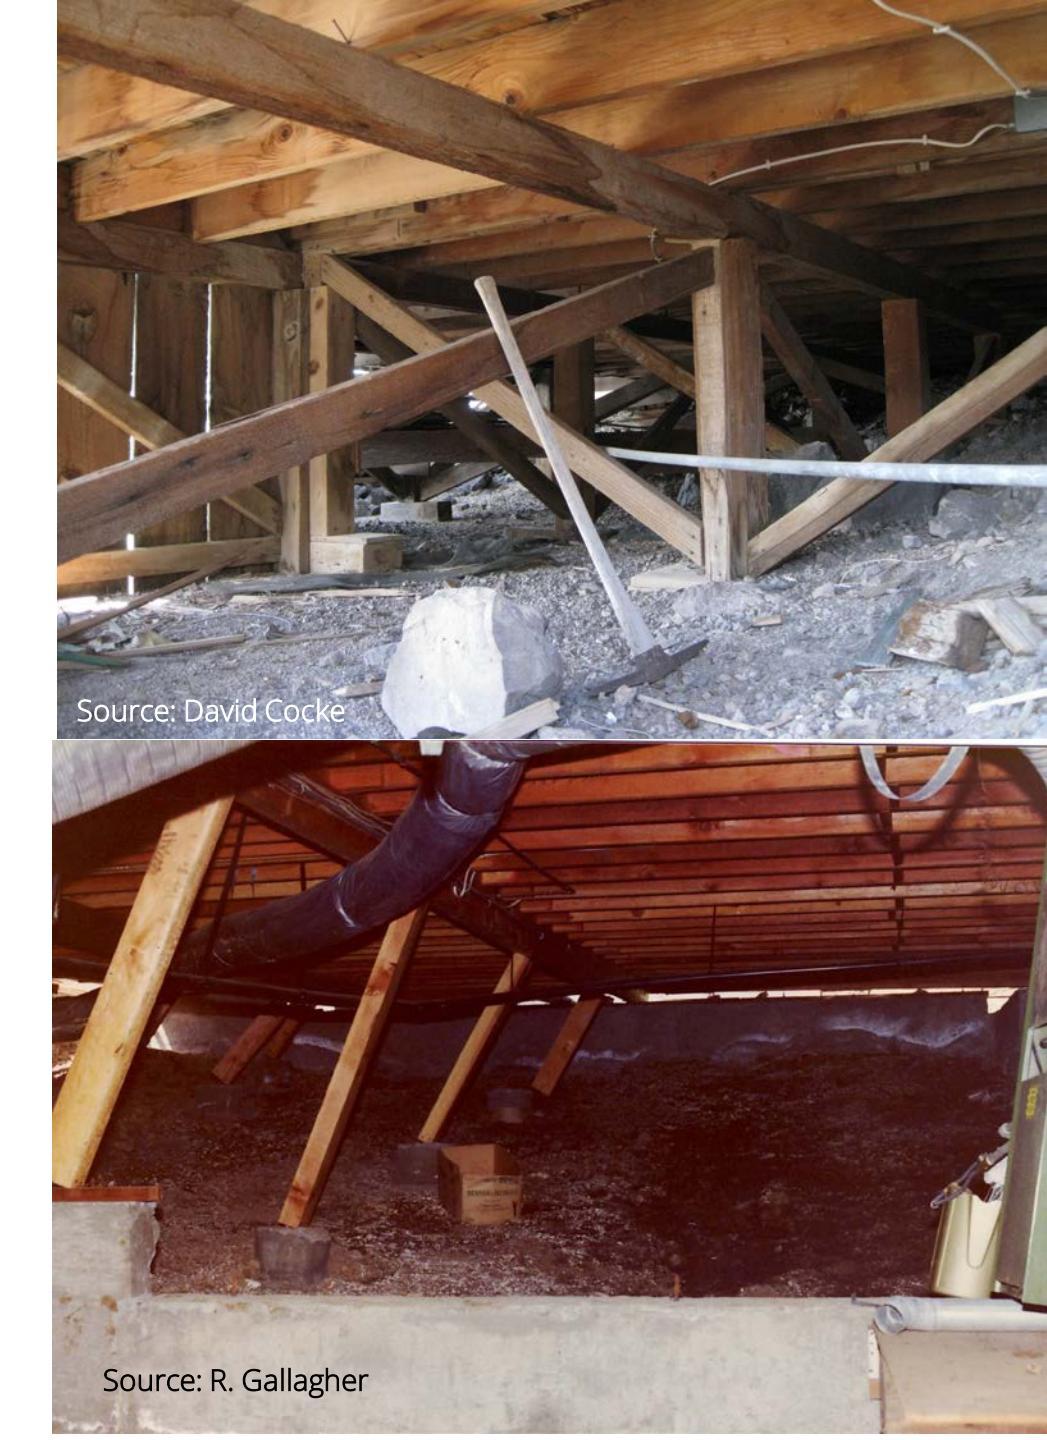
Wood frame foundations: Posts and individual footings

- Usually open beneath house
- Used when on a sloped lot or in coastal areas
- Sometimes no lateral bracing to prevent "leaning" of posts
- Individual footings can "drift" if not tied together

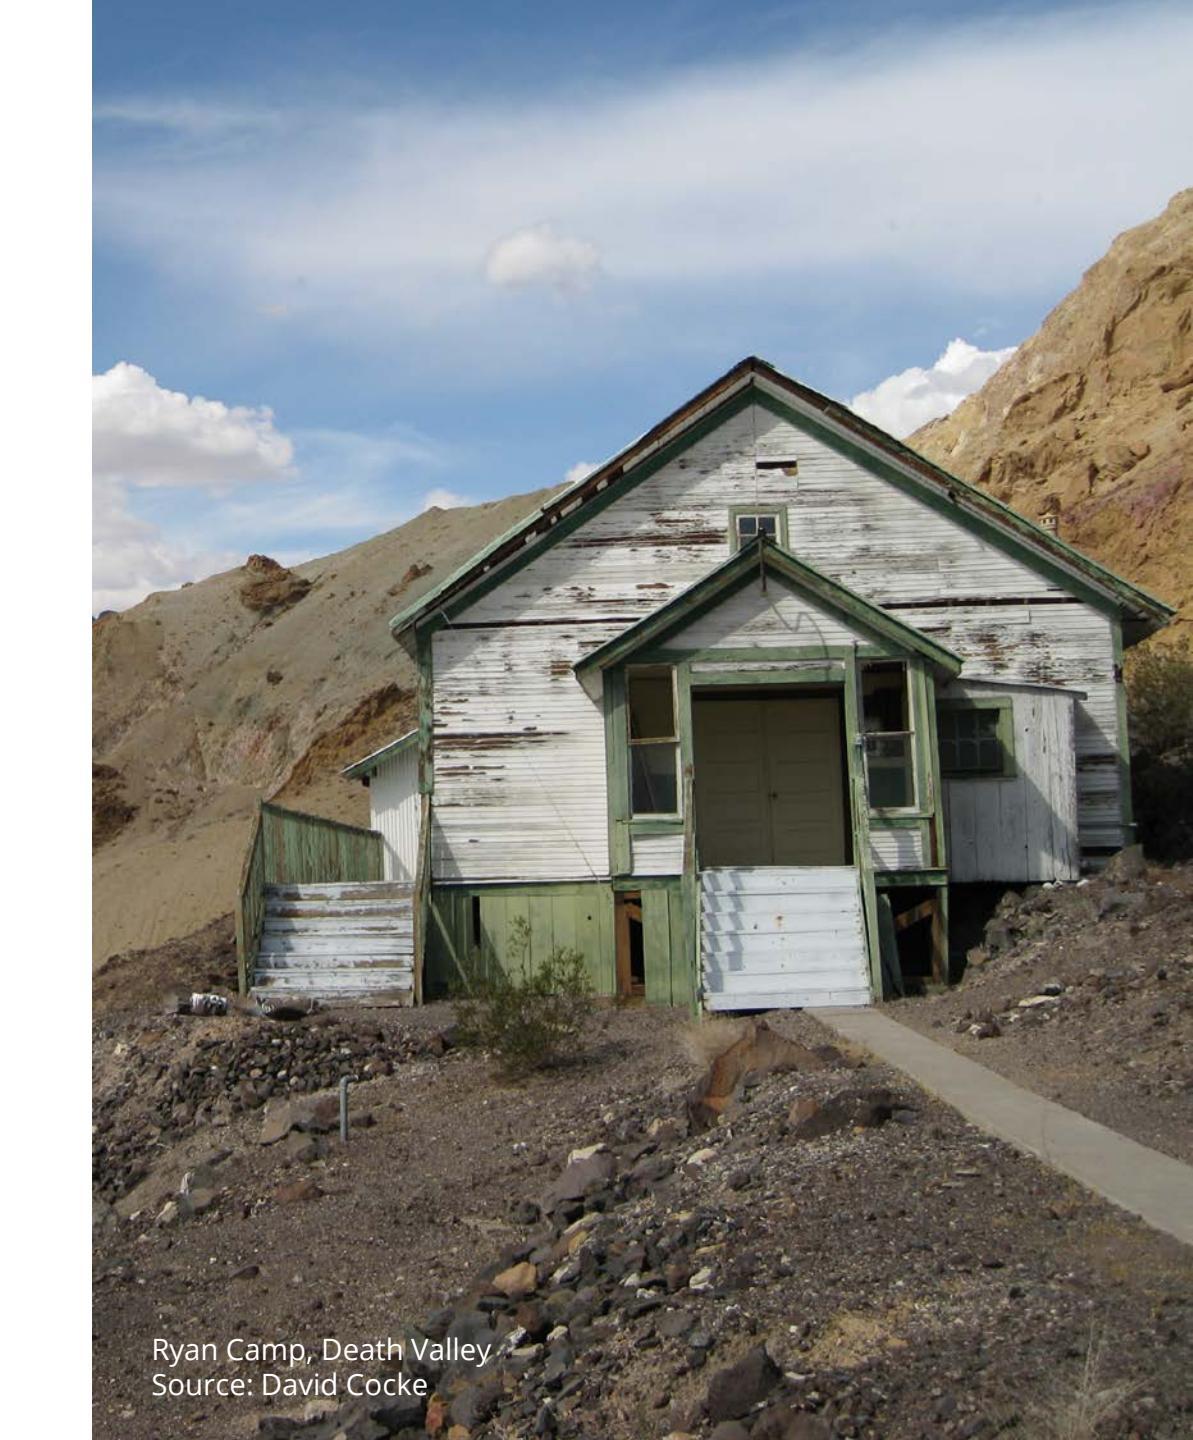
Hillside Foundations

- Similar to previous example
- Any building system can be supported by hillside foundations
- Special challenges related to foundation performance
- In older homes, sophisticated geological information may not have been available
- Older foundation systems, not designed to recent codes are vulnerable
- Individual footings can "drift" if not tied together

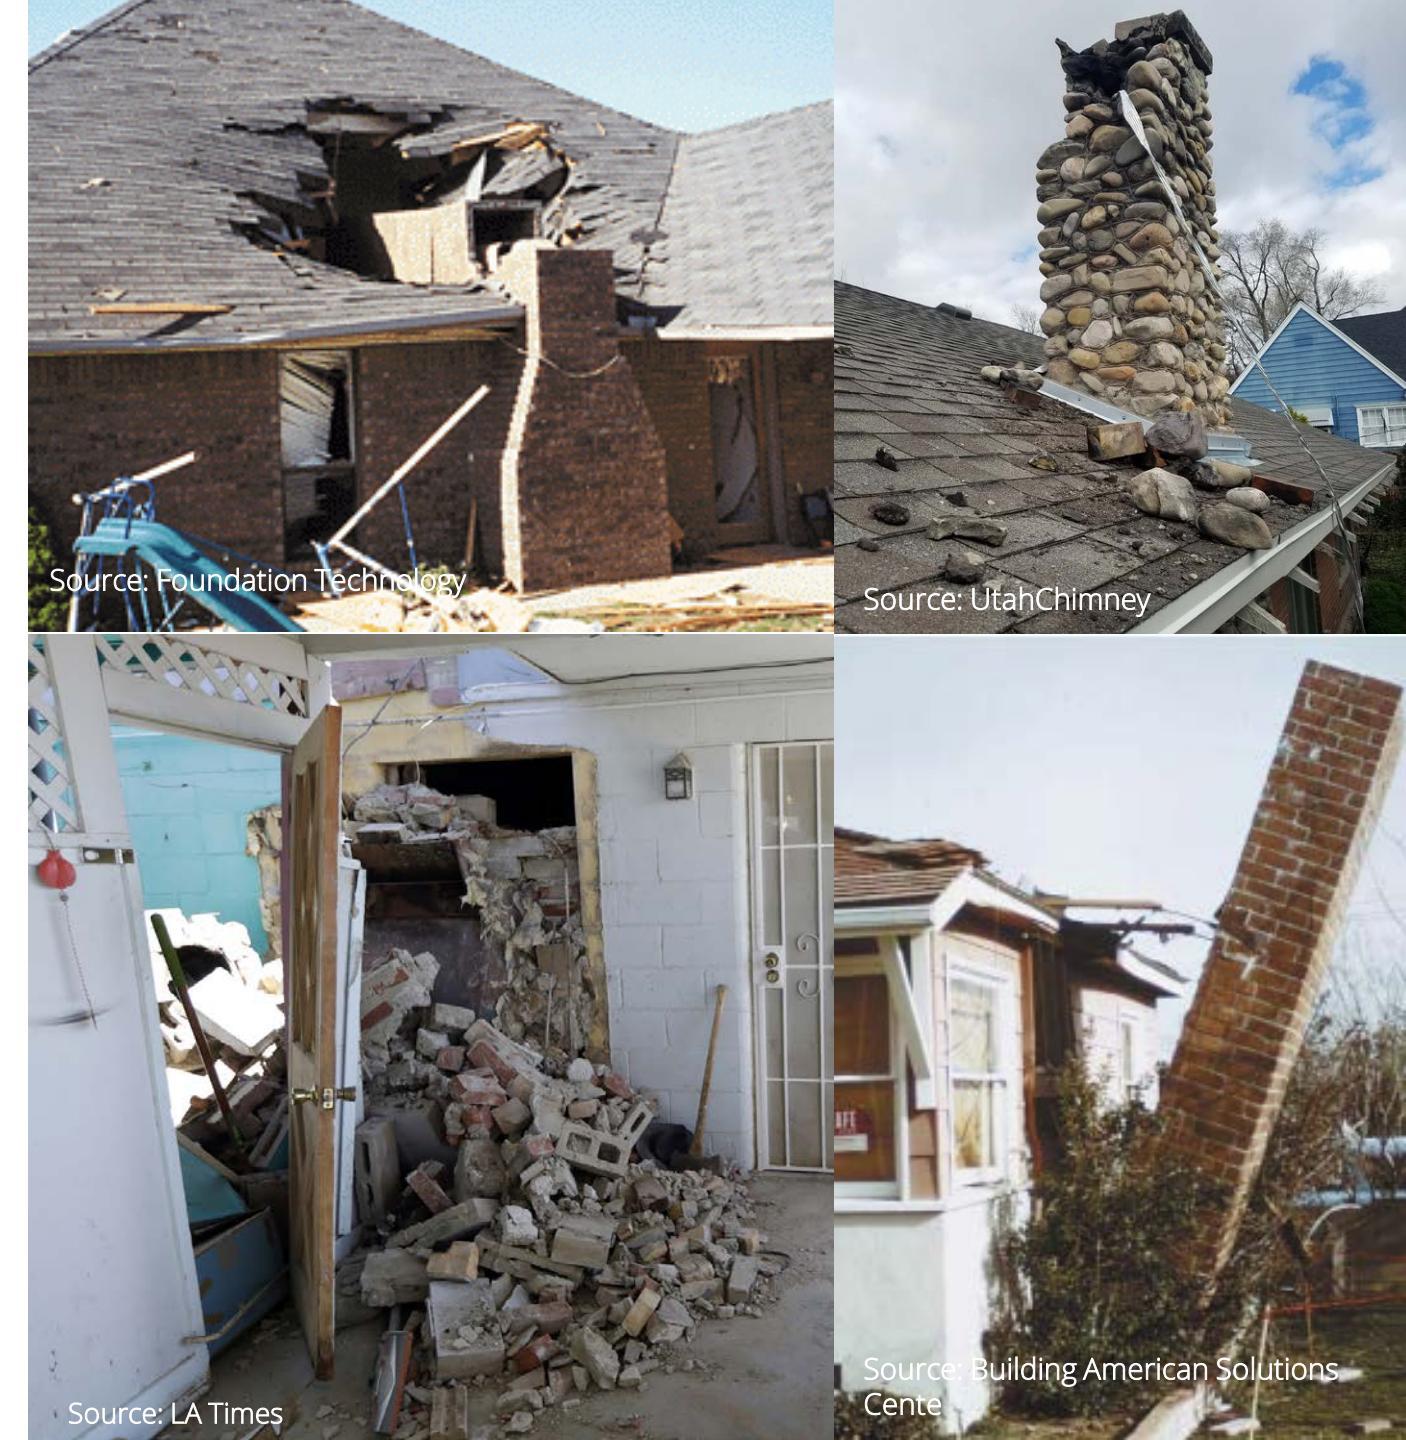
Chimneys in older houses

- Usually first item to fail
- Usually masonry heavy
- No or only minor reinforcing
- No anchorage to structure at roof level
- Tall and slender shape is subject to lateral loads
- Can resist only minor shaking levels
- Represents a significant falling hazard

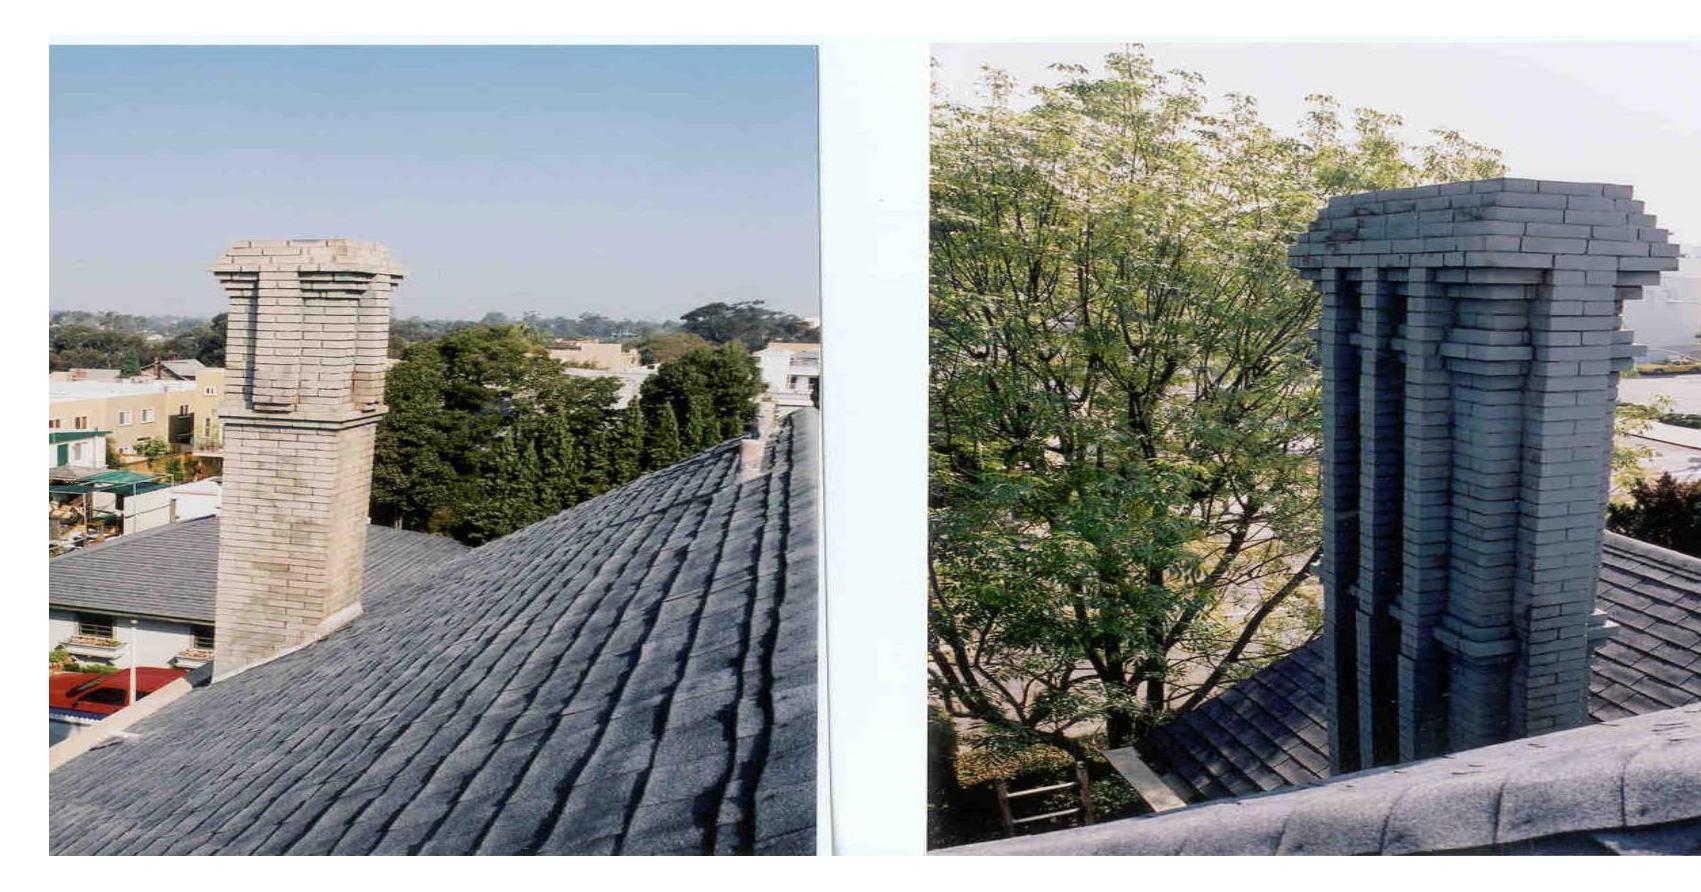
Chimneys

Taller chimneys are often ornate and as high as 30 feet above the roof.

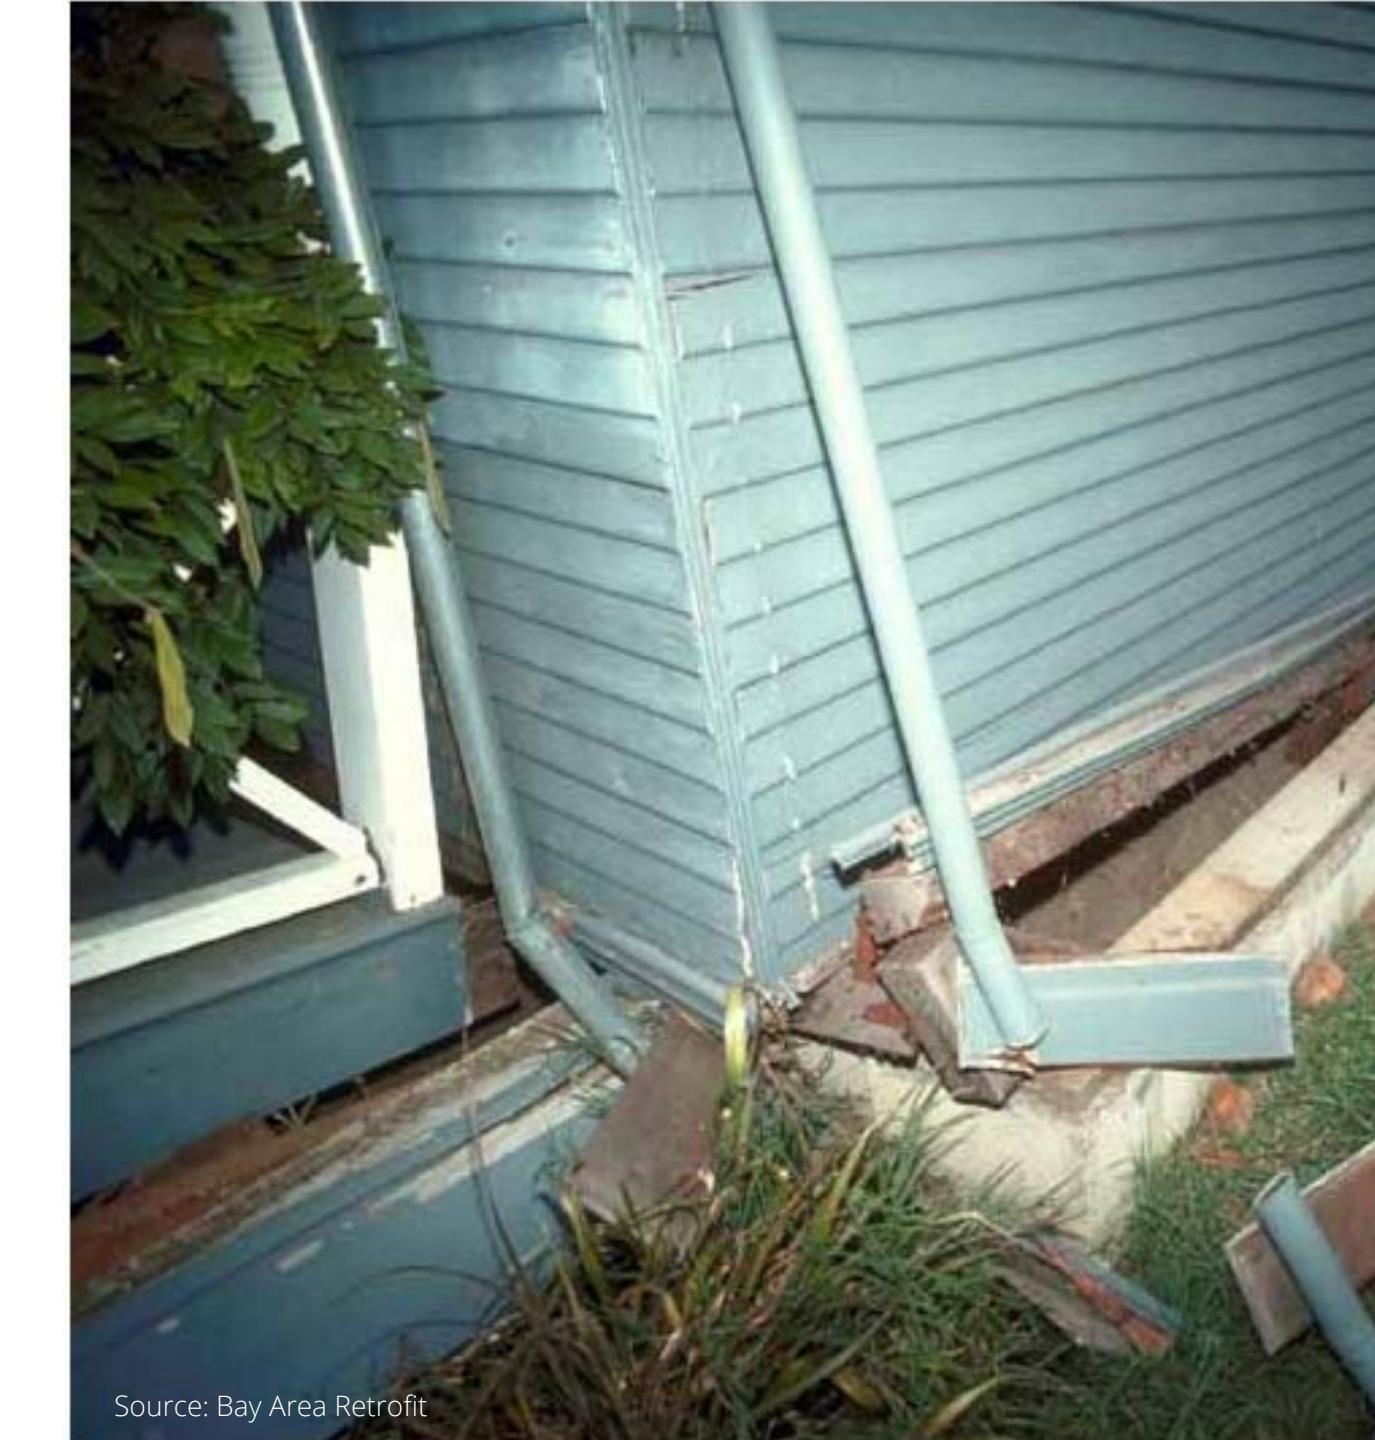
Concrete Foundation

- Building has slid off the foundation due to the lack of anchor bolts.
- No anchors between wall and foundation

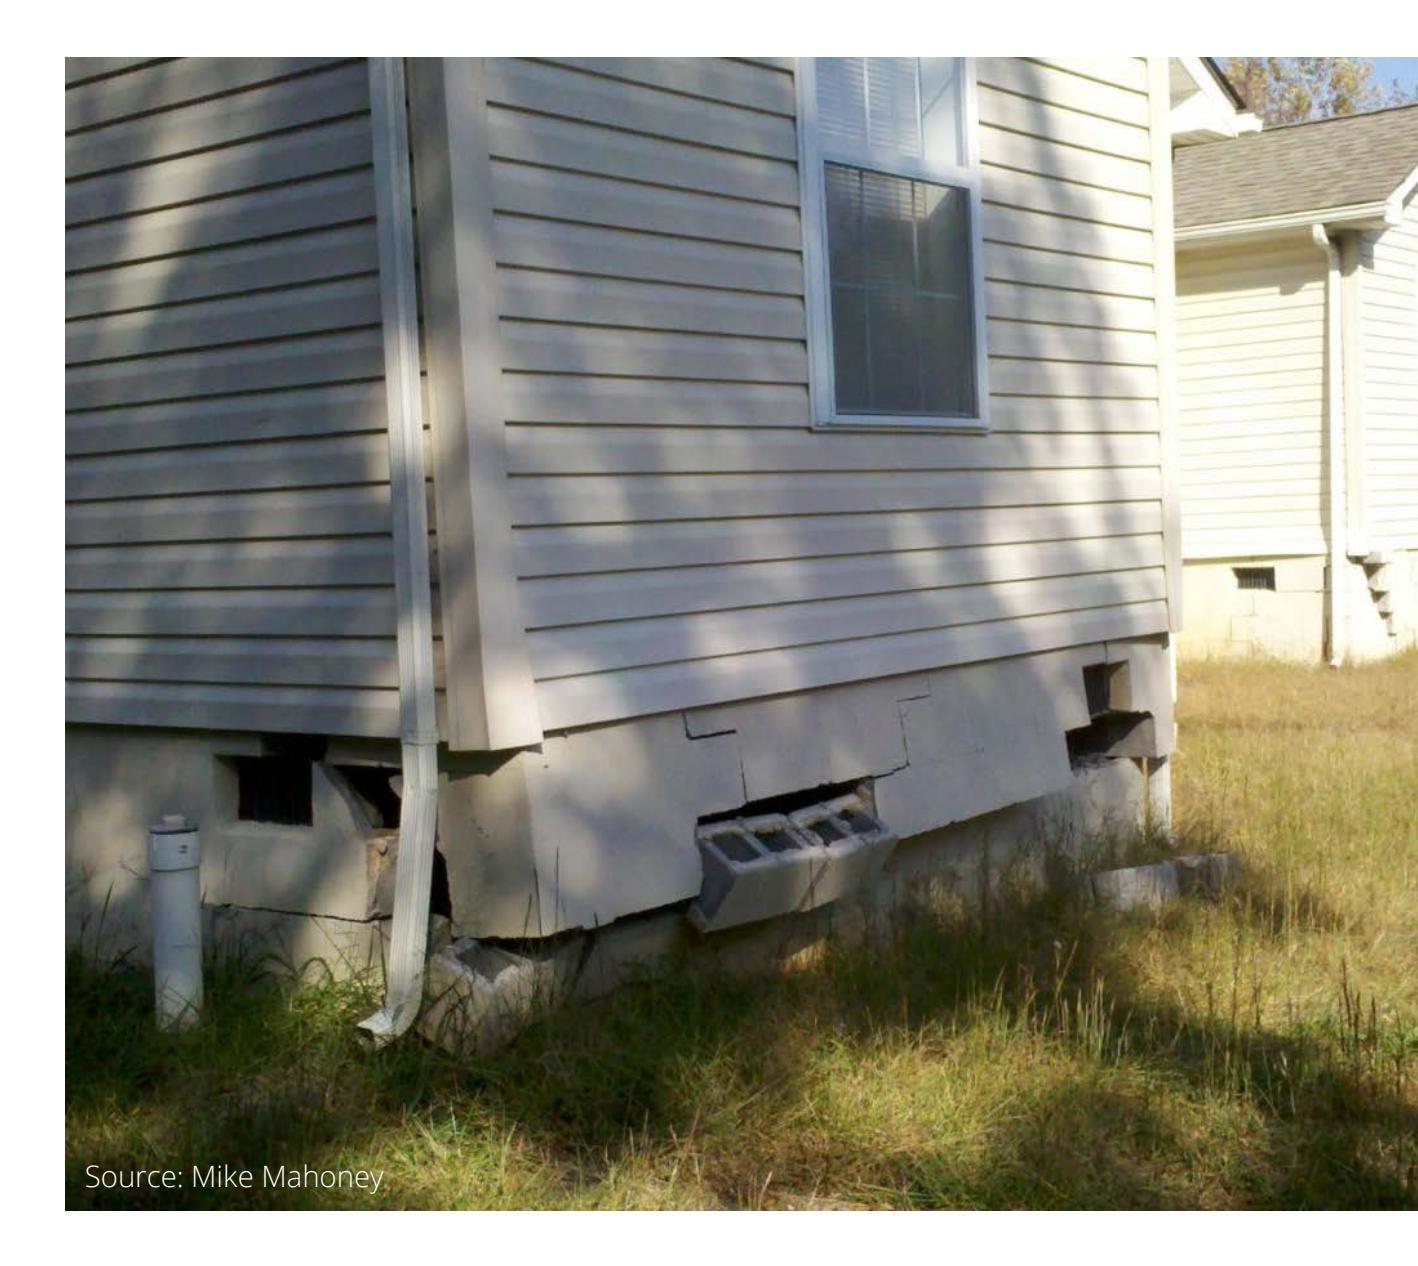
- Failed masonry foundations
- No reinforcing bars to tie blocks together and resist lateral loading

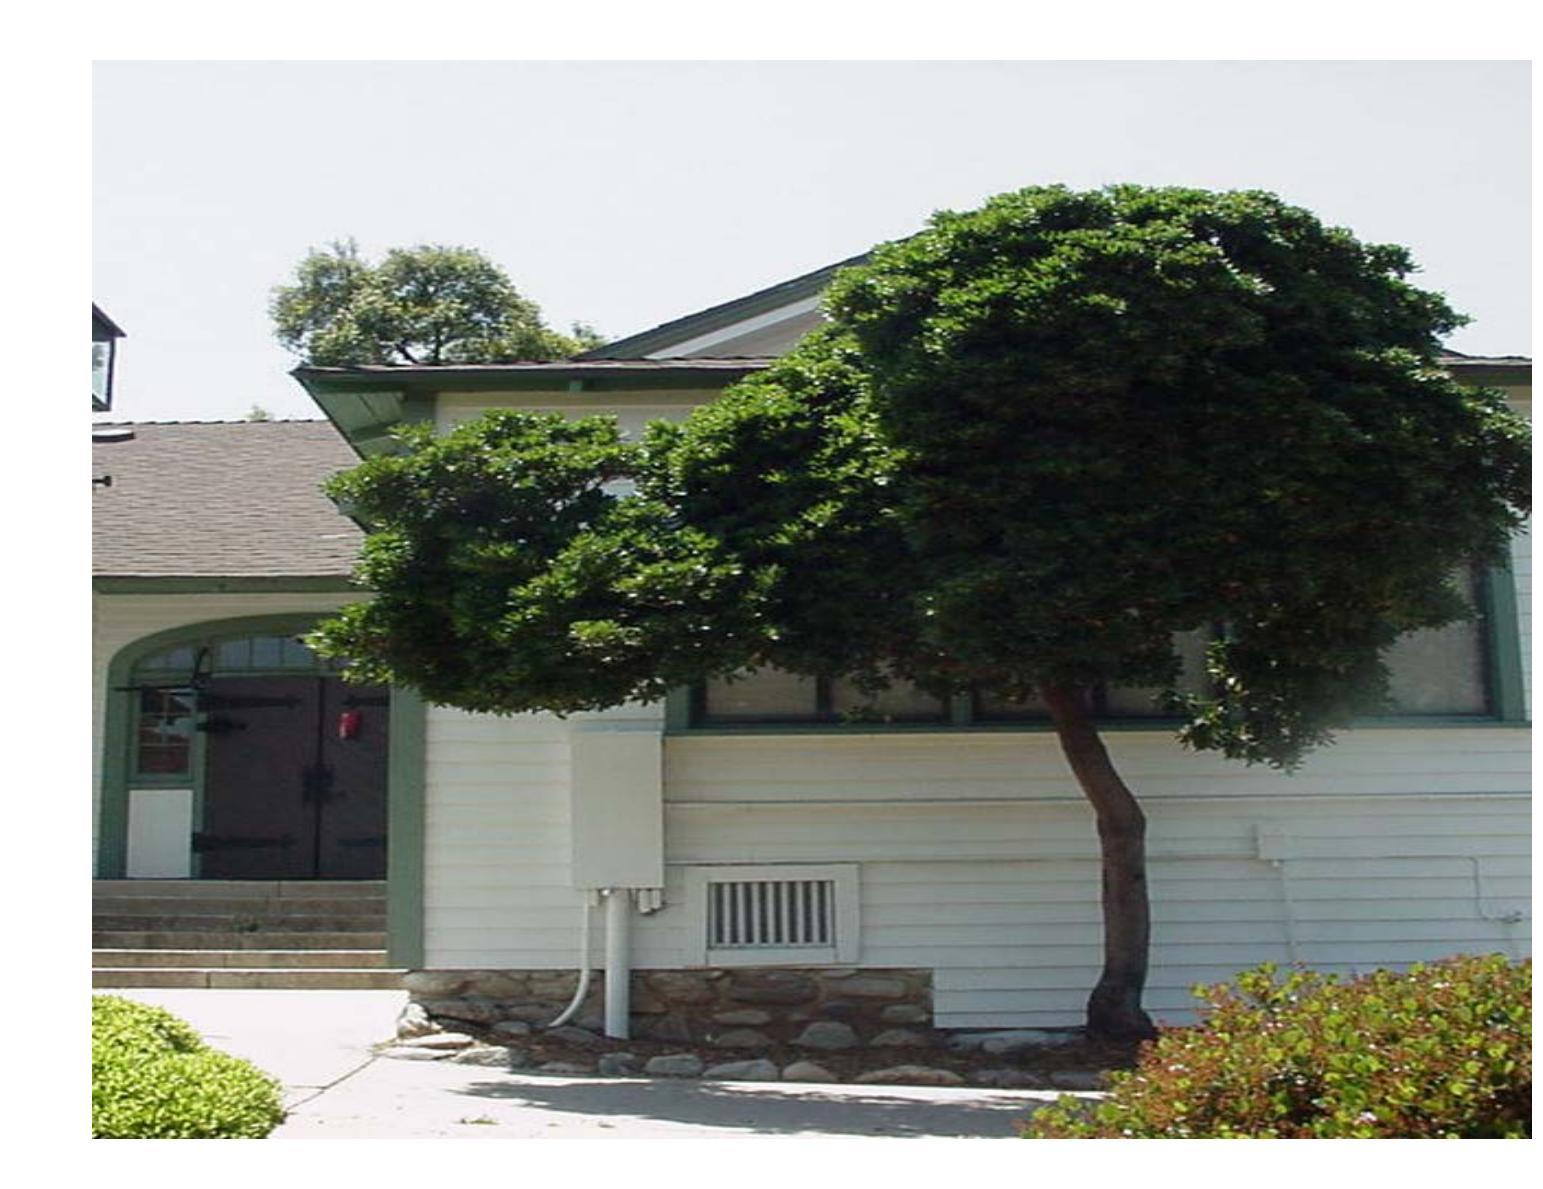
Stone Foundations

Example: Stone foundations are not reinforced.

There typically not be anchor bolts between the foundation and the floor.

Note: This example has the stone foundation plus a cripple stud foundation.

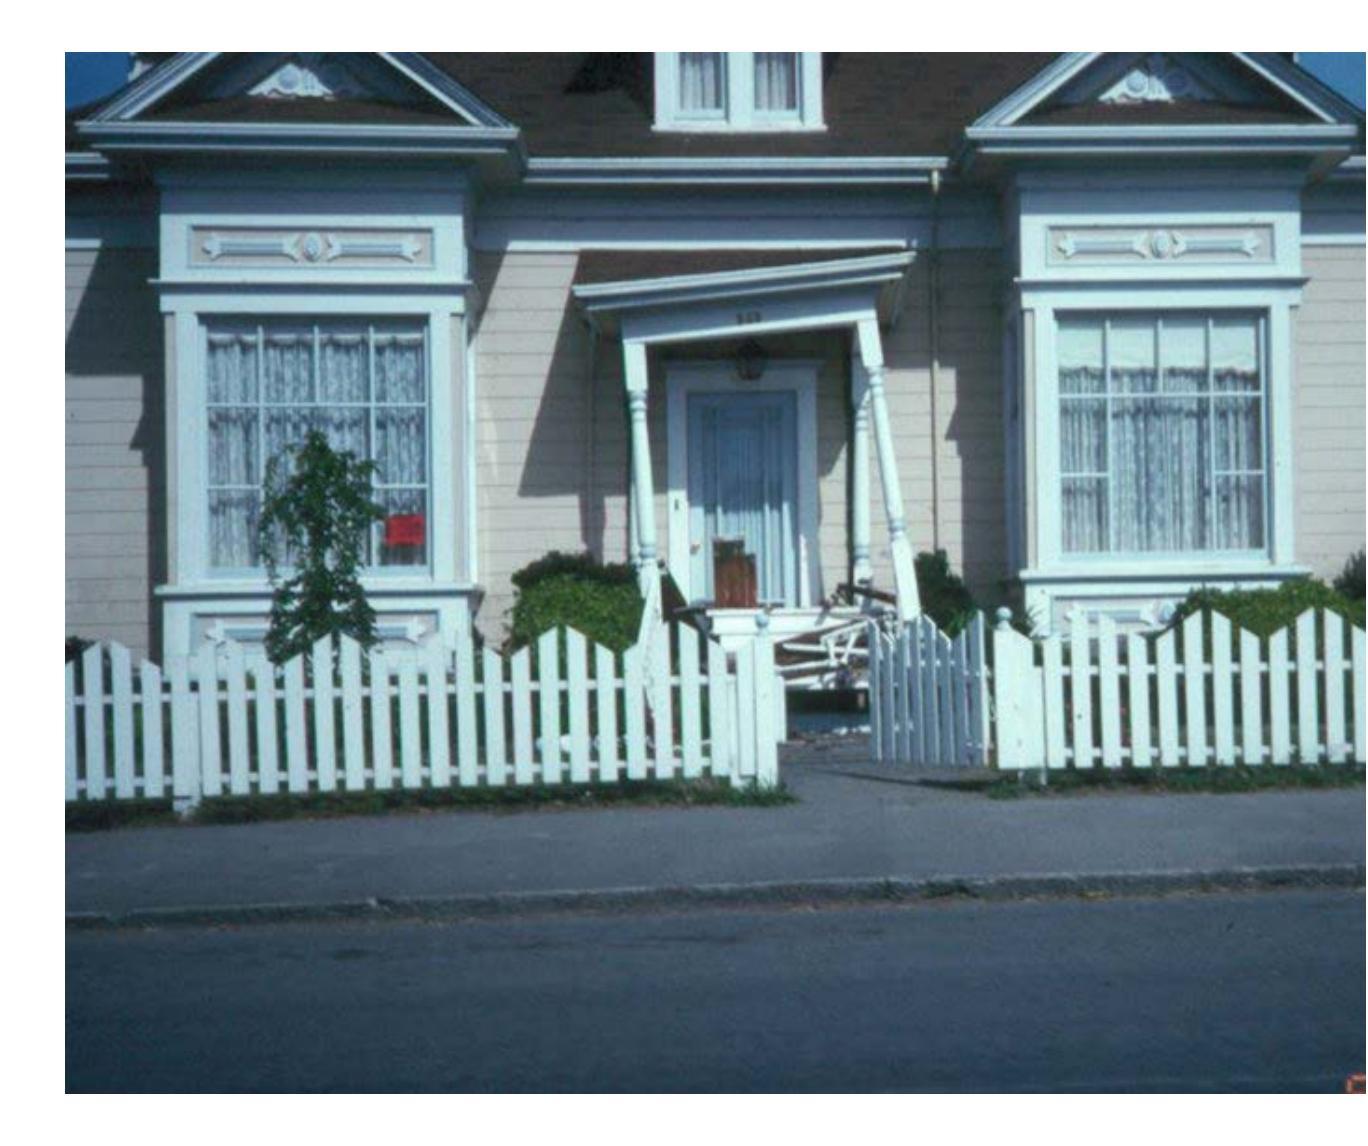
Porches

- Often porches topple or lean blocking the exit path from the building
- Significant falling hazard

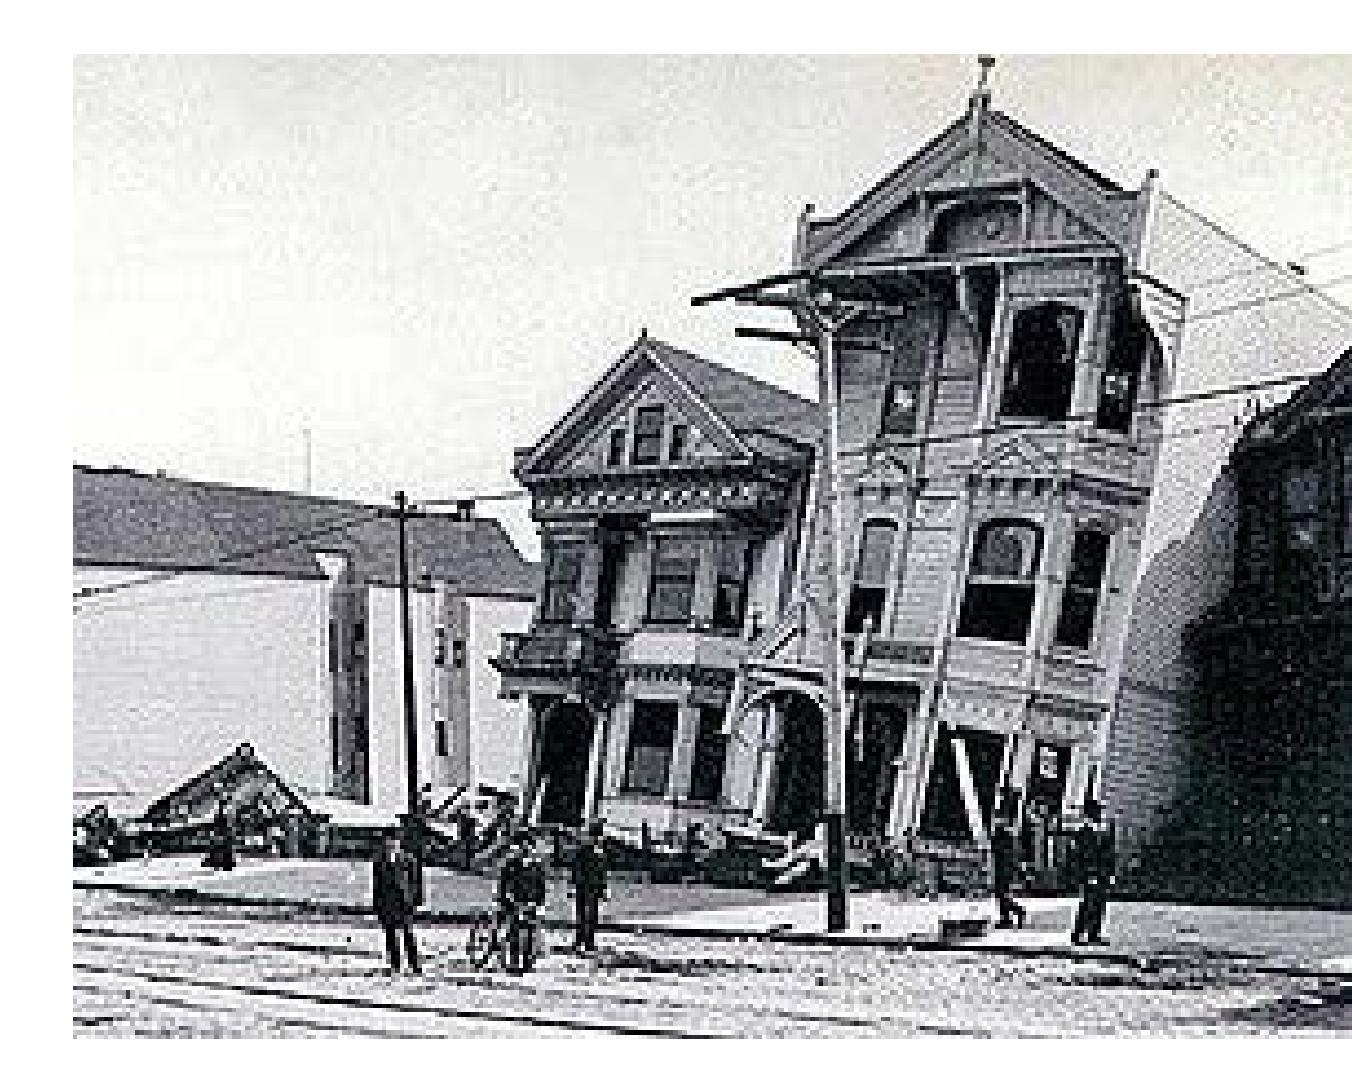
- Open elevations (soft story) with living space above
- Little resistance in ground level

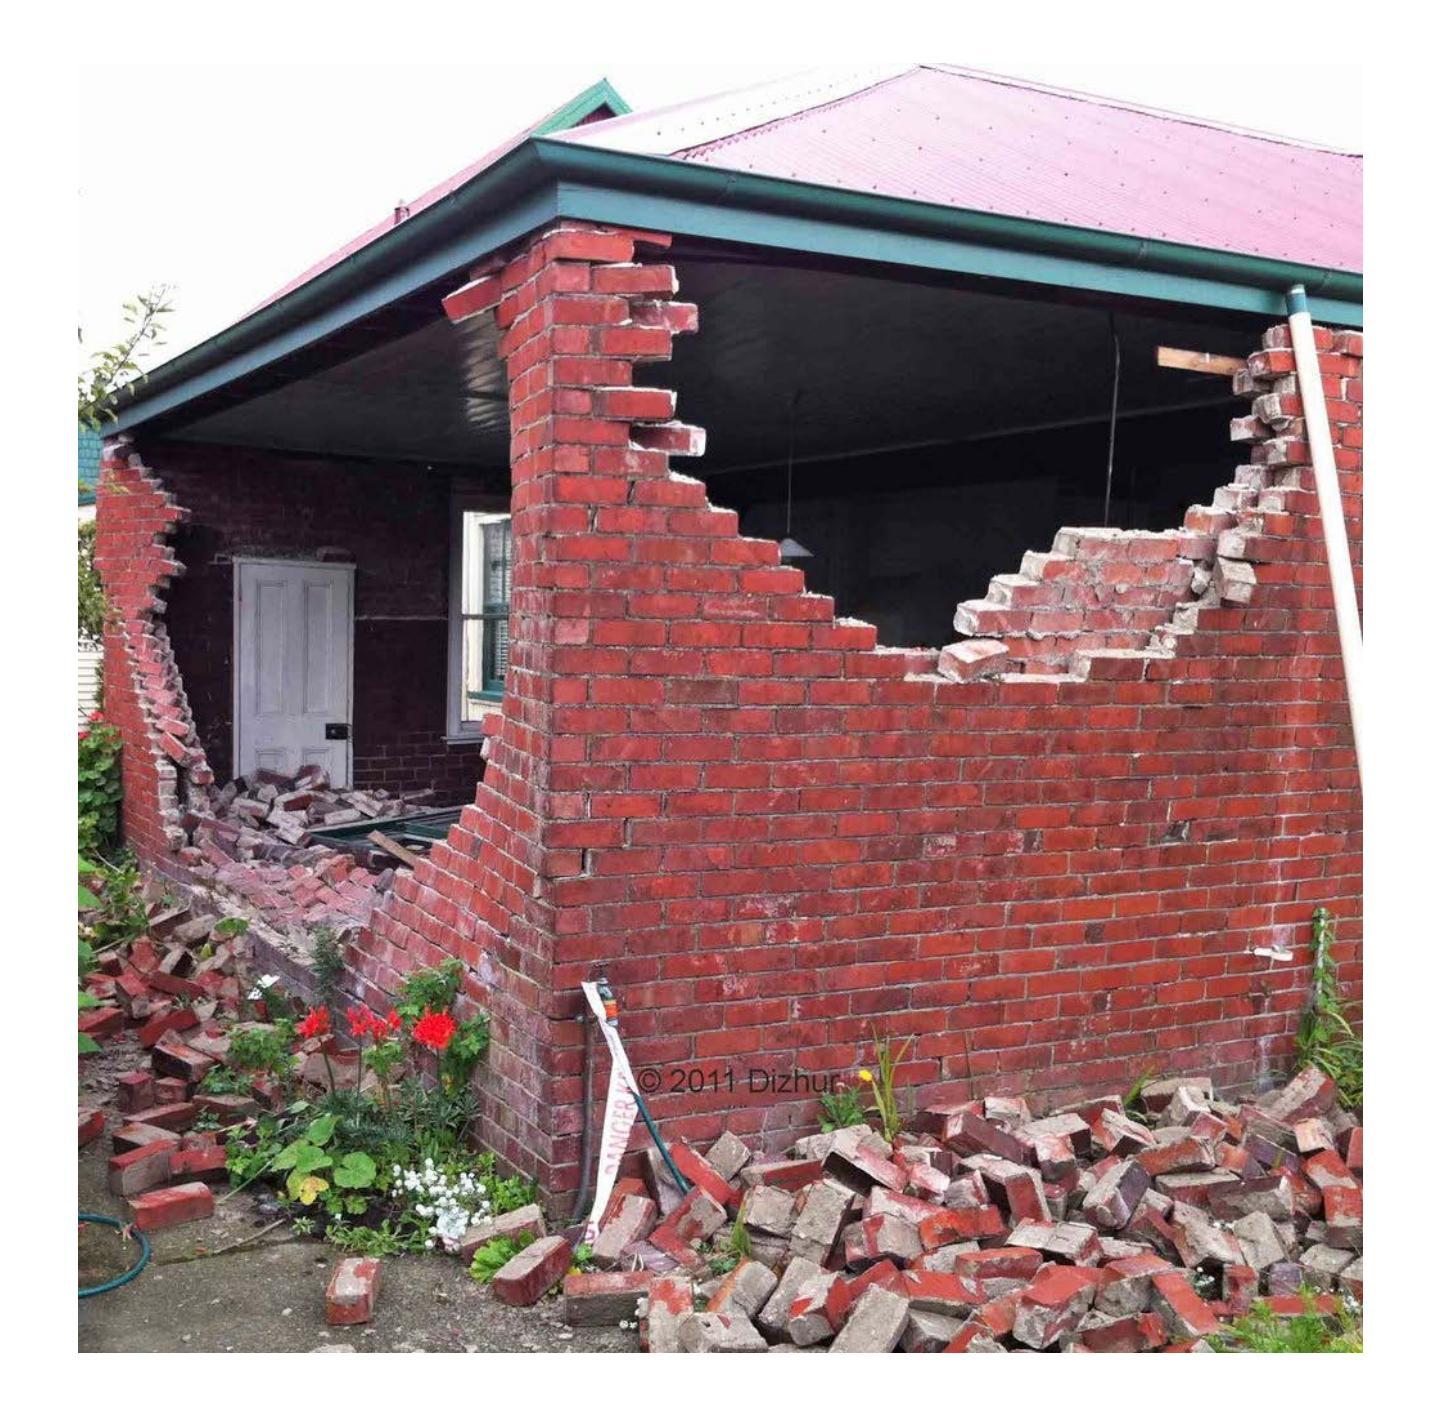
Masonry wall connections to diaphragms

• Failure usually starts at top and "zips" downward

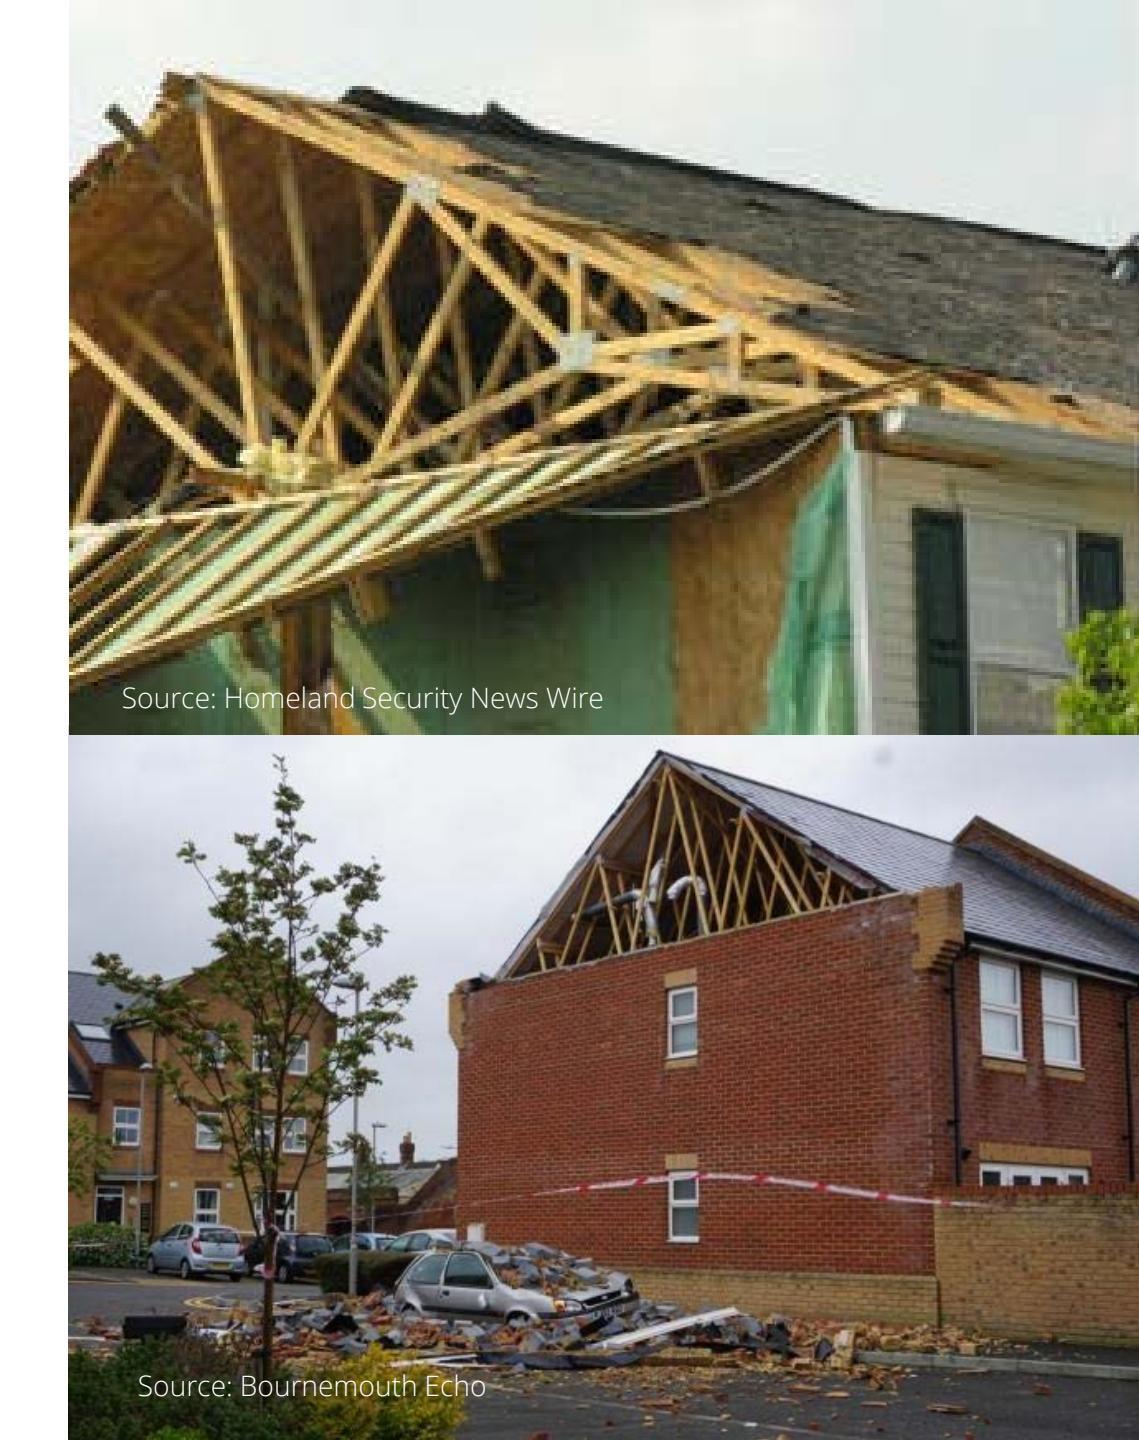
Gables

- Separation along top edge at roof
- Hinging at wall plate (attic level)

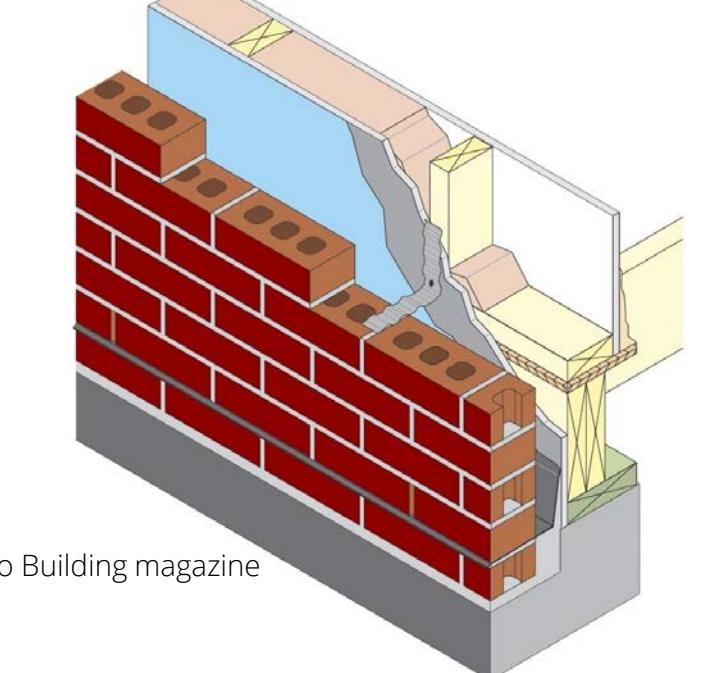
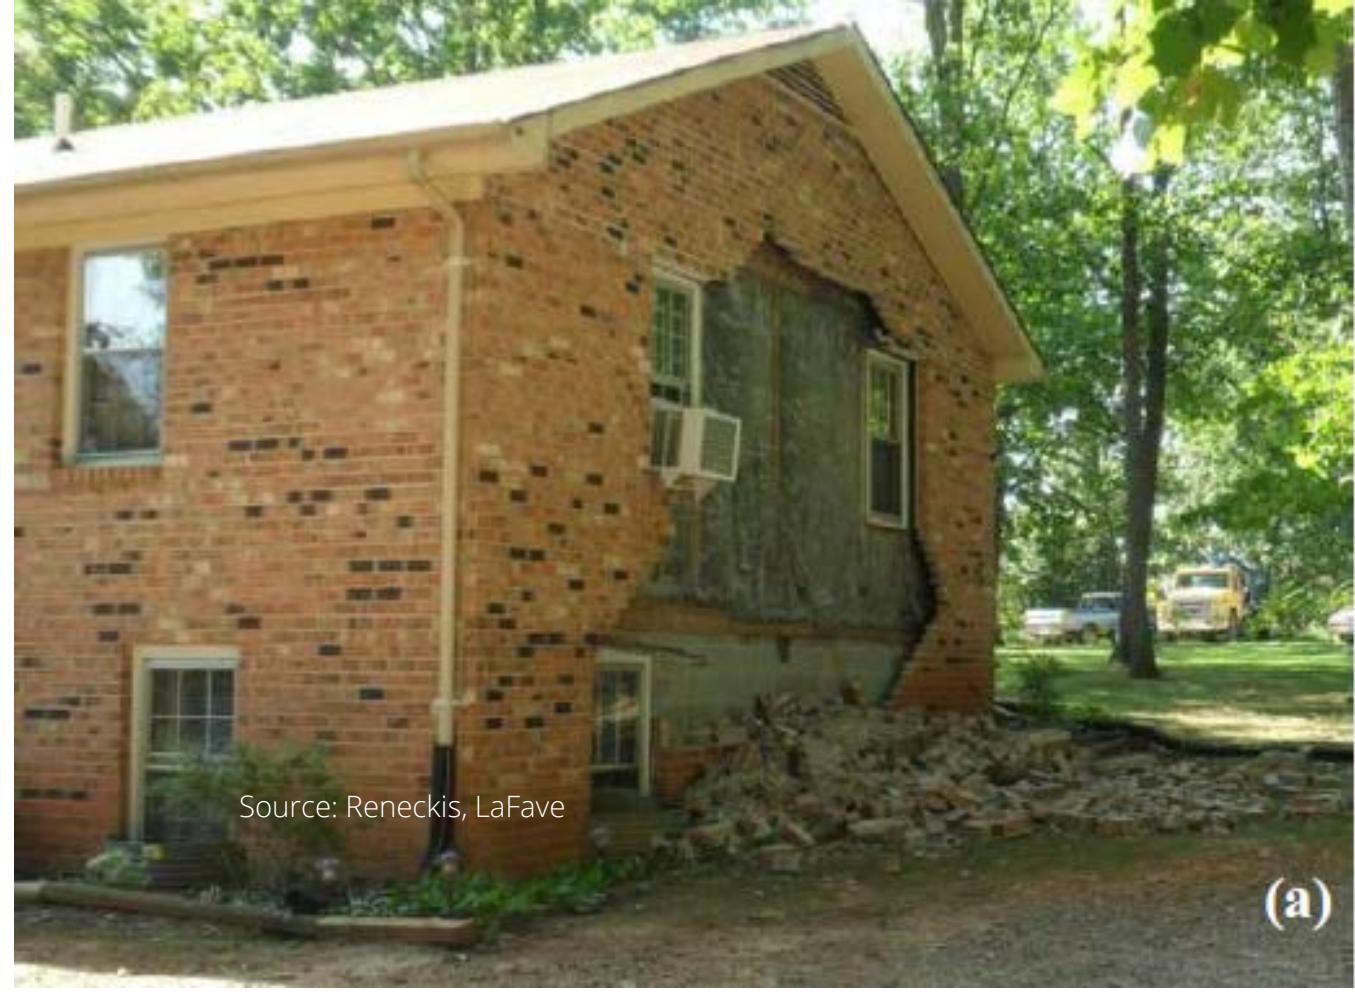
Heavy facades on wood frame

- Anchorage can fail under significant shaking
- Anchorage can lose strength over time with corrosion

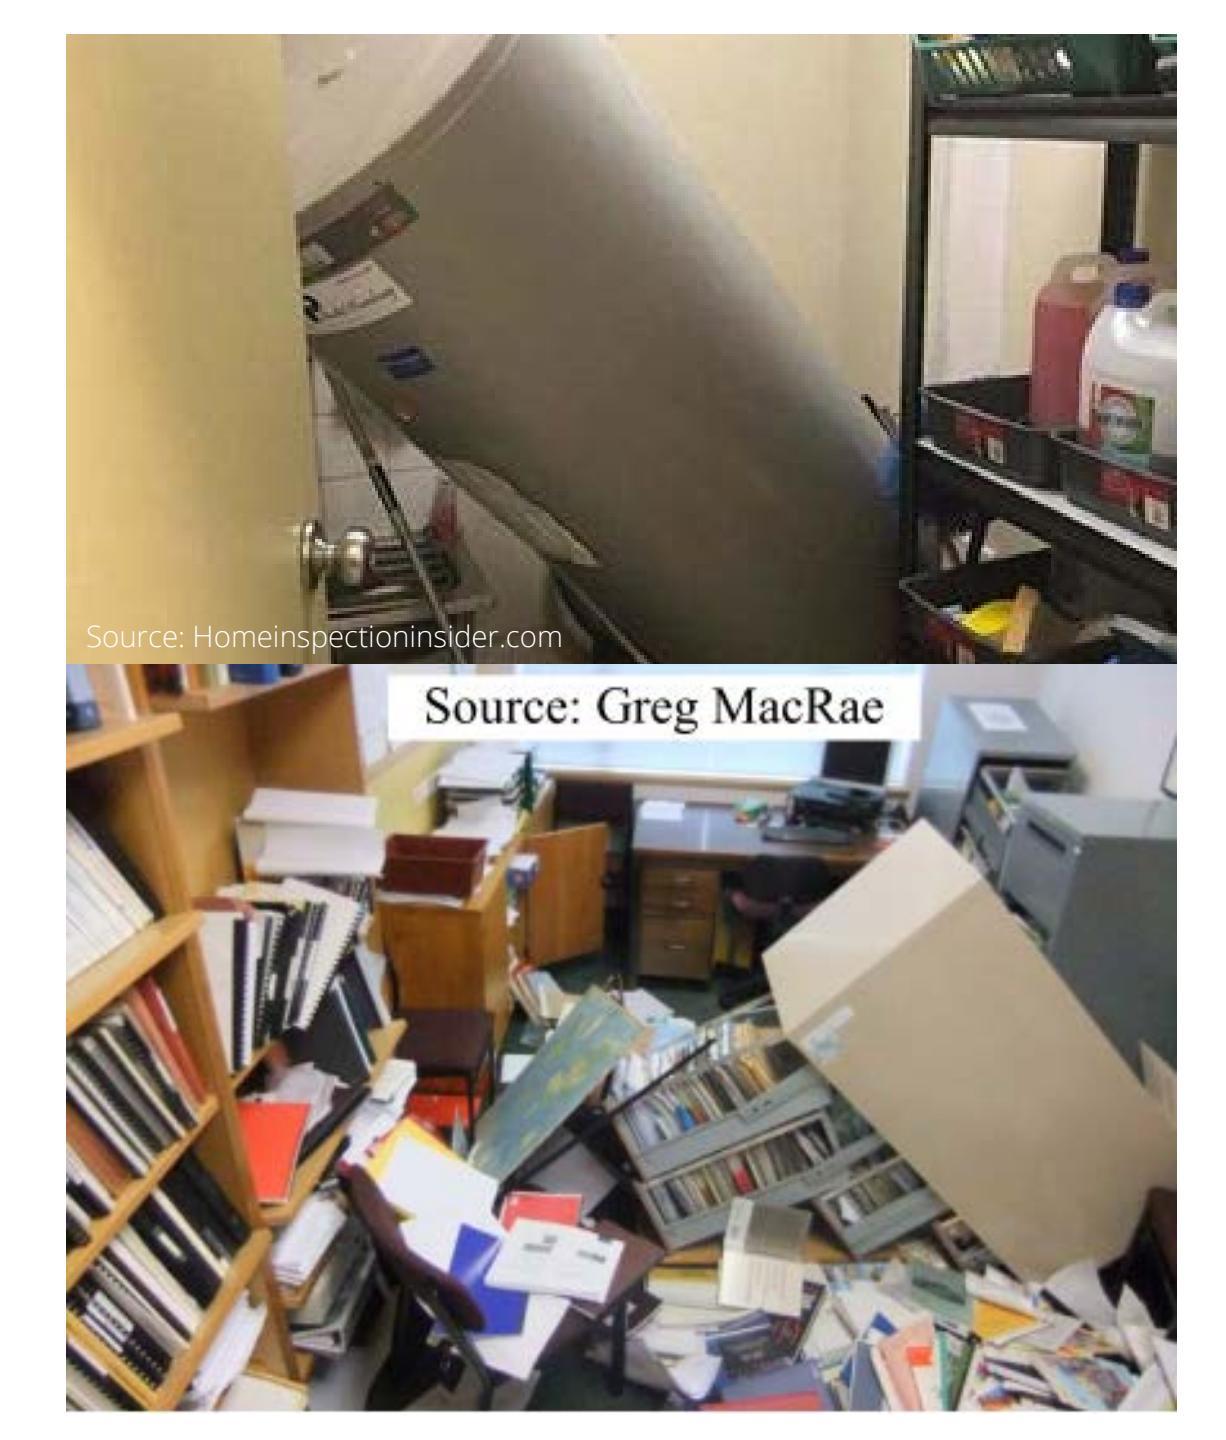
Non-structural issues

- Water heaters
- Bookcases and shelves
- Heavy mirrors
- Objects on display
